## Technical Service Bulletin

| <b>Topic</b> | DTC B17B801 and/or B17B804 - evident within address 0019 and/or DTC U112300 evident in 00A5 |
| <b>Brand</b> | Bentley |
| <b>Transaction No.</b> | 2063855/12 |

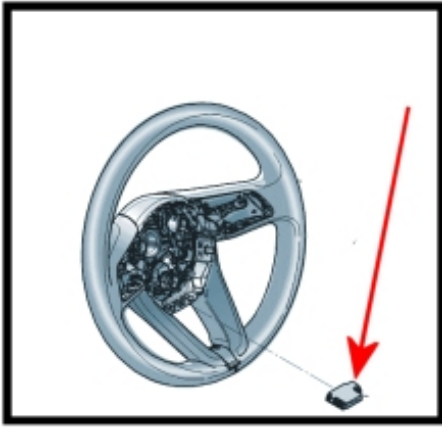
- Lane Assist and / or Traffic Assist are not functional
- DTC - B17B801 - Steering Wheel Touch Recognition Control Module evident within address 0019

- DTC B17B804 - Steering Wheel Touch Recognition Control Module electrical error - evident within address 0019

- 1) Referring to Rep.Gr 69 - Remove the driver's air bag
- 2) Referring to Figure 1 - Replace the Steering Wheel Contact Detection control unit (J1158)

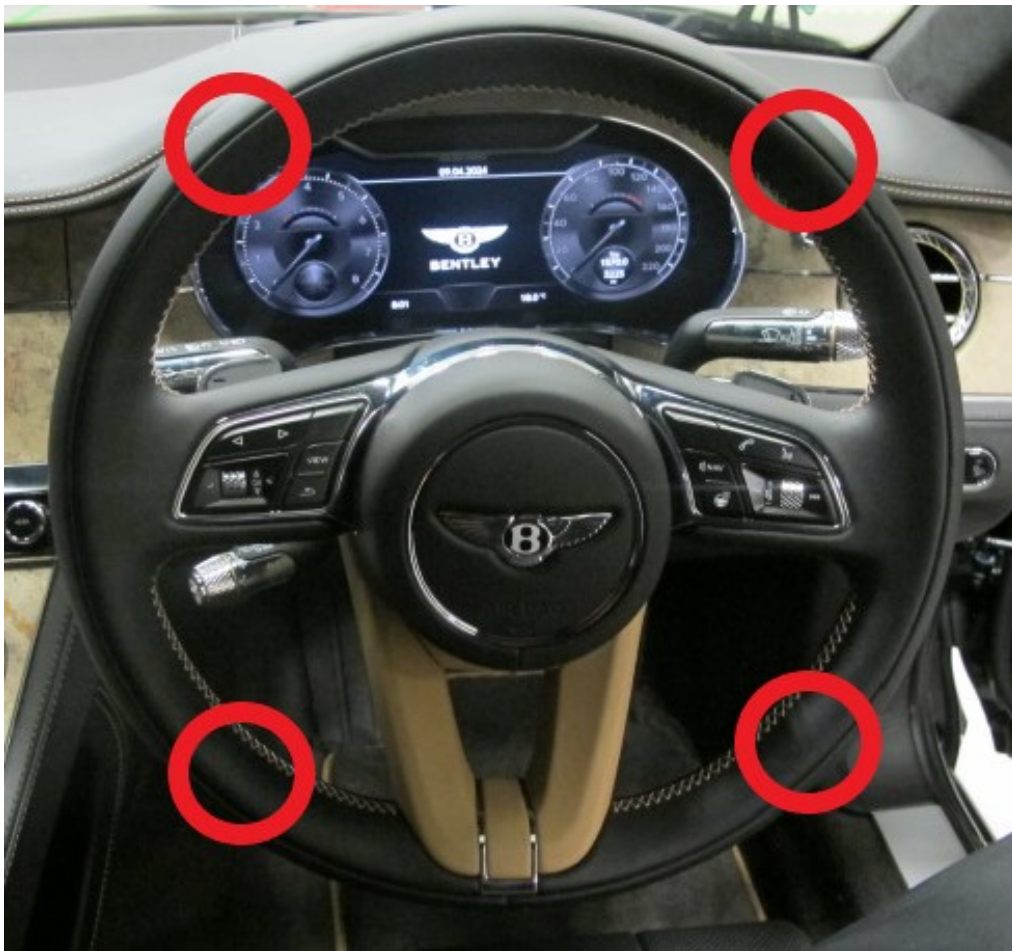
- Monitor the Sensor 2 and Sensor 3 values whilst holding the steering wheel at the points shown - The expected values are between 40 and 60 and No malfunction Detected

Sensor 2 and sensor 3 should recognise contact with the steering wheel and will show the values changing if the system is working to specification

- Place hands (light grip) on the steering wheel at the various points as shown in Figure 3
