## Technical Service Bulletin (TSB)

### Gasoline Particulate Sensor Lines Incorrect Routing

| REFERENCE: | TSB: 25-001-25 REV. A<br>GROUP: 25 - Emissions Control | Date: | October 29, 2025 | REVISION: | 25-001-25 |
| VEHICLES AFFECTED: | 2023 (WL) Jeep Grand Cherokee / Grand Cherokee L<br>This bulletin applies to vehicles built on or before July 21, 2024 (MDH 0721XX) equipped with 2.0L I4 DOHC DI Turbo PHEV Engine (Sales Code ECX). | | | MARKET APPLICABILITY:<br><div><input type="checkbox"/> NA<input type="checkbox"/> MEA</div> <div><input type="checkbox"/> SA<input type="checkbox"/> IAP</div> <div><input type="checkbox"/> EE<input checked="" type="checkbox"/> CH</div><br><b>NOTE:</b> This bulletin applies to the China market. | |

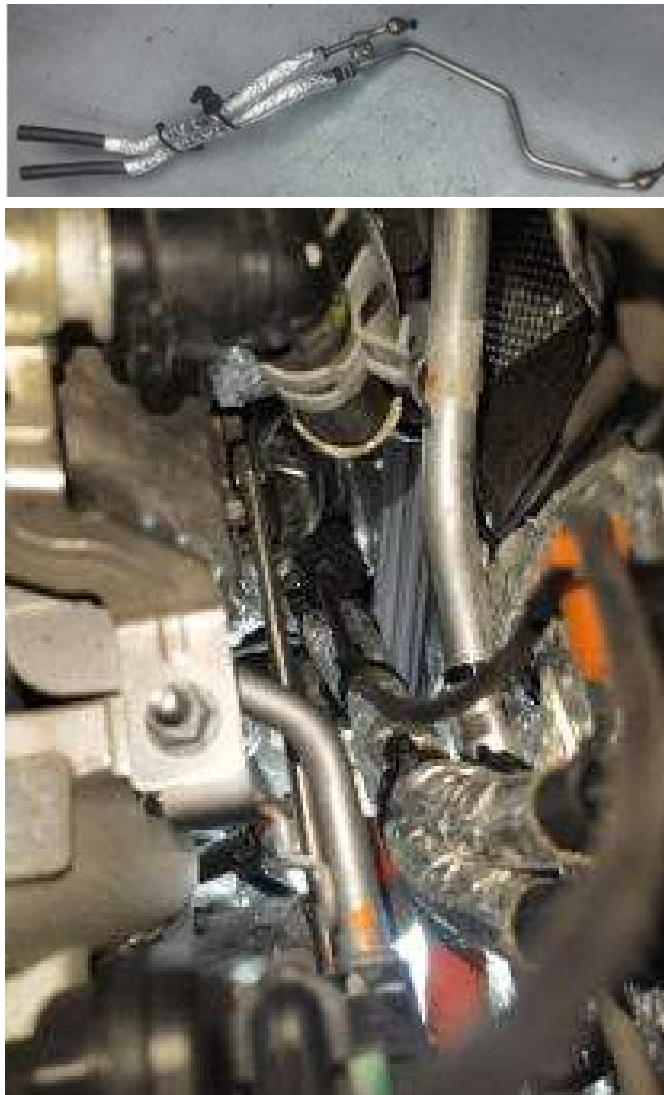
**Fig. 1**

Correct Orientation

1. Using wiTECH, select PCM and then the Data menu. Monitor the PFPS DELPRESS signal for changes when varying RPM.
2. Does the PCM -PFPS DELPRESS (PSI) signal vary with RPM?
  - YES>>> This bulletin does not apply. Use Inspect LOP (25-06-06-02) to close the active RSU.
  - NO>>> Proceed to [Step 3](#).
3. Return the gasoline particulate differential pressure sensor lines to the correct orientation. Refer to the detailed service procedures available in DealerCONNECT/Service Library under: Service Info> 11 - Exhaust System / SENSOR, Differential Pressure / Removal and Installation.

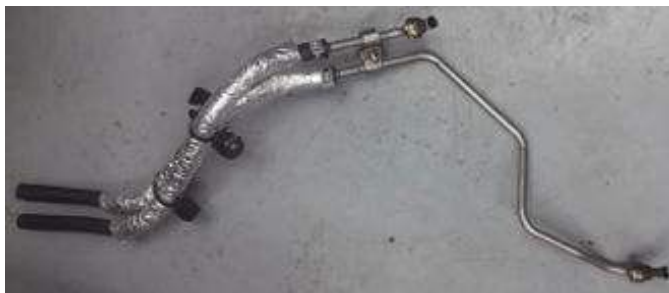
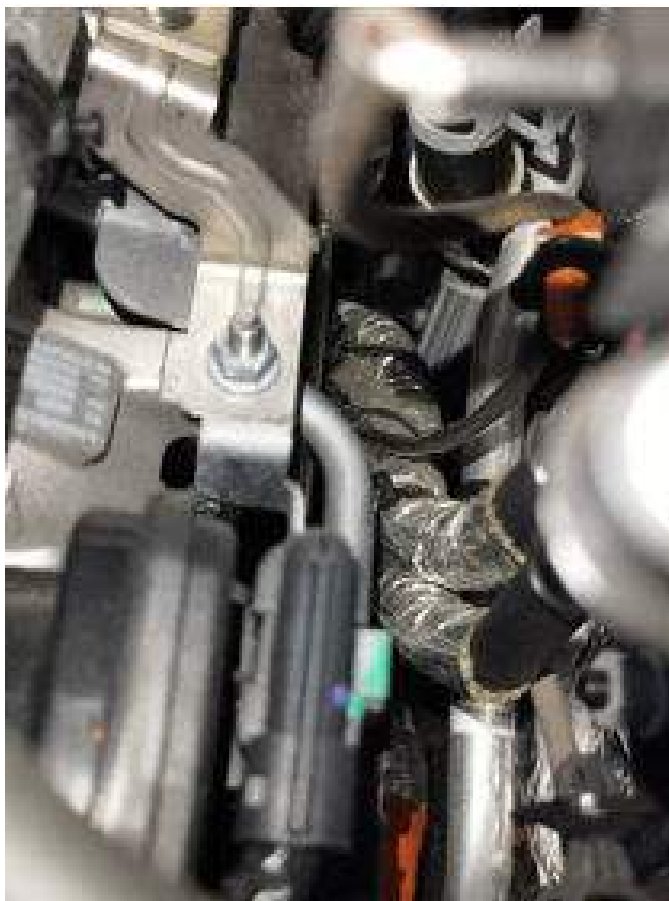
**Fig. 3**  
Incorrect Orientation
