**Technical Service Bulletin (TSB)**  
**Collision Warning And Lane Keep Assist**  
**Indicators Illuminate When Turning Steering Wheel**

| REFERENCE: | TSB: 08-364-25<br>GROUP: 08 - Electrical | Date: | October 30, 2025 | REVISION: | — |
| VEHICLES AFFECTED: | 2023 - 2026 (H1) Jeep Commander<br>2023 - 2026 (M1) Jeep Compass<br>This bulletin applies to vehicles equipped with Active Lane Management System (Sales code XNW) and/or Blind Spot & RR Cross Path Detection (Sales code XAN) built on or before September 26, 2025 (MDH 0926XX). | | | MARKET APPLICABILITY:<br><div><input type="checkbox"/> NA<input type="checkbox"/> MEA</div> <div><input checked="" type="checkbox"/> SA<input type="checkbox"/> IAP</div> <div><input type="checkbox"/> EE<input type="checkbox"/> CH</div><br>NOTE: This bulletin applies to the South America market. | |

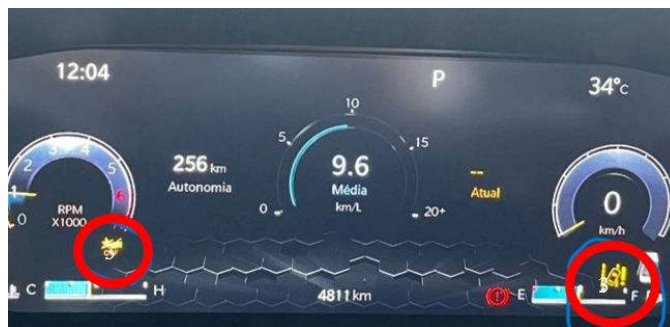
| CUSTOMER SYMPTOM: | Customers must experience a Malfunction Indicator Lamp (MIL) illumination and the vehicle must exhibit/set one or more of the following Diagnostic Trouble Codes (DTCs): <ul style="list-style-type: none"><li>• B178F-15 - Turn Signal Switch-circuit Short To Battery Or Open.</li><li>• B1051-15 - Column Switch Module Turnlights - Circuit Short To Battery Or Open.</li></ul> Customers may also comment on the following: <ul style="list-style-type: none"><li>• The collision warning light and lane-keeping light Fig. 1 illuminate on the Instrument Panel Cluster (IPC) when the steering wheel is turned.</li></ul><br>NOTE: There are no other abnormal behaviors in the vehicle due to this concern. | | | | |
| CAUSE: | Manufacturing issue | | | | |

**Fig. 1**  
Illuminated Collision Warning Light and Lane Keep Light On The IPC

This bulletin involves replacing the signal lever assembly.

1. If the electrical connectors and terminations of the turn signal lever and Body Control Module (BCM) connectors are in compliance, replace the turn signal lever. Refer to the detailed service procedures available in DealerCONNECT/Service Library under: 5550A12 - Comando Indicadores de Direção - Remoção/Recolocação para Veículos com Air Bag.
2. Clear DTCs.
