# Technical Service Bulletin

| Topic | DTC U110100 evident within address 0084 (Night Vision System) Bentayga Series 24MY |
| Transaction No. | 2079206/1 |

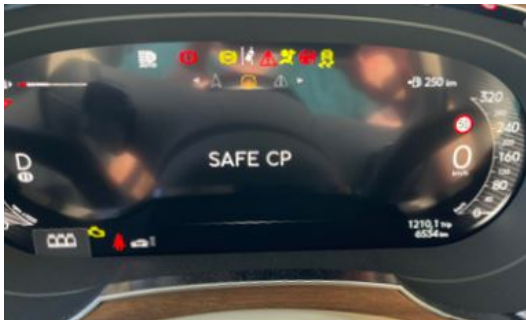
Customer reports that 'SAFE CP' (component protection) is illuminated on the Driver's Instrument Panel.

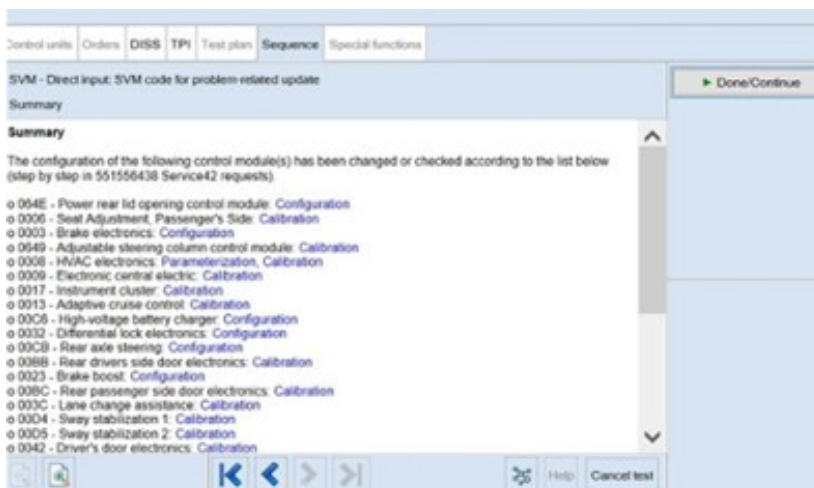
8. If the SVM code completes successfully, ODIS should display as per the image above.
