# Service Bulletin

Bulletin No.: PIT6218C

**Subject:** SES light P059F

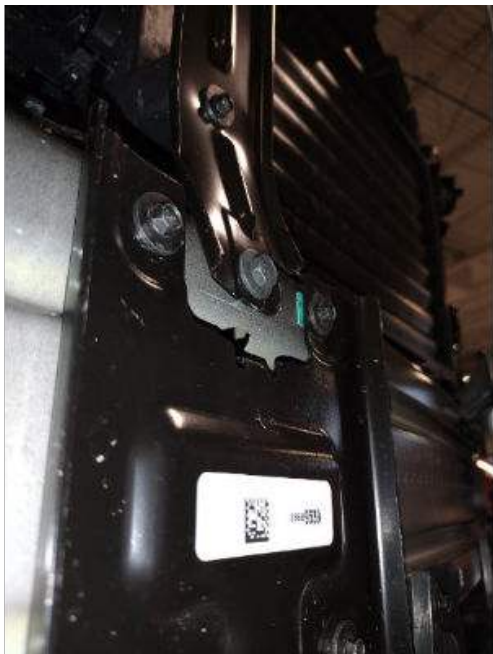
6719668

| Condition | SES light on with code P059F set for active grill shutter malfunction. |
| Cause | Possible bent hood support front bumper bracket. |

Before replacing the grill shutter inspect the bracket in front of it for being bent as shown below.

If the bracket is bent, remove the bracket and command the shutter with GDS2.

If the shutter will move when commanded replace the bracket only.

If the shutter does not move or does not move smoothly, replace the bracket and shutter.

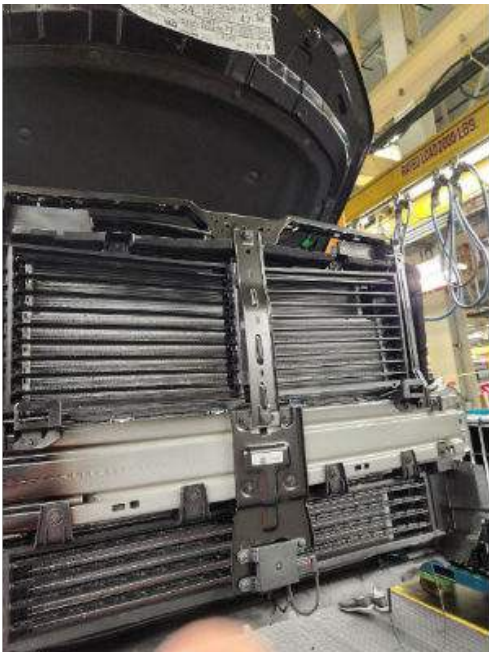
6719671

See the photo below of a good bracket for comparison.

If the bracket is not bent follow SI diagnostics for the code.
