**Technical Service Bulletin (TSB)**  
**Fuel Injector Leak**

| REFERENCE: | TSB: 14-009-25 REV. B<br>GROUP: 14 - Fuel System | Date: | November 8, 2025 | REVISION: | 14-009-25 REV. A |
| VEHICLES AFFECTED: | 2022 - **2025** (B1) Jeep Renegade<br>2022 - **2025** (H1) Jeep Commander<br>2022 - **2025** (M1) Jeep Compass<br>This bulletin applies to the vehicle built on or before **July 31, 2025 (MDH 0731XX)** equipped with a 1.3L I4 Turbo MAIR DI Engine w/ESS E100 (Sales Code EYJ). | | | MARKET APPLICABILITY:<br><div><input type="checkbox"/> NA<input type="checkbox"/> MEA</div> <div><input checked="" type="checkbox"/> SA<input type="checkbox"/> IAP</div> <div><input type="checkbox"/> EE<input type="checkbox"/> CH</div><br>NOTE: **This bulletin applies to the South America market.** | |

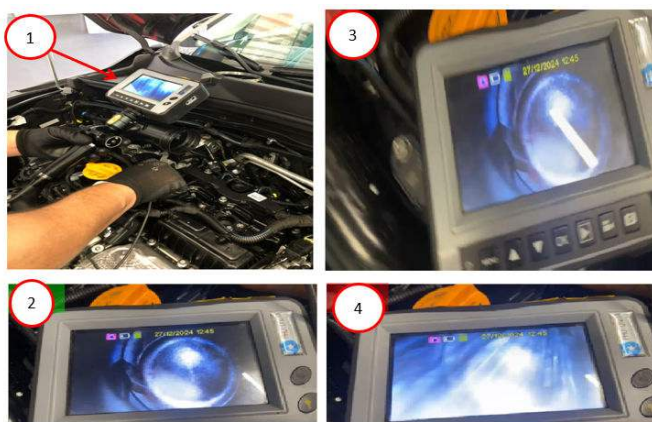
**Fig. 2**  
Endoscope

2. Using an Endoscope, check all injectors [Fig. 2](#). With the help of a collaborator, ask helper to turn the ignition key without starting the vehicle. **Keep the ignition on for one minute per injector.**

1 - Endoscope  
2 - Injector Inspection Okay  
3 - Injector Inspection Not Okay  
4 - Injector Inspection Not Okay

- NOTE:**
- **\*\*If only one injector is defective, replace one injector and the high pressure tube.**
  - **If two injectors are defective, replace only the two defective injectors and the high pressure tube.**
  - **If three or all four injectors are defective, replace all four defective injectors and the high pressure tube.\*\***
1. **Replace the fuel injectors as required if defective and the high pressure tube.** Refer to the detailed service procedures available in DealerCONNECT/Service Library under: Service Info> 1056F60 - Turbo Coletor de Combustível Único - Completo de Eletroinjeter Remoção/Recolocação.
  2. Clear DTCs.
