## Vehicle does not start due to interlock failure

| Topic number | LI54.10-P-080004 |
| Function group | 54.10 - Battery, power supply, voltage converter |
| Validity | 243 with SA codes BAD or BAE |

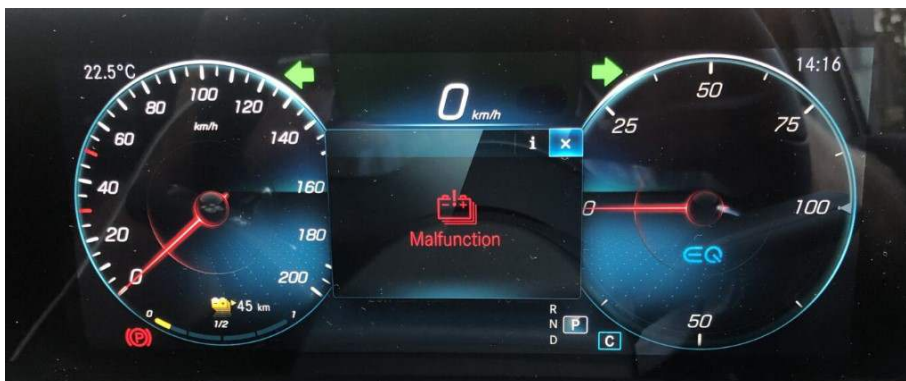
Instrument cluster warning messages :

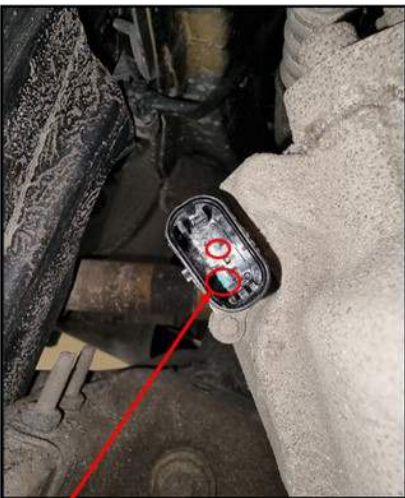
Oxidation in LV connector in ILK circuit pins (Check AC compressor and PTC heater)

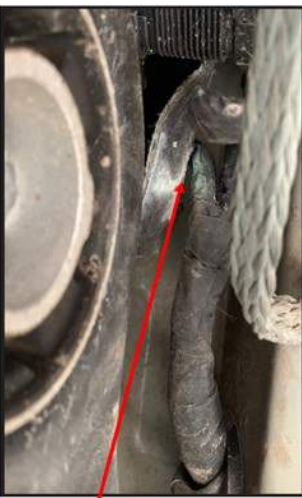
Twisted harness | Harness scratching with the body

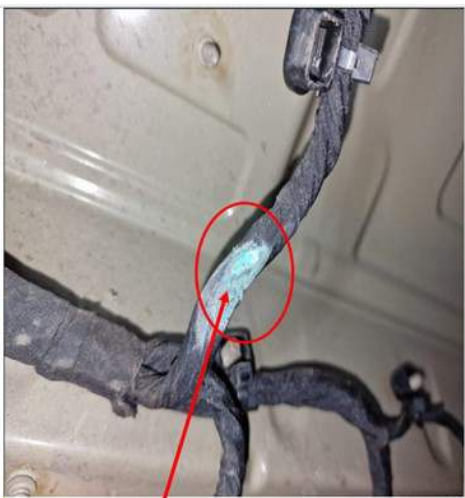
Harness scratching with the body

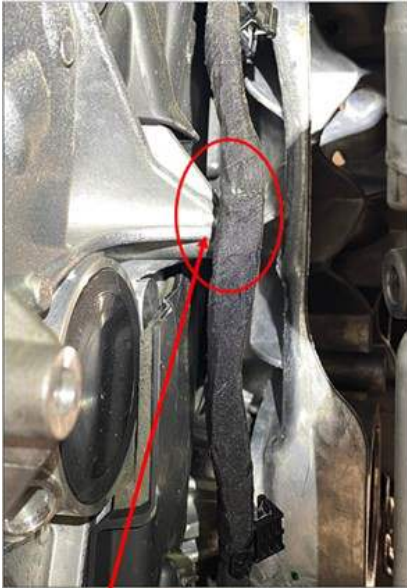
Wiring harness chafed with body near rear e-ATS

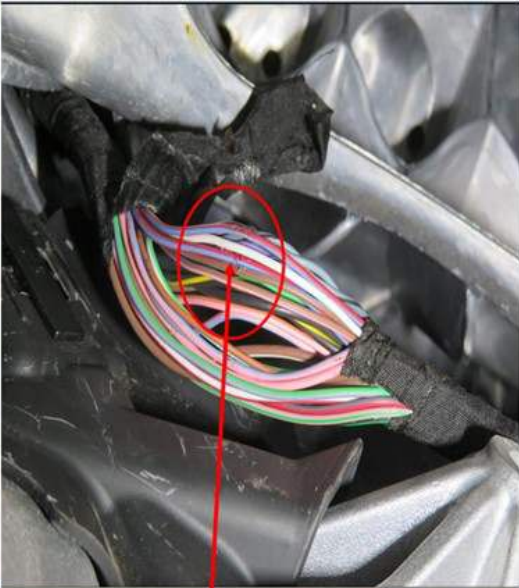
Wiring harness cut near rear e-ATS

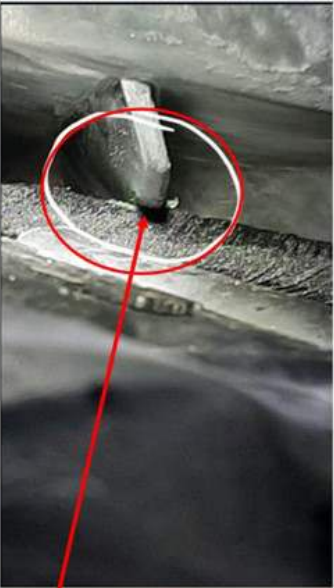
Wiring harness chafed with the body near AC compressor
