| REFERENCE: | TSB: 18-011-25 REV. C<br>GROUP: 18 - Vehicle Performance | Date: | November 18, 2025 | REVISION: | 18-011-25 REV. B |
| VEHICLES AFFECTED: | 2024 (JL) Jeep Wrangler<br>This bulletin applies to vehicles equipped with a 2.0L I4 DOHC DI Turbo Engine W/ESS (Sales Code EC1). | | | MARKET APPLICABILITY:<br><div><input type="checkbox"/> NA<input type="checkbox"/> MEA<br/><input type="checkbox"/> SA<input type="checkbox"/> IAP<br/><input type="checkbox"/> EE<input type="checkbox"/> **CH**</div><br>NOTE: This bulletin applies to the Enlarged Europe, North America, South America, India & Asia Pacific, Middle East and Africa and China markets. | |
| CAUSE: | PCM software | | | | |

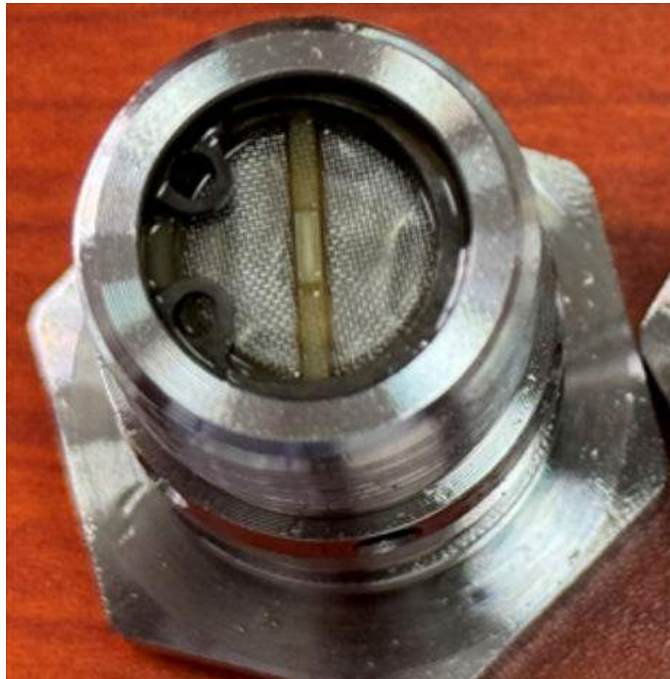
**Fig. 1**  
OCV Filter OK

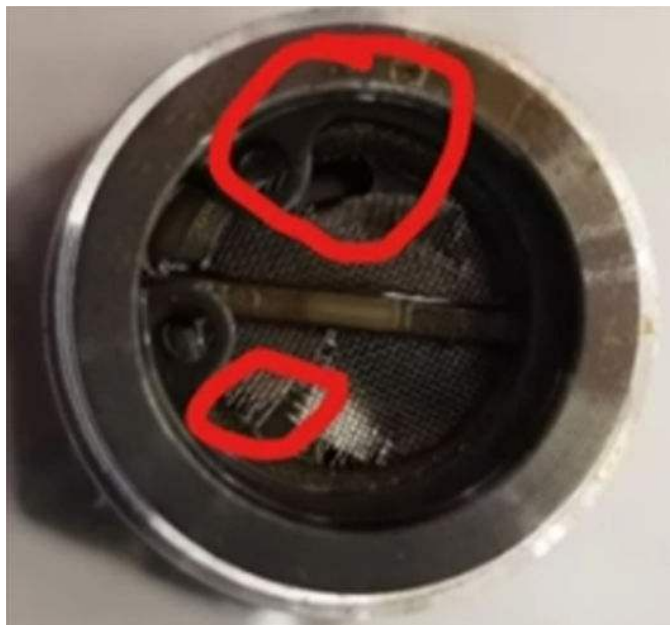
**Fig. 2**  
OCV Filter Torn

5. Are the OCV filter screen(s) torn?

- YES >>> Replace the OCVs and change the engine oil and filter. Refer to the detailed service procedures listed in DealerCONNECT>Service Library>Service Info>under: 09 - Engine, 2.0L / Lubrication / Standard Procedure Engine oil and filter change. Use LOPs (09-05-37-91) and (26-99-00-10). Proceed to [Step 11](#).
- NO >>> Proceed to [Step 6](#).

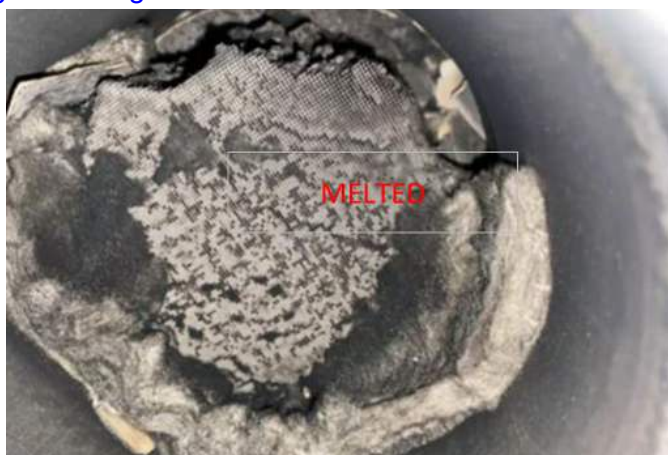
10. Remove the Upstream Oxygen Sensor and using a borescope, is the catalytic converter internally melted/ cracked or brain pattern [Fig. 3](#) and [Fig. 4](#) ?

**Fig. 3**  
Melted Catalyst

- YES >>> Replace the catalytic converter. Refer to the detailed service procedures listed in DealerCONNECT>Service Library>Service Info>under: 11 - Exhaust System / Converter, Catalytic / Removal and Installation. Use LOP (11-50-01-91). Proceed to [Step 11](#).
- NO >>> Use Inspect LOP (11-50-01-90). Proceed to [Step 11](#).
