2021-2024MY  
K5 (DL3a)  
w/Theta III 2.5L T-GDI

260

November 2025

ITM REPLACEMENT AND ECM  
LOGIC IMPROVEMENT (CA2511)

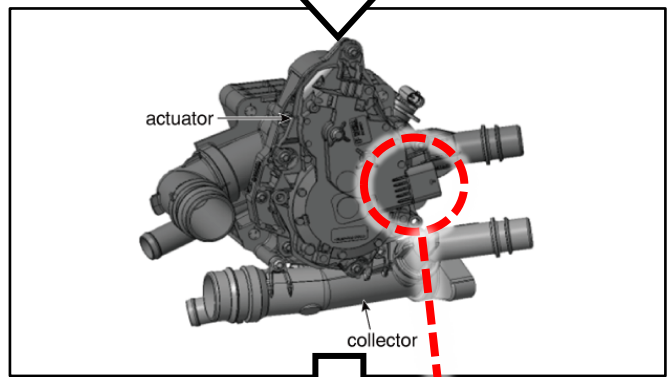
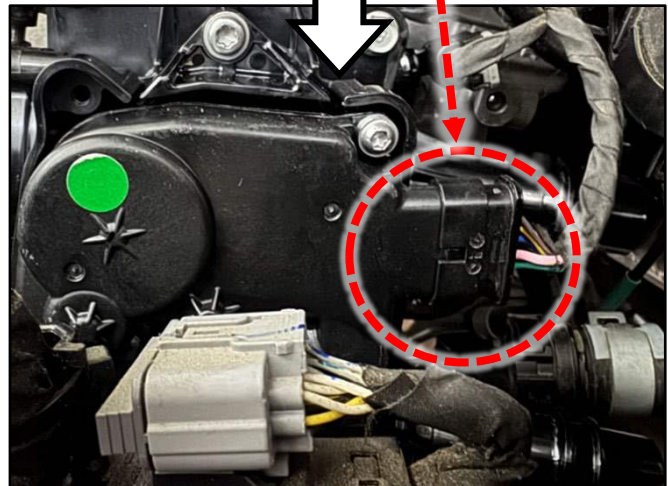
**Note:** The ITM connection orientation changes after replacing the new ITM part. The locking tab will face the engine.

Trying to make the connection on the new ITM in the same orientation as the original ITM may damage the connector pins/terminals.

2. Reinstall all removed parts in reverse order of removal.
