2023MY  
Sportage (NQ5, NQ5a)  
w/Theta III 2.5L GDI

259 (Rev 1, 11/6/2025)

## TECHNICAL SERVICE BULLETIN

## LOGIC IMPROVEMENT (CA2509)

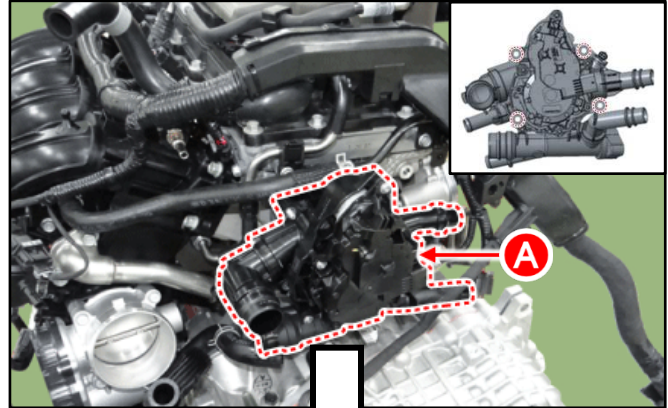
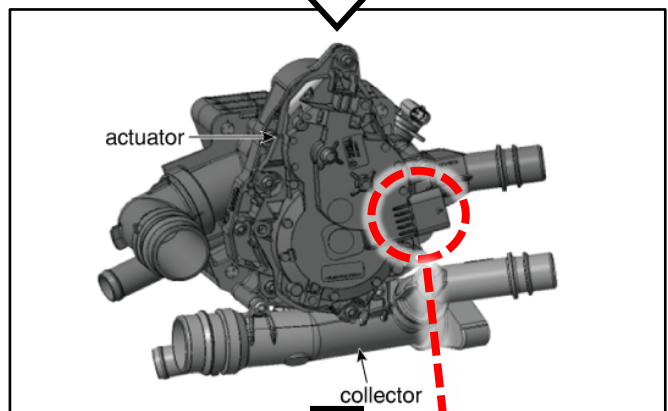
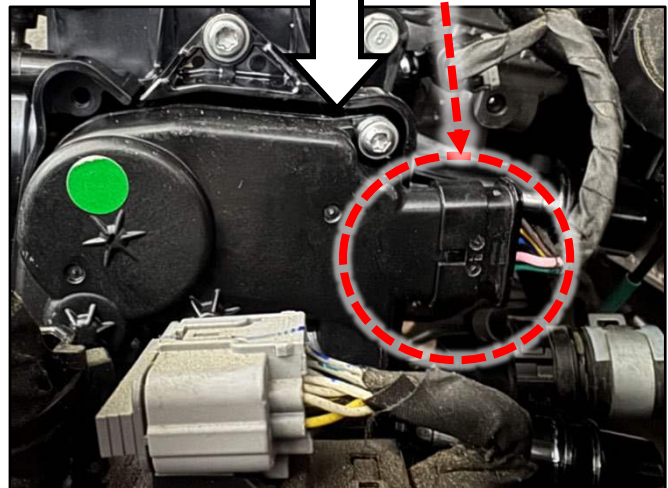
**Note:** The ITM connection orientation changes after replacing the new ITM part. The locking tab will face the engine.

Trying to make the connection on the new ITM in the same orientation as the original ITM may damage the connector pins/terminals.

1. Replace the Integrated Thermal Management Module 'ITM' (A) by referring to "Engine Mechanical System → Cooling System → Integrated Thermal Management Module (ITM) → Repair procedures" in the applicable Shop Manual on KGIS.

Tightening torque for bolts:  
7.2 - 8.7 lb.ft (9.8 - 11.8 N.m)

Do NOT disassemble the actuator and collector. The new ITM is supplied as an assembly unit.

2. Reinstall all removed parts in reverse order of removal.
