## SERVICE BULLETIN

**APPLICABILITY:** 2024MY Crosstrek & Impreza

**NUMBER:** 09-118-24R

**SUBJECT:** DTCs P2404 & P0087 / Reprogramming Files

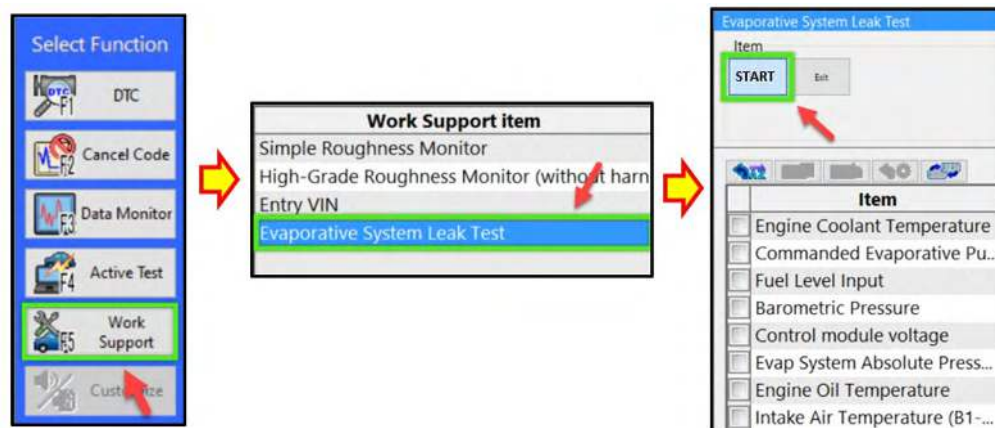
Once the evaporative system leak test is complete, check the DTCs and examine the vacuum value results. Record the value shown in the row labeled MID: \$3C, TID: \$C4, and Scaling ID: \$FE. This value should be lower than -0.26 PSI.

**STEP 6:** Connect the vehicle to a recommended power supply. See **APPENDIX A** for additional information regarding power supply. Using SSM, perform the Evaporative System Leak Test. Collect and save all data.

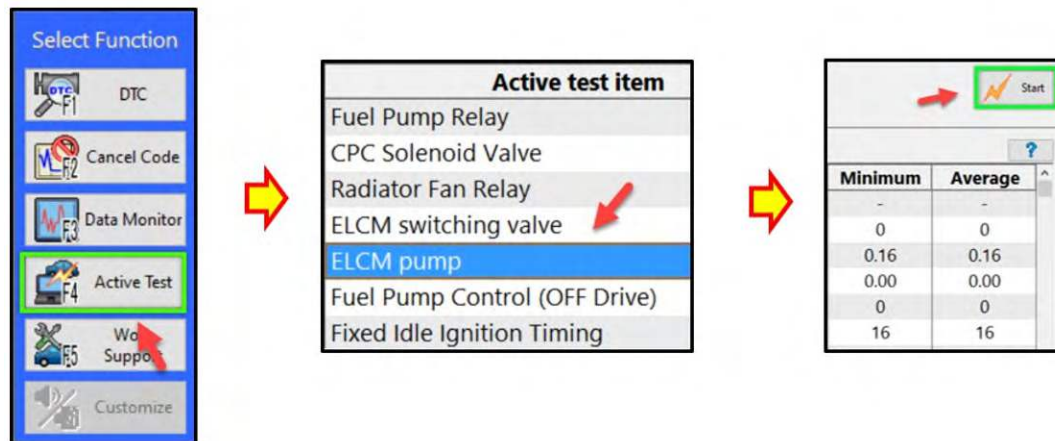
Once the ELCM Pump Active Test has been performed for a period of 35 minutes or more, repeat the Evaporative System Leak Test outlined in STEP 6. Check the DTCs and the vacuum value results.

**STEP 8:** Using SSM, perform the ELCM Pump Active Test for a period of 35 minutes or more. See **APPENDIX A** for additional information regarding power supply.
