## TECHNICAL SERVICE BULLETIN

### Illuminated MIL With DTCs P0301-P0306, P0201-P0206 And/Or Various Other DTCs Stored In The PCM

**25-2569**

| <b>Ford</b><br>2021-2025 F-150 | Engine: 3.5L PowerBoost<br>Built on or before 14-Apr-2025 |

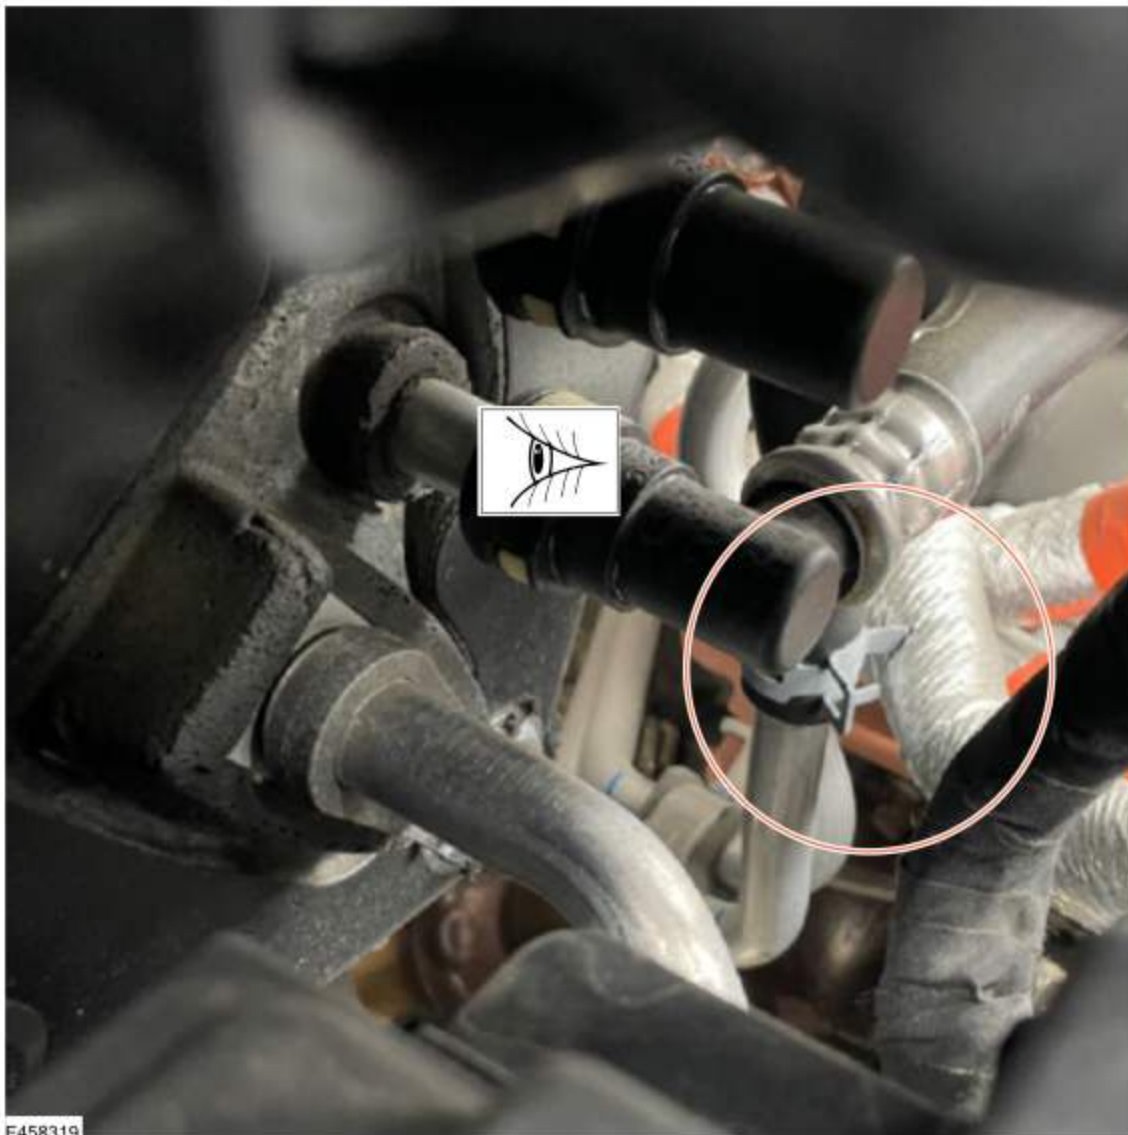
Figure 1

**4. Locate the exhaust heat exchanger heater hose assembly spring clamp under the hood near the rear of the engine beneath the PCM. Refer to the WSM, Section 303-03C > Description and Operation > Component Location and Figure 1. Observe the orientation of the spring clamp. Are the heater hose clamp tangs pointed toward and/or contacting the 12A581B engine harness? (Figure 1)**
