# TECHNICAL SERVICE BULLETIN

## Gear Shift Module (GSM) Concerns

**25-2579**  
26 November  
2025

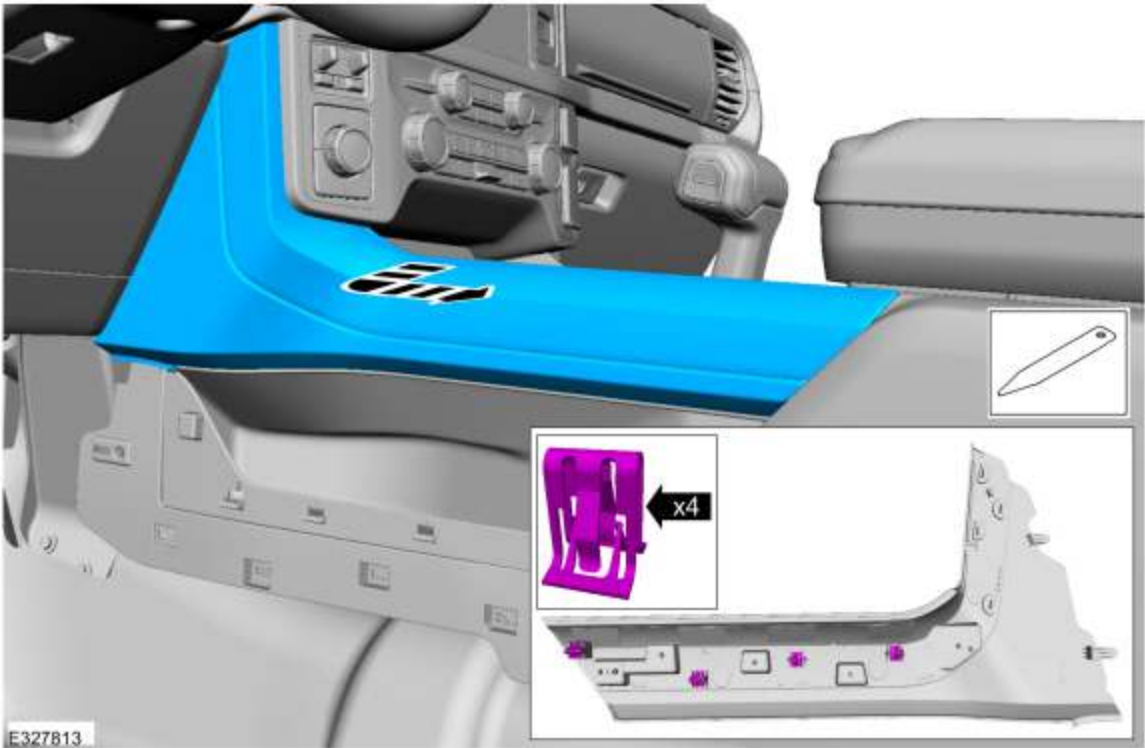
Figure 1

- 1. With the system in Ready to Drive mode/engine running, apply and release the brake pedal while observing BRK\_PDL\_SW2 PID in the BCM. Does the BRK\_PDL\_SW2 PID change status when the brake pedal is pressed and released?
  - (1). Yes - proceed to Step 2.
  - (2). No - diagnose the brake pedal switch output and repair outside of this article. Refer to WSM, Section 307-05.
- 2. Is the vehicle built on or before 08-Sep-2025?
  - (1). Yes - proceed to Step 3.
  - (2). No - This article does not apply. Refer to WSM, Section 307-05.
- 3. Remove the left console trim to inspect the GSM build date. Refer to WSM, Section 501-12. (Figure 1)
