# Service Bulletin

Bulletin No.: 24-NA-166

**Subject: DTC C1171 C1172 C1173 C1174 Tire Pressure Monitor Sensor Unable to Relearn Ethernet Cable Overlay for TCP OnStar Module**

**This Service Bulletin replaces PIT6188E. Please discard all versions of PIT6188.**

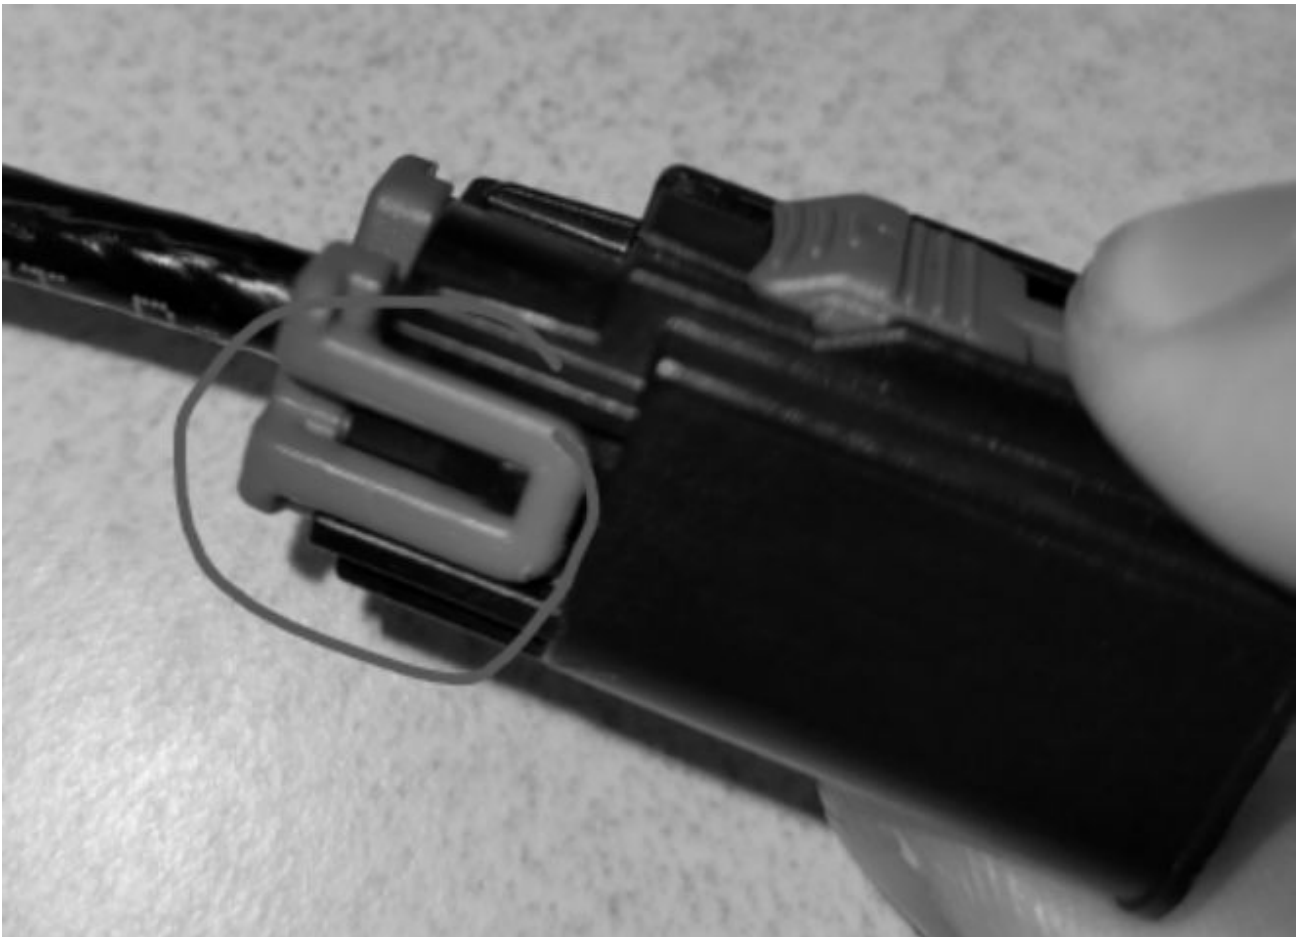
6720403

Empty housing shell. Circle in red is the 1 release tab. Arrow shows the direction the tab needs to be pressed to release the cable, moving it away from the middle.

15.1. Remove the rear clip by releasing both clips from the outer housing and remove it.

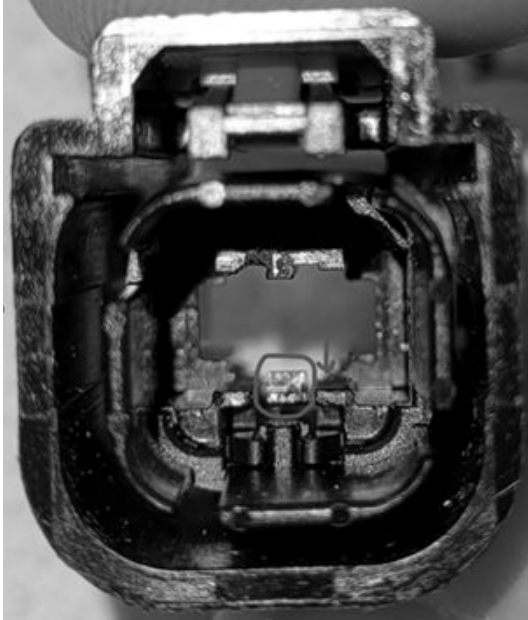
6720429

The X205 housing tab is very difficult to see with the cable installed.

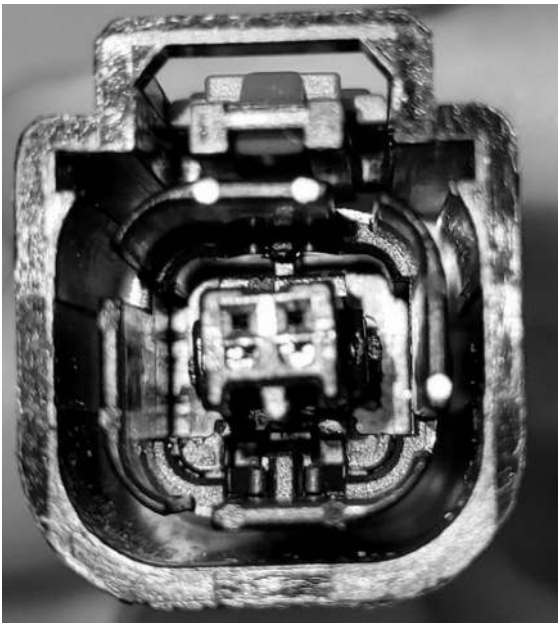
6720432

Following the middle ridge to the back, this is where the housing locks onto the cable.

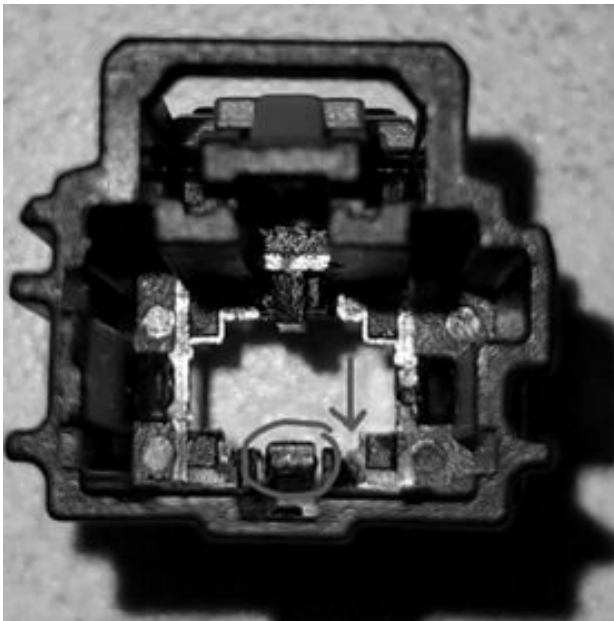
6720422

The X7 housing tab is very difficult to see with the cable installed.

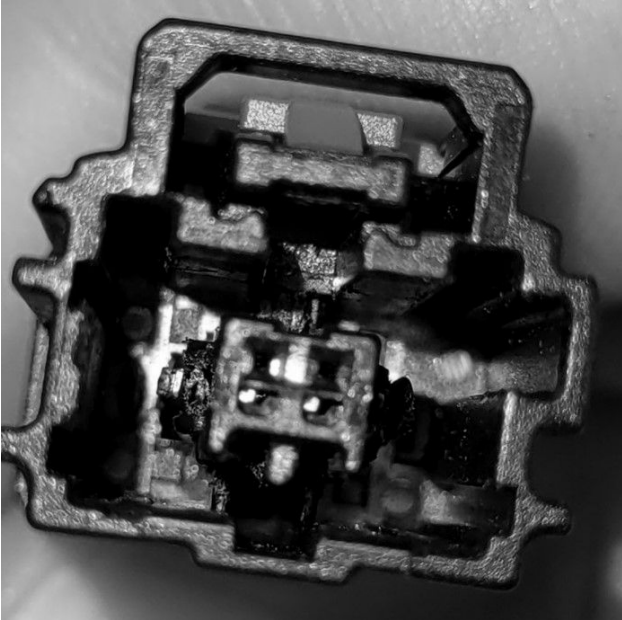
6720426

Following the middle ridge to the back, this is where the housing locks onto the cable.

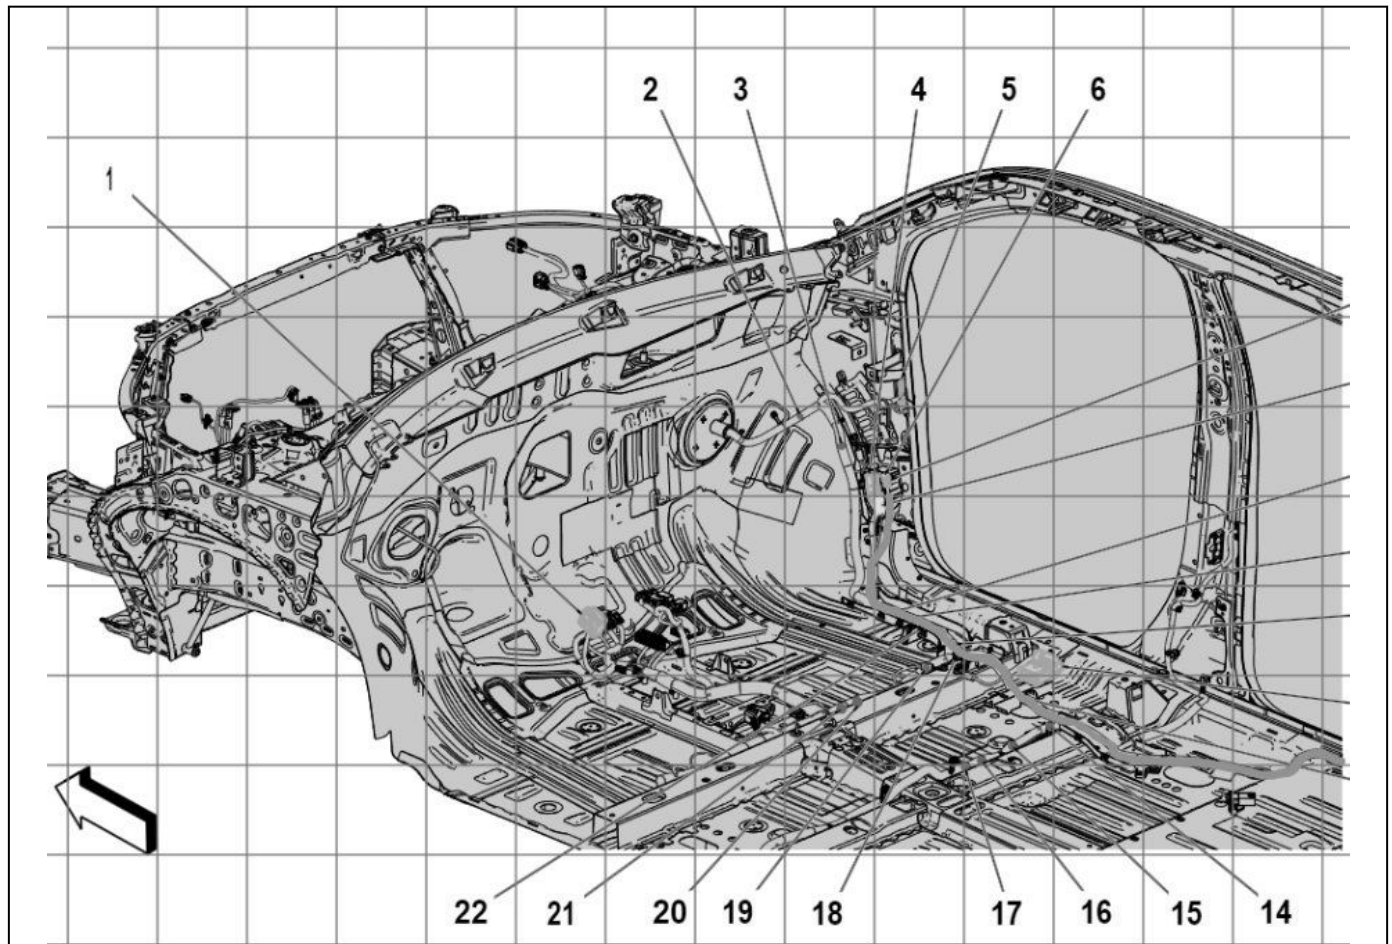
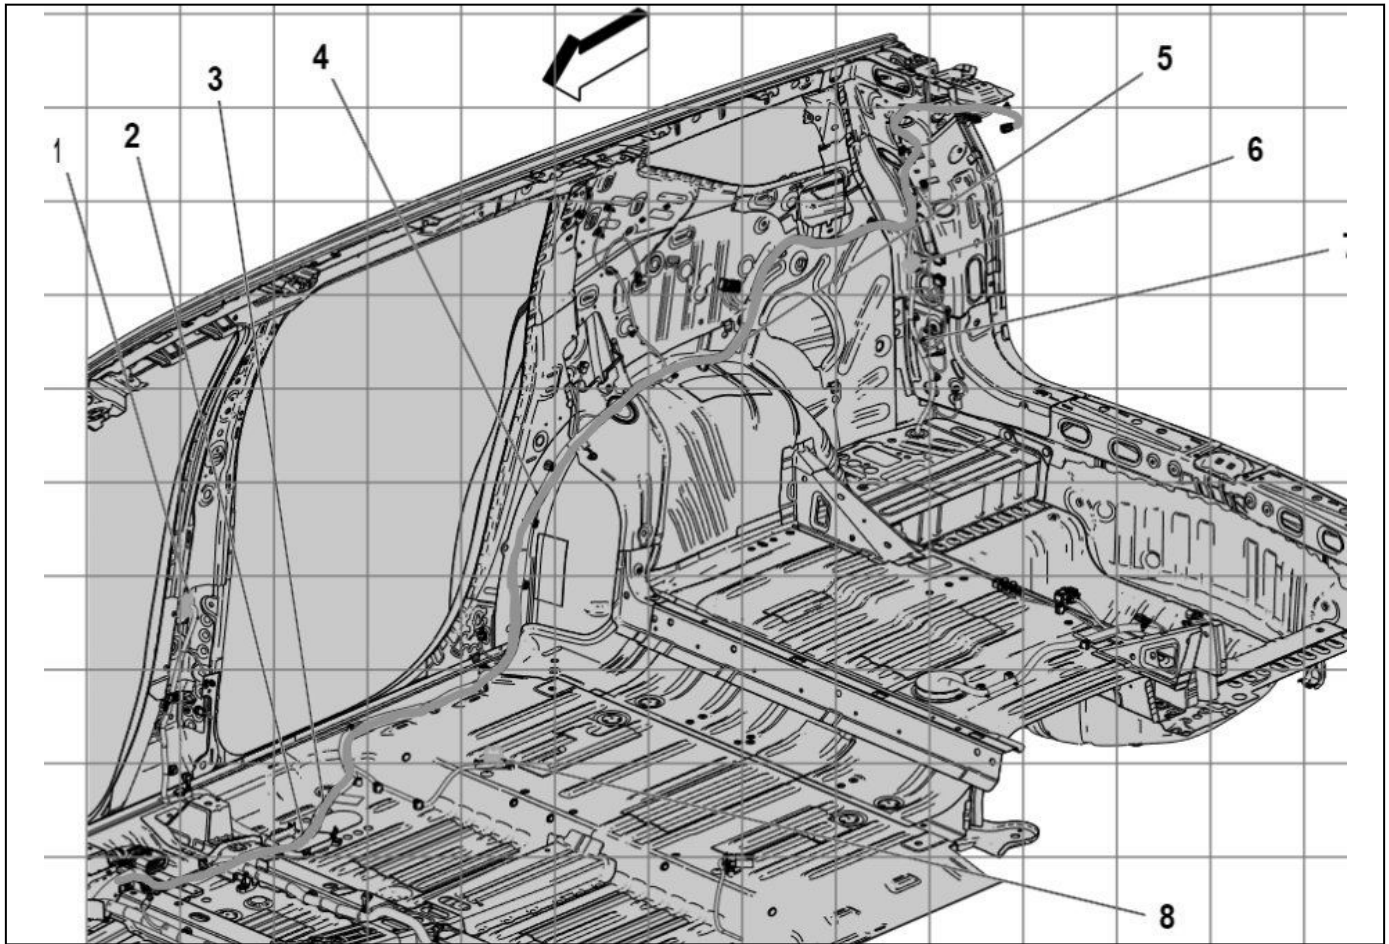
**Note:** Replacement Ethernet Cable routing shown in Green.

18. Begin to route the new Service cable starting at X205 and following the Body Wiring Harness running back towards the Telematic Control Module. Use the diagrams above to reference cable routing.
