## Condition

### Customer states:

- Exhaust emissions warning lamp on

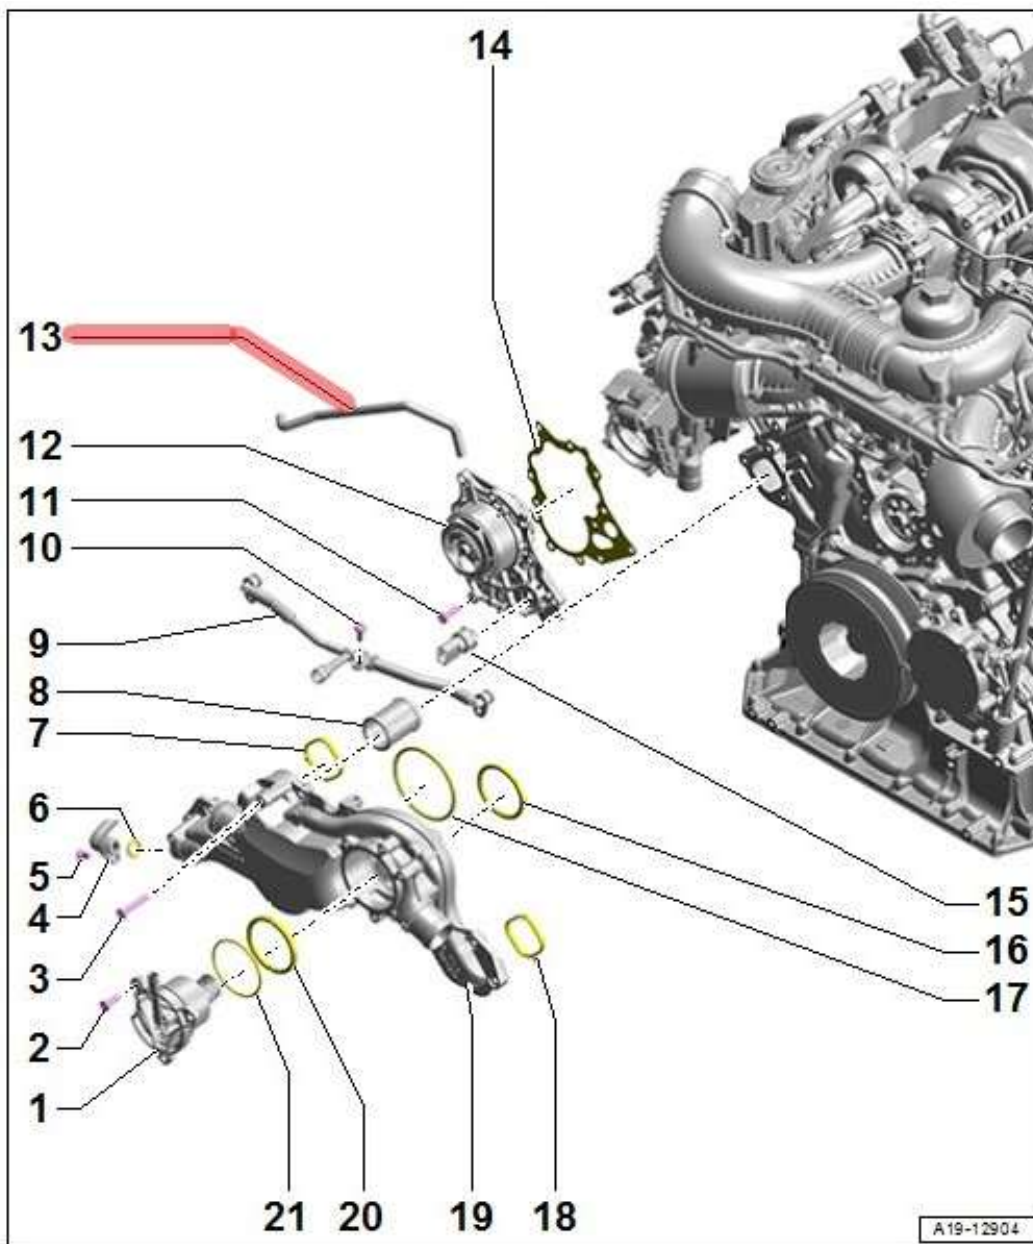
First, please check the vacuum hose between the mechanical coolant pump and the switch valve for mechanical coolant pump (N649) for damage and leaks.

When performing the check, please note that the switch valve for mechanical coolant pump (N649) is closed when not activated and therefore does not supply vacuum to the mechanical pump.

**Figure 1.** Assembly overview; coolant pump/thermostat including switchable mechanical coolant pump in position 12, vacuum hose between mechanical coolant pump and switch valve for mechanical coolant pump (N649) in position 13.

If you discover damage or a leak, please replace the vacuum hose.

If you do not find any damage or a leak, please continue with Guided Fault Finding.
