# Field campaign

| Topic | Software Update BiL 5.3.1 v1 to v2 Flying Spur 25MY (SC25/11) |
| Campaign number | ED42 |

## 25MY Flying Spur

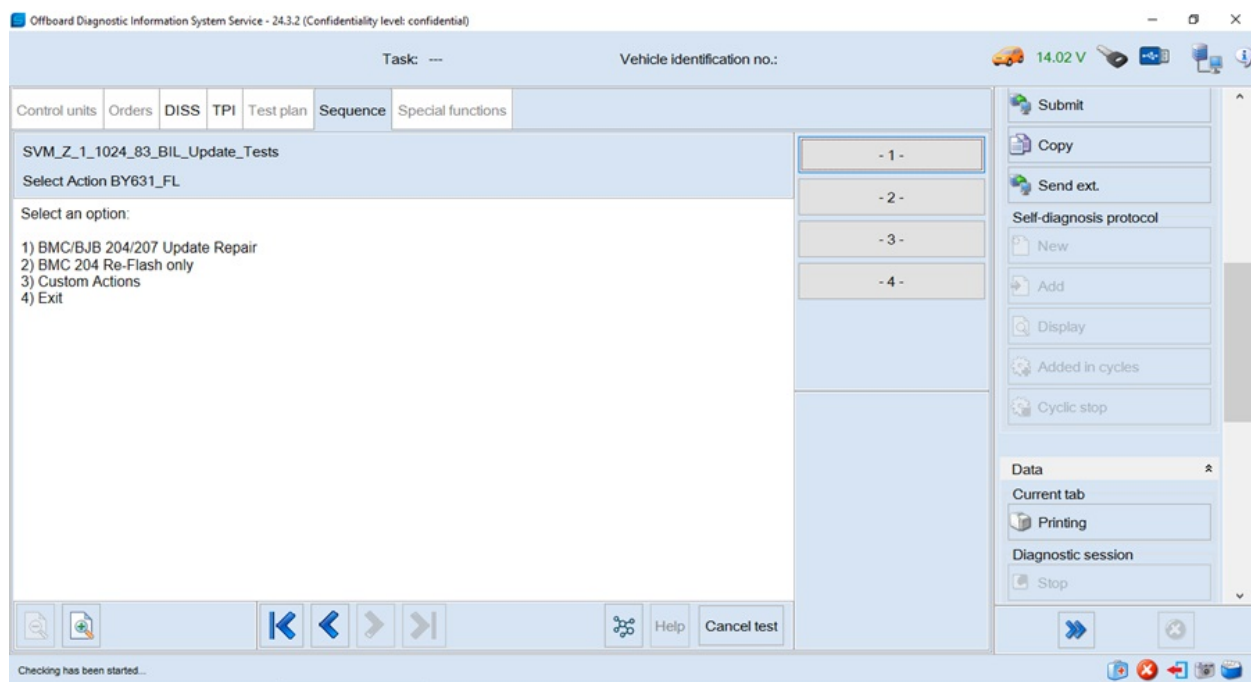
2. Navigate to 'Special functions' and select 'SVM – Pre 372BIL5201 Hotfix Routines', then 'Perform test'.
3. Switch to 'DoIP' when prompted.
4. Select '1) BMC/BJB 204/207 Update Repair' and follow the on-screen instructions.
  - When the tester attempts to flash '008C - Battery regulation control module' you may receive a message informing you that the pre-conditions have not been met. Select 'done/continue'.
  - On the following screen (shown below) select option 2 to attempt to flash the ECU – this should allow the '008C - Battery regulation control module' to flash successfully.

- If the flash fails, perform the below actions.
1. Exit the test.
  2. Allow the car to sleep for 5 minutes.
    - a. Turn off the ignition.
    - b. Remove all equipment from the car (Diagnostic tester/dongle, battery charger, keys).
    - c. Close all doors, windows, bonnet and boot lid.
    - d. Lock the vehicle to perform a CAN-BUS sleep (wait 5 minutes).

3. Clear DTCs from '008C - Battery regulation control module'.
- 3a. To do this, right click on control unit 008C, click Guided Functions and then click 'Clear Fault Memory'.
4. Return to 'Special functions' and run the test plan 'SVM – Pre 372BIL5201 Hotfix Routines'.
5. Within this test plan, select option 2 and run until completion.
6. Once the test has been completed, right click on control unit 008C and select guided functions. Then, read ECU Identification and ensure that the 06D0 (Battery Junction Box) appears as a subsystem within the read identification test plan.
7. Continue to the next SVM update.

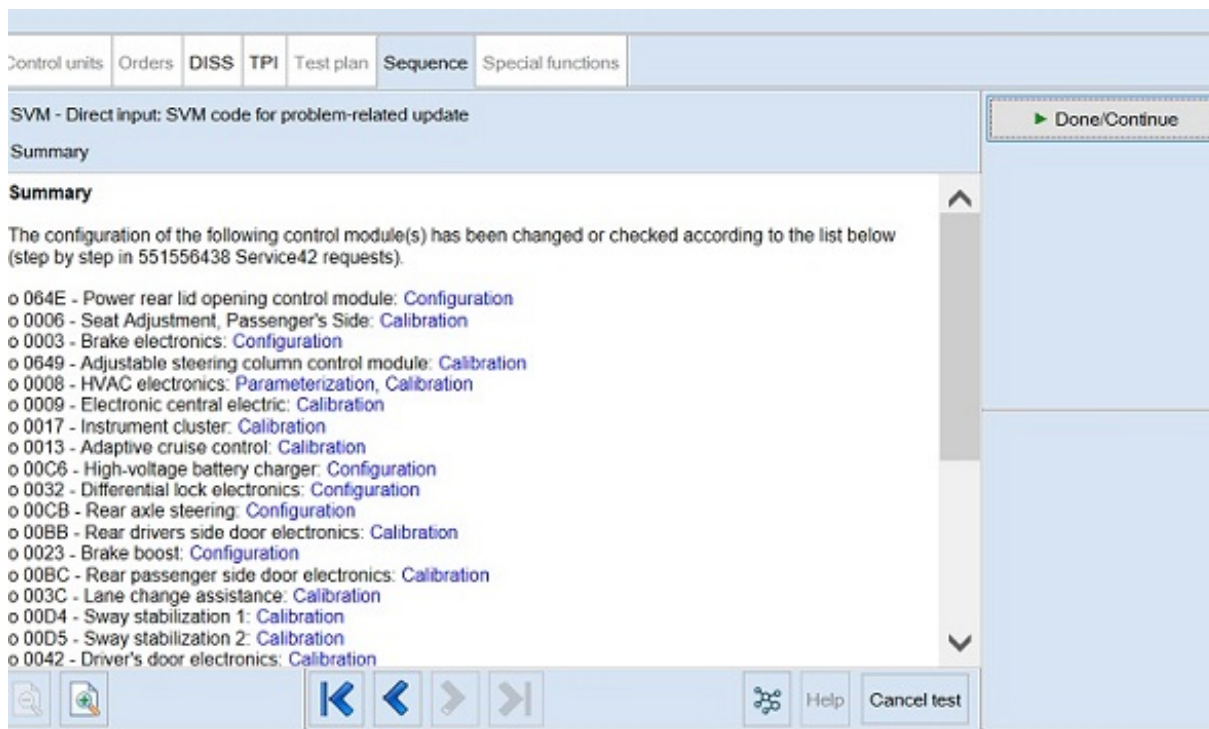
Fig 3

9. If you are presented with this screen (Fig 3) at the end of the update, the update was successful. Please continue to step 11.

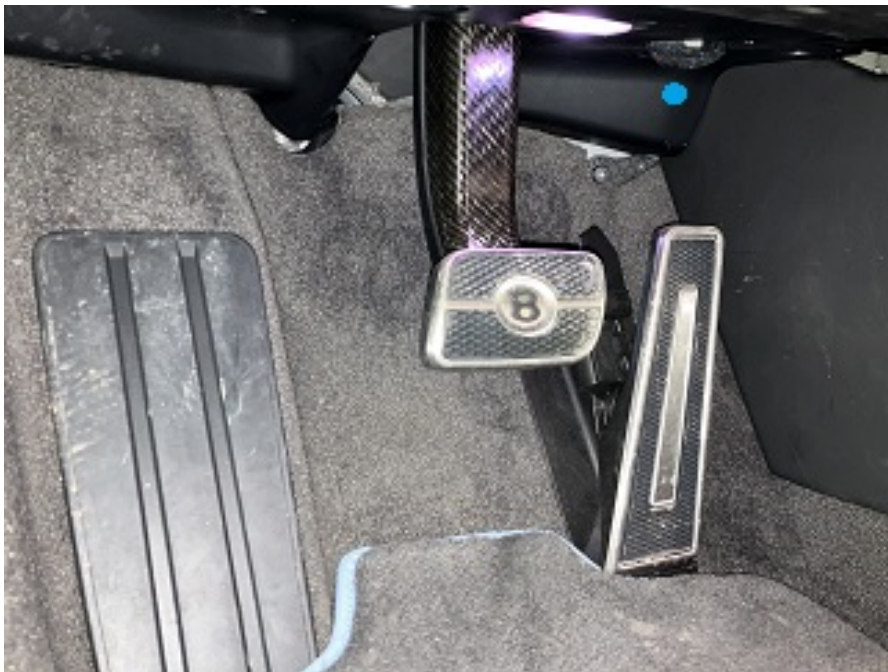
You must also add a blue paint mark as per the picture below.
