# Technical Service Bulletin

| <b>Topic</b> | Engine coolant - Overheat condition - Warning evident within the DIP - DTC's P2B6500 and P2B8600 are evident |
| <b>Transaction No.</b> | 2066669/4 |

Engine coolant - Overheat condition - Warning evident within the DIP - DTC's  
P2B6500 and P2B8600 are evident

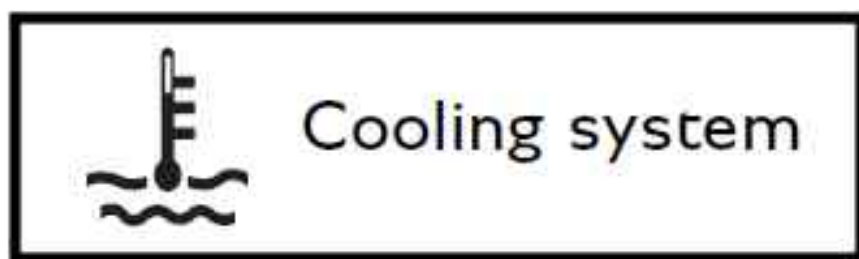
- Warning light in Drivers Information Panel (DIP) as Figure 1

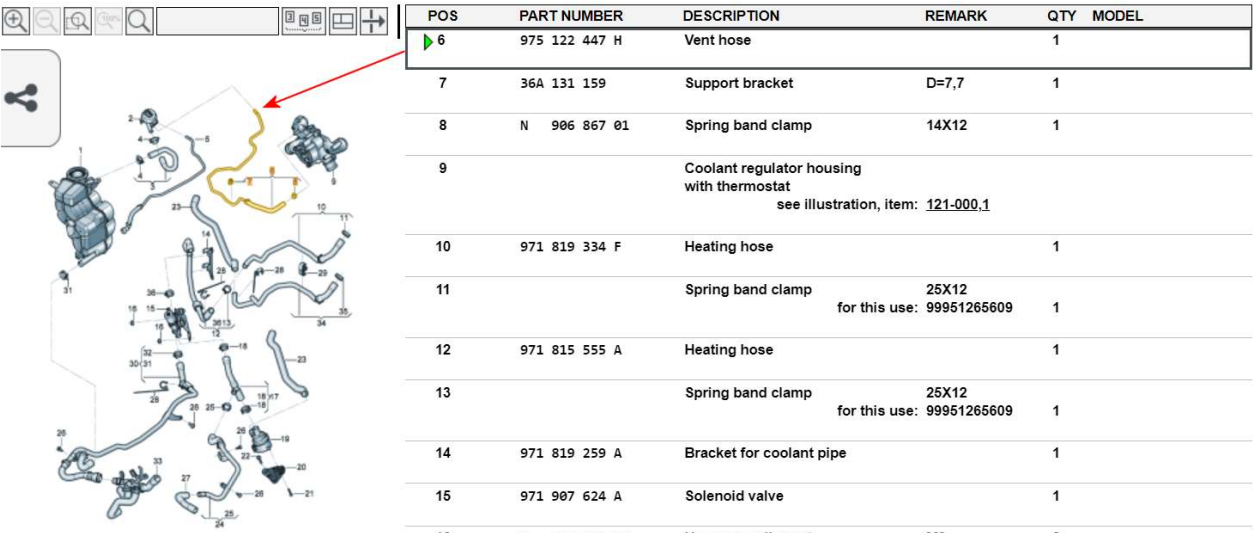
2) Referring to Figure 2 - Locate the vent hose shown (975 122 447H)

4) Replace the vent line

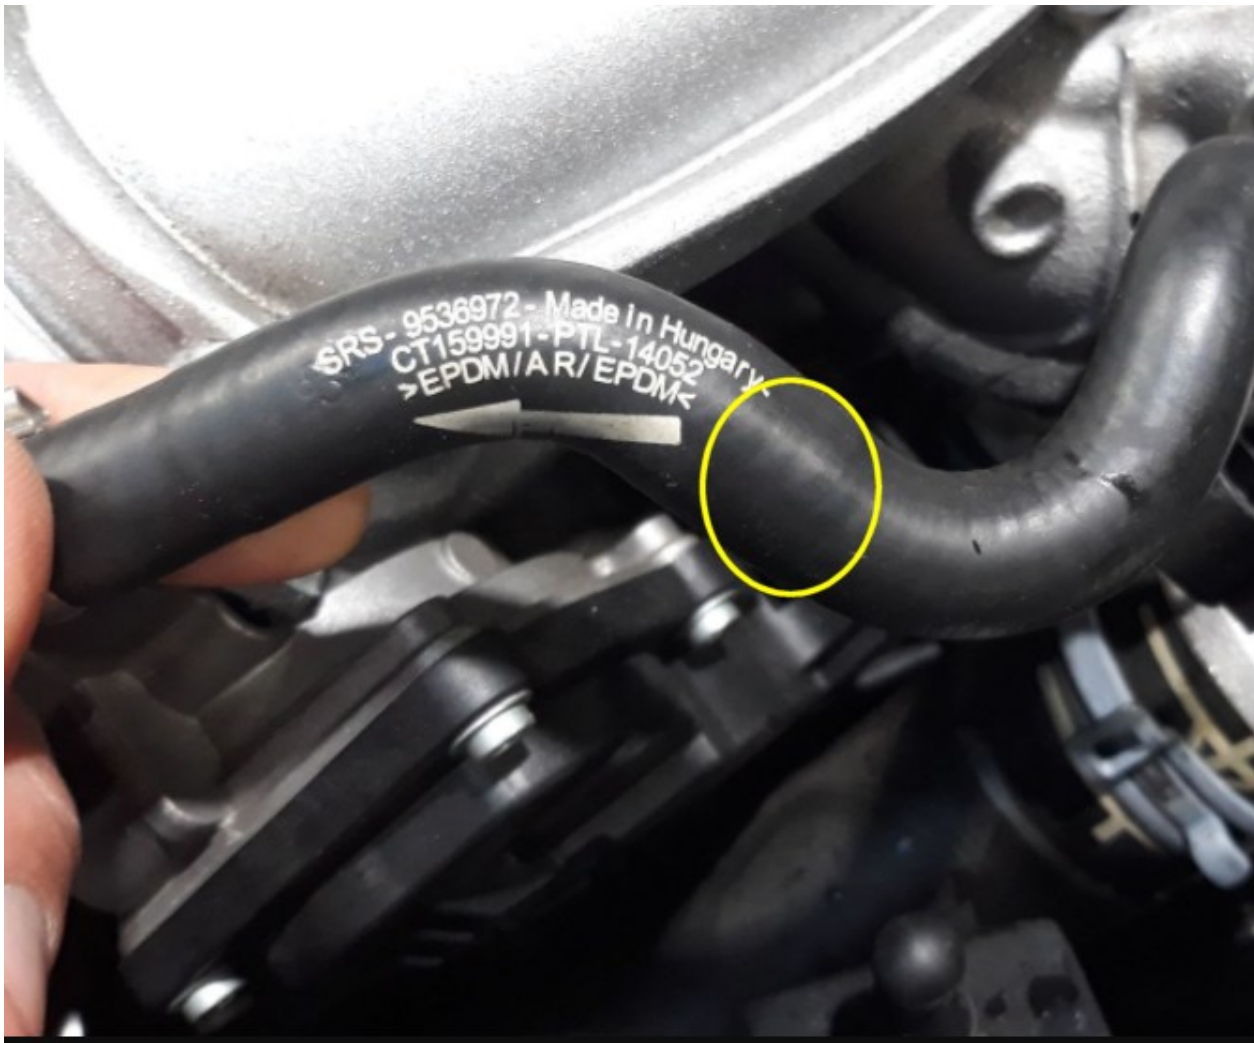
- The vent hose has an internal check valve, the valve is positioned within the vent hose at the location shown in Figure 3 (Circled)

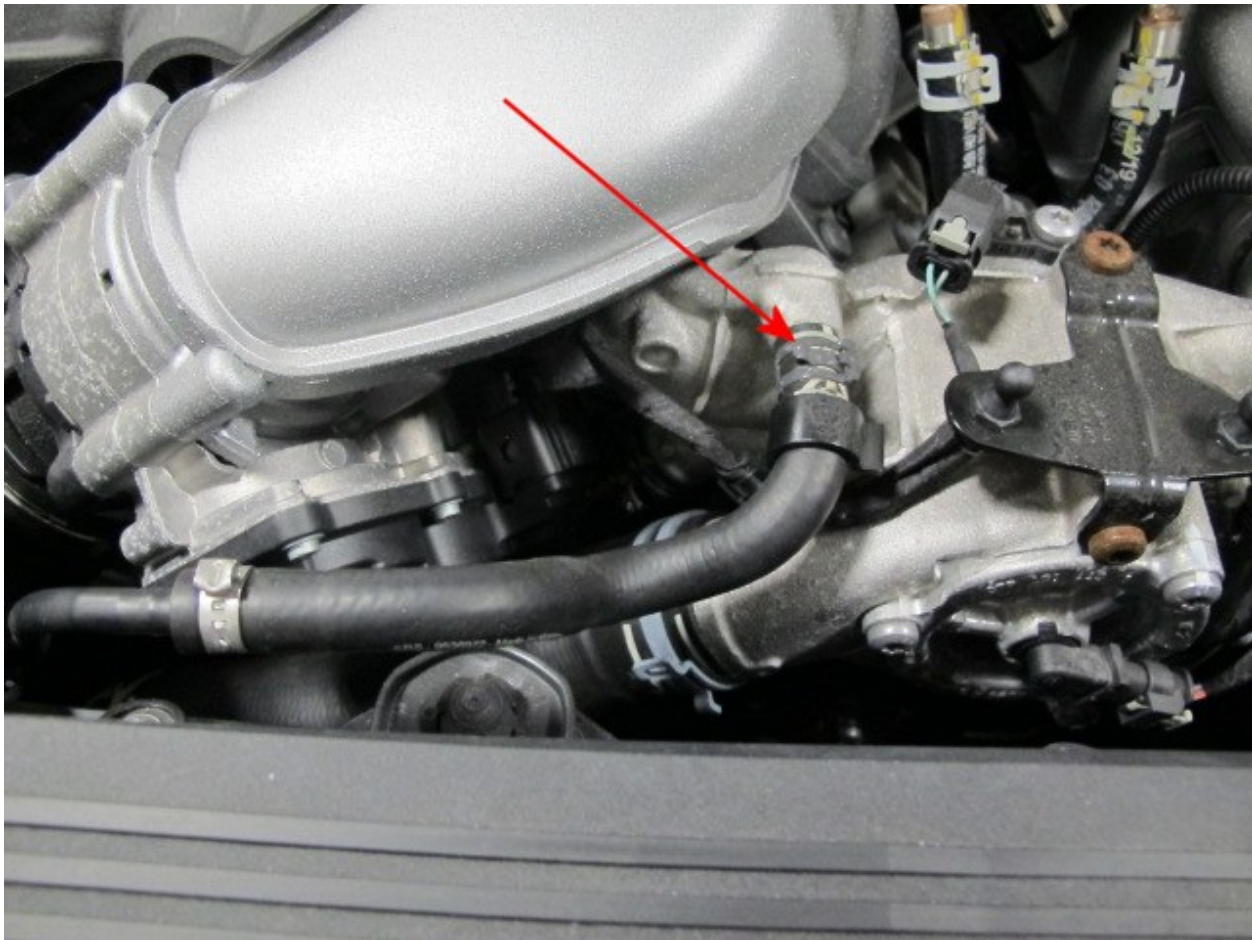
- Referring to Figure 5 - Disconnect the vent hose from the Thermostat housing

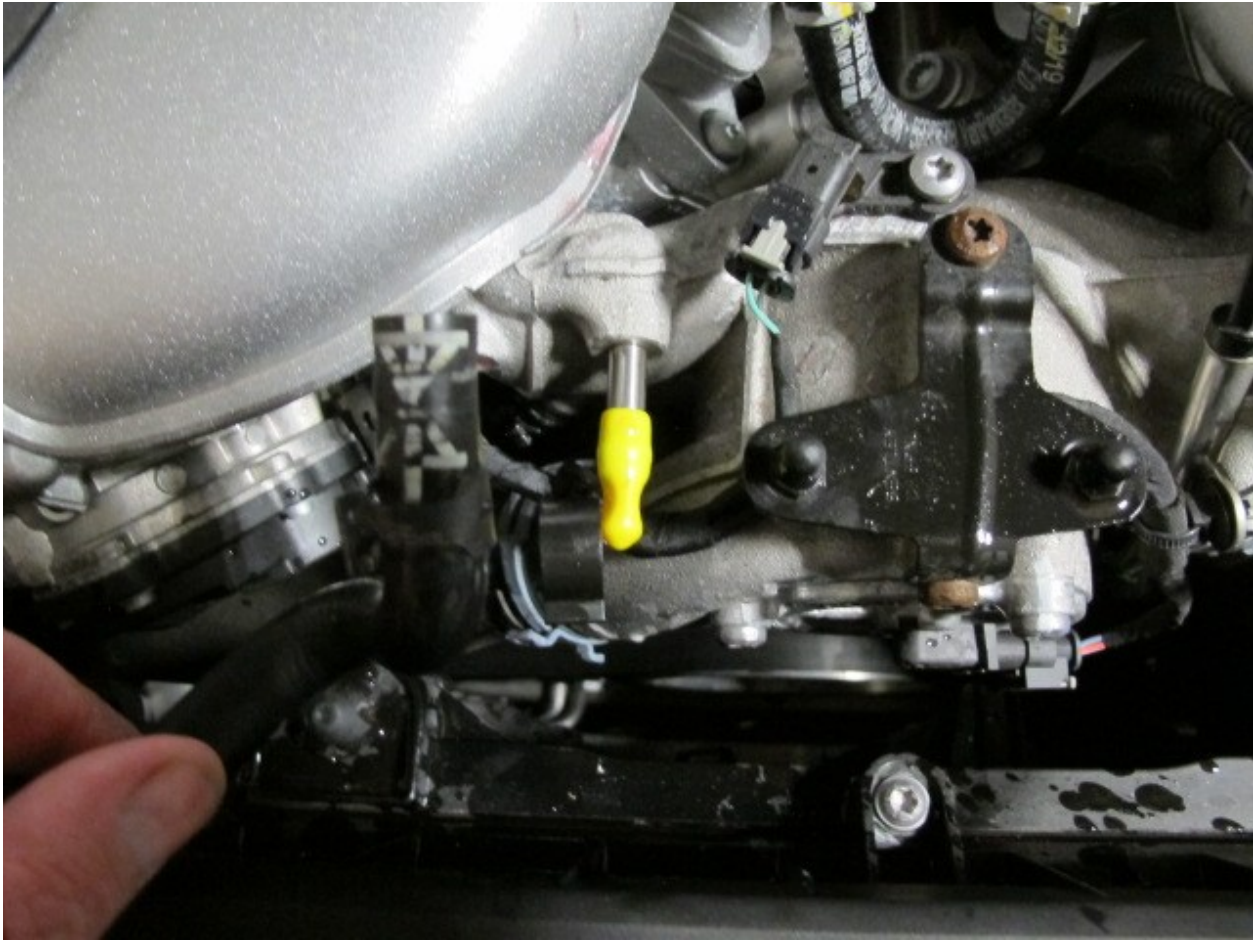
- Referring to Figure 6 - To minimise coolant loss, temporarily fit a blanking plug over the stub pipe

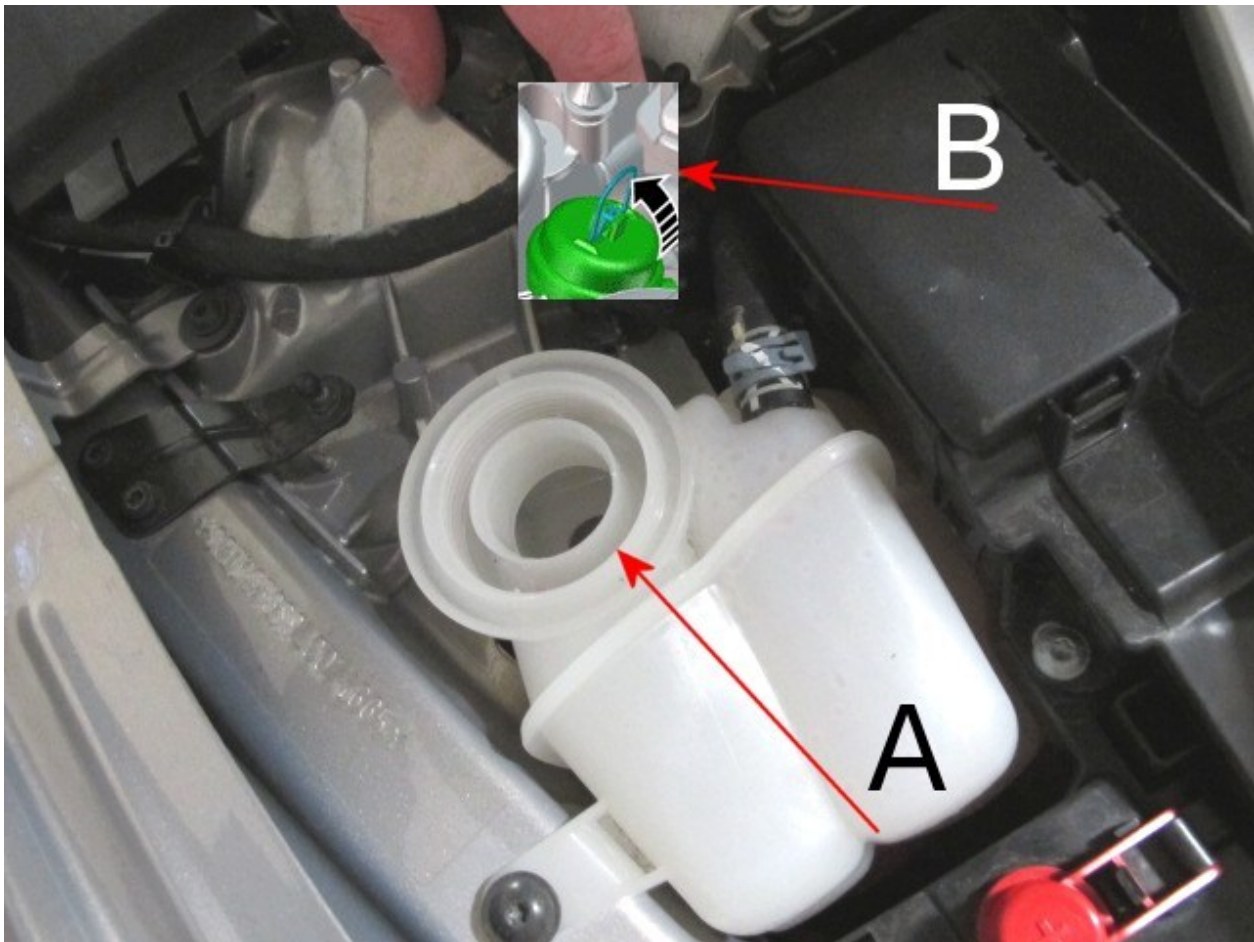
4) Referring to Figure 7 - Remove the coolant reservoir cap (Point A)

- Open the service clip on the bleeder valve (Point B)

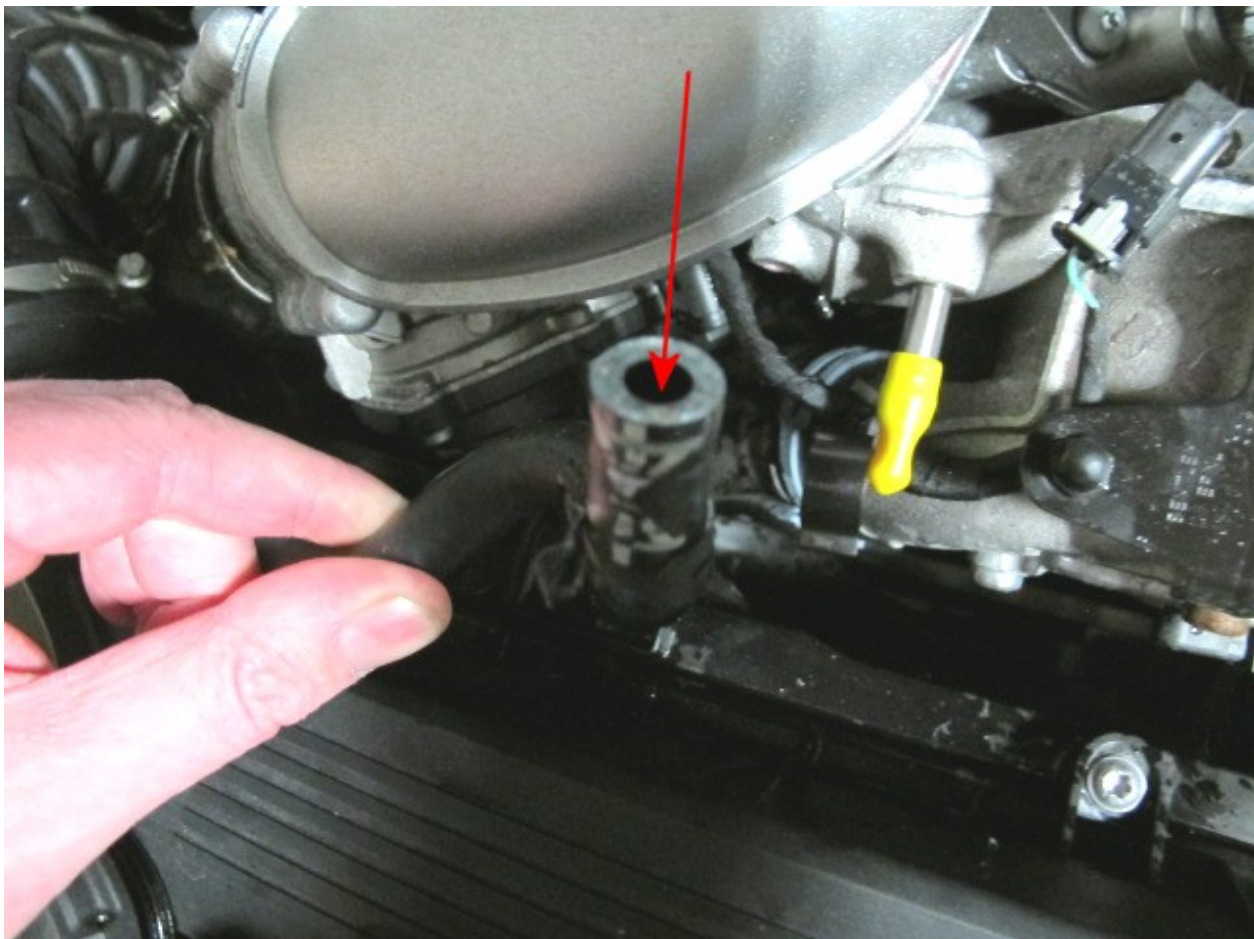
5) Referring to Figure 8 - Apply light air pressure into hose (Arrow)

**Does the air flow through the vent line without any restrictions?**

- Once the vent line has been replaced - Referring to Rep.Gr 19 - Bleed the coolant system
- Erase all applicable DTC's
- Conduct a road test - On return check to confirm that no coolant related DTC's are evident
