# Technical Service Bulletin

| Topic | Engine Overheating - Coolant Pump Leaking and Low Coolant Warning W12 |
| Transaction No. | 2071239/4 |

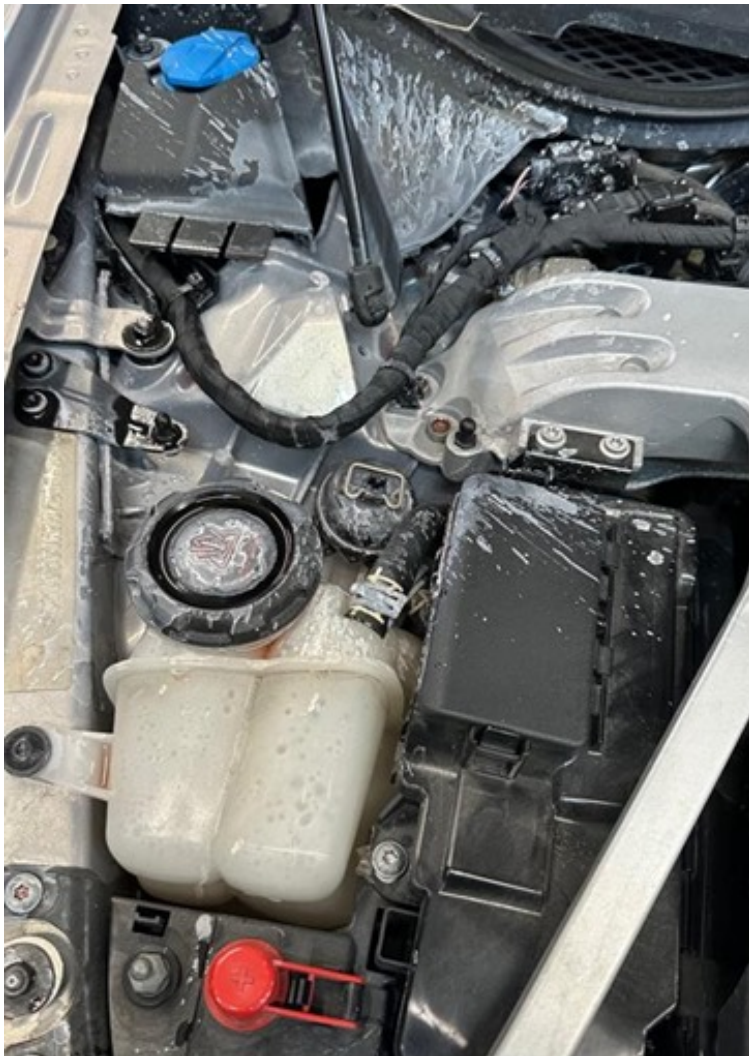
Figure 1

1) On receipt of the vehicle - Take a photograph of the coolant level within the coolant reservoir and inspect the engine bay for any coolant residue (figure 1).

If coolant residue is found in the engine bay, please raise a full technical DISS query and attach a photograph of the coolant residue and a photograph of the coolant level.

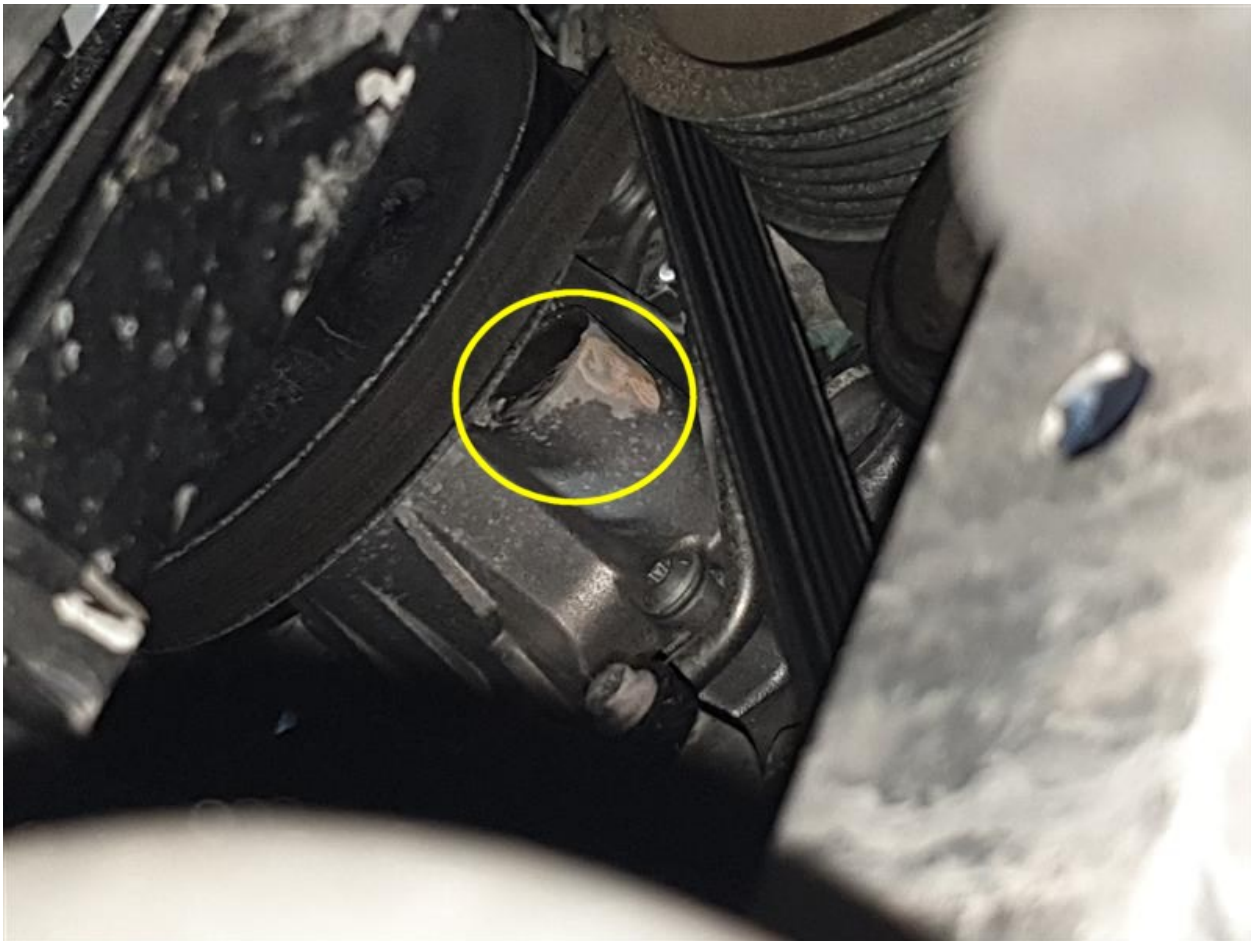
Figure 2

The video shows an example of a coolant pump with no leak, although a small coolant witness mark is evident (Figure 2). In this scenario the coolant witness mark should be cleaned off (using a suitable cleaning agent) to the condition shown in Figure 3

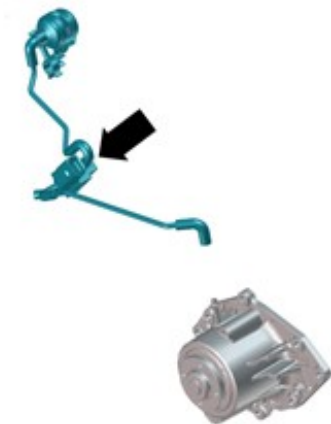
5) Referring to Figure 4 - Disconnect each vacuum hose with care from the Solenoid for coolant circuit N492  
- visually monitor for any traces of coolant

**VERY IMPORTANT:** If traces of coolant are evident during disconnection, take clear photos or record a clear video of any coolant within the vacuum hoses or N492 and attach to a new or existing technical DISS query
