## Technical Service Bulletin (TSB)

### Telematics Box Module (TBM) Firmware Over The Air (FOTA) Software Updating from 5.39 to 5.65

| REFERENCE: | TSB: 08-219-25 REV. A<br>GROUP: 08 - Electrical | Date: | December 10, 2025 | REVISION: | 08-219-25 |

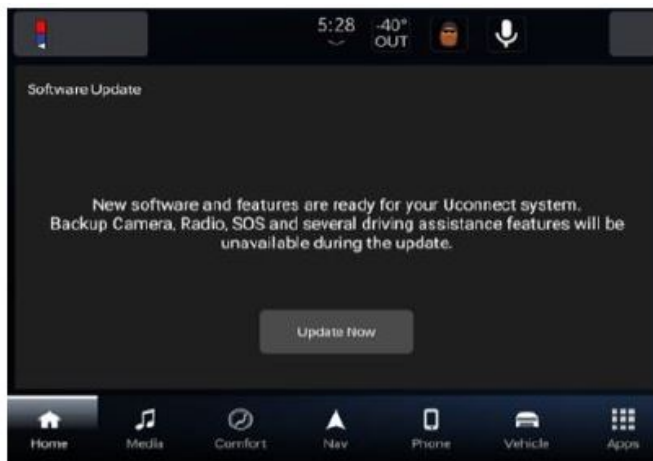
**Fig. 1**

Vehicles sold in the U.S. and Canada can now receive software updates “over-the-air”. Updates to software will occur in a phased roll-out. The software is updated through a builtin cellular modem in the vehicle. Customers will see a notification on their radio screen when new software is available for their TBM [Fig. 1](#).

Software Acceptance Screen

1. The vehicle needs to be in 'Park'. The ignition needs to be in the off position.
2. If the customer selects "Update Now" [Fig. 1](#) they can shut off the vehicle and leave. The update will be completed automatically.

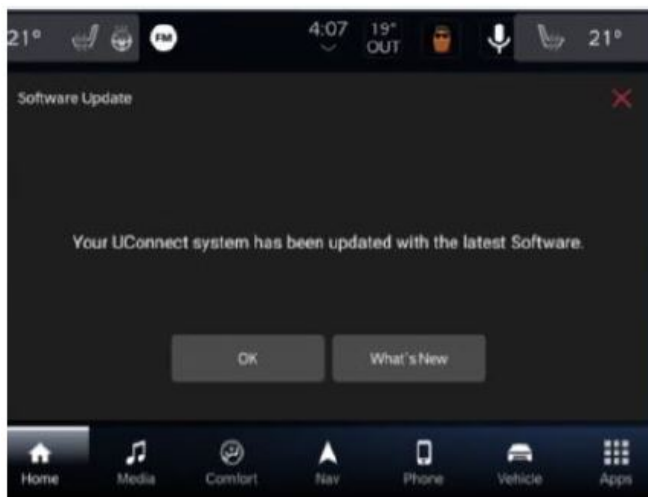
**Fig. 2**

3. Upon completion of update, the radio will display a confirmation message [Fig. 2](#).

Software Update Confirmation Screen
