| REFERENCE: | TSB: 08-011-25 REV. D<br>GROUP: 08 - Electrical | Date: | December 18, 2025 | REVISION: | 08-011-25 REV. C |
| VEHICLES AFFECTED: | 2024 (KM) Jeep Wagoneer S<br>This bulletin applies to vehicles equipped with 400V G2500 FR/RR Elec Drive Motors (Sales Code ELD). | | | MARKET APPLICABILITY:<br><div><input checked="" type="checkbox"/> NA<input type="checkbox"/> MEA<br/><input type="checkbox"/> SA<input type="checkbox"/> IAP<br/><input type="checkbox"/> EE<input type="checkbox"/> CH</div><br><b>NOTE:</b> This bulletin applies to the North America market. | |

| <b>CAUSE:</b> | <b>BPCM software update</b> |

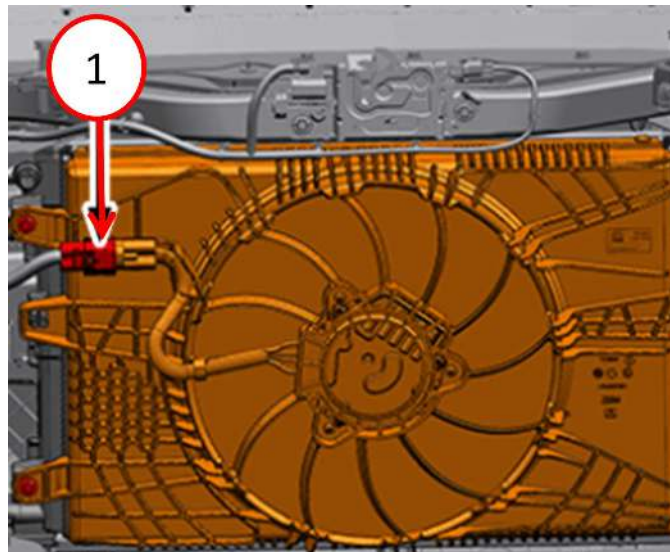
**Fig. 1**  
Cooling Fan Assembly

**NOTE: The cooling fan must be disconnected to prevent it from powering on, which may interrupt/ abort the flash process.**

1 - Wire Harness To Disconnect/Connect

4. Disconnect the cooling fan wire harness connector [Fig. 1](#).

34. Connect the cooling fan wire harness connector [Fig. 1](#).
