| REFERENCE: | TSB: 08-014-25 REV. E<br>GROUP: 08 - Electrical | Date: | December 18, 2025 | REVISION: | 08-014-25 REV. D |
| VEHICLES AFFECTED: | 2024 (KM) Jeep Wagoneer S<br>This bulletin applies to vehicles equipped with 400V G2500 FR/RR Elec Drive Motors (Sales Code ELD). | | | MARKET APPLICABILITY:<br><input checked="" type="checkbox"/> NA <input type="checkbox"/> MEA<br><input type="checkbox"/> SA <input type="checkbox"/> IAP<br><input type="checkbox"/> EE <input type="checkbox"/> CH<br><br>NOTE: This bulletin applies to the North America market. | |

| <b>CAUSE:</b> | <b>EVCU software update</b> |

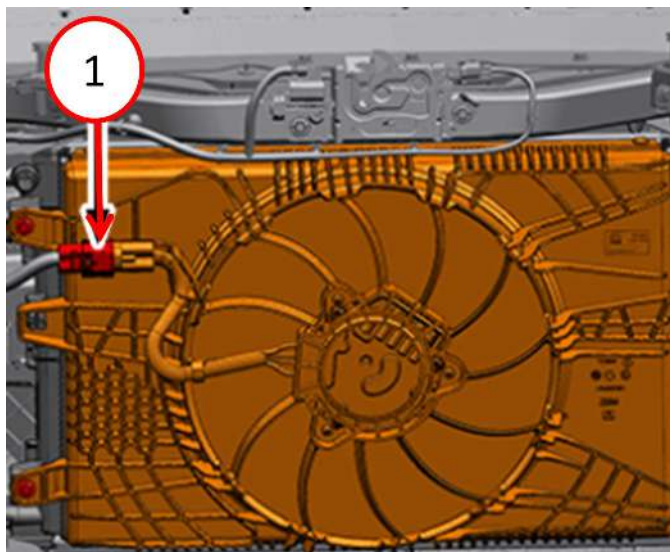
**Fig. 1**  
Cooling Fan Assembly

**NOTE: The cooling fan must be disconnected to prevent it from powering on, which may interrupt/ abort the flash process.**

1 - Wire Harness To Disconnect/Connect

4. Disconnect the cooling fan wire harness connector [Fig. 1](#).

34. Connect the cooling fan wire harness connector [Fig. 1](#).

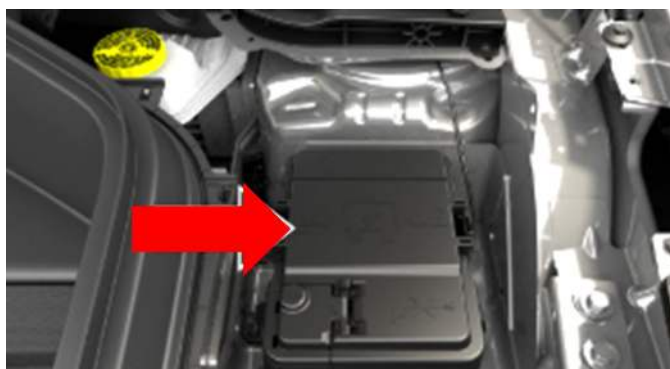
**Fig. 2**  
Front PDC Cover

**\*\*Failure to remove the #32 AGSM/GSM fuse will result in damage to the shifter.**

5. Remove the front PDC cover, locate and remove the #32 AGSM/GSM fuse [Fig. 2](#)\*\*.

33. \*\*Install the #32 AGSM/GSM fuse and the front PDC cover [Fig. 2](#)\*\*.
