## Technical Service Bulletin (TSB)

### Flash: Motor Control Processor B (MCP B) Updates 11B3

| REFERENCE: | TSB: 08-021-25 REV. D<br>GROUP: 08 - Electrical | Date: | December 18, 2025 | REVISION: | 08-021-25 REV. C |
| VEHICLES AFFECTED: | 2024 (LB) Dodge Charger<br>This bulletin applies to vehicles equipped with 400V G2500 FR/RR Elec Drive Motors (Sales Code ELD). | | | MARKET APPLICABILITY:<br><div><input checked="" type="checkbox"/> NA<input type="checkbox"/> MEA<br/><input type="checkbox"/> SA<input type="checkbox"/> IAP<br/><input type="checkbox"/> EE<input type="checkbox"/> CH</div><br>NOTE: **This bulletin applies to North America markets.** | |

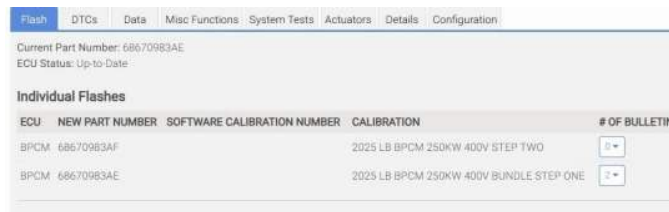
**Fig. 4**

Two Step Software Level AE And AF Screen

**If the BPCM is already at the AE level, the module must be reprogrammed to the AF level. Do not over flash at the AE level to get to the AF level.**

7. Inspect the software level on the BPCM by going into the "Flash" tab and compare to what software is available [Fig. 4](#).

8. Is the BPCM software at the **AE** level?
  - YES >>> Proceed to [Step 10](#).
  - NO >>> Proceed to [Step 9](#).
9. Reprogram the BPCM to the AE level. **Then proceed to [Step 10](#).**

10. Reprogram the BPCM to the AF level.\*\*
11. Reprogram the BPCM to the latest available software.
12. Clear DTCs.
13. Are any of the following DTCs now active or pending in the BPCM?
