## Technical Service Bulletin (TSB)

### Flash: Motor Control Processor A (MCP A) Updates 11B3

| REFERENCE: | TSB: 08-023-25 REV. D<br>GROUP: 08 - Electrical | Date: | December 18, 2025 | REVISION: | 08-023-25 REV. C |
| VEHICLES AFFECTED: | 2024 (LB) Dodge Charger<br>This bulletin applies to vehicles equipped with 400V G2500 FR/RR Elec Drive Motors (Sales Code ELD). | | | MARKET APPLICABILITY:<br><div><input checked="" type="checkbox"/> NA<input type="checkbox"/> MEA<br/><input type="checkbox"/> SA<input type="checkbox"/> IAP<br/><input type="checkbox"/> EE<input type="checkbox"/> CH</div><br>NOTE: **This bulletin applies to North America markets.** | |

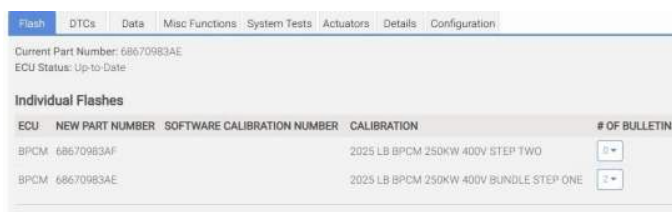
**Fig. 4**

Two Step Software Level AE And AF Screen

**If the BPCM is already at the AE level, the module must be reprogrammed to the AF level. Do not over flash at the AE level to get to the AF level.**

7. Inspect the software level on the BPCM by going into the "Flash" tab and compare to what software is available [Fig. 4](#).
