## Technical Service Bulletin (TSB)

### Flash: Motor Control Processor B (MCP B) Updates 6B3

| REFERENCE: | TSB: 08-024-25 REV. D<br>GROUP: 08 - Electrical | Date: | December 18, 2025 | REVISION: | 08-024-25 REV. C |
| VEHICLES AFFECTED: | 2025 (LB) Dodge Charger<br>This bulletin applies to vehicles equipped with 400V G2500 FR/RR Elec Drive Motors (Sales Code ELD). | | | MARKET APPLICABILITY:<br><div><input checked="" type="checkbox"/> NA<input type="checkbox"/> MEA<br/><input type="checkbox"/> SA<input type="checkbox"/> IAP<br/><input type="checkbox"/> EE<input type="checkbox"/> CH</div><br>NOTE: **This bulletin applies to North America markets.** | |

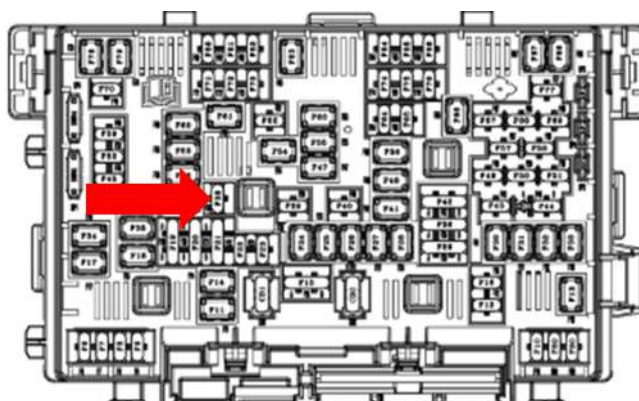
**Fig. 3**  
#38 AGSM Fuse Location

**Failure to remove the #38 AGSM fuse will result in damage to the shifter.**

6. Remove the PDC cover, locate and remove the #38 AGSM fuse [Fig. 3](#).

35. Install the #38 AGSM fuse [Fig. 3](#) and the PDC cover [Fig. 2](#).

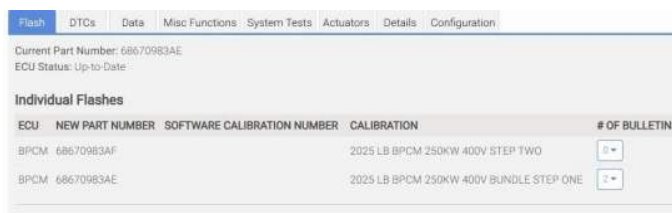
**Fig. 4**  
Two Step Software Level AE And AF Screen

**If the BPCM is already at the AE level, the module must be reprogrammed to the AF level. Do not over flash at the AE level to get to the AF level.**

7. Inspect the software level on the BPCM by going into the "Flash" tab and compare to what software is available [Fig. 4](#).
