**Technical Service Bulletin (TSB)**  
**Flash: Battery Pack Control Module (BPCM) Updates 6B3**

| REFERENCE: | TSB: 08-025-25 REV. D<br>GROUP: 08 - Electrical | Date: | December 18, 2025 | REVISION: | 08-025-25 REV. C |
| VEHICLES AFFECTED: | 2025 (LB) Dodge Charger<br>This bulletin applies to vehicles equipped with 400V G2500 FR/RR Elec Drive Motors (Sales Code ELD). | | | MARKET APPLICABILITY:<br><input checked="" type="checkbox"/> NA <input type="checkbox"/> MEA<br><input type="checkbox"/> SA <input type="checkbox"/> IAP<br><input type="checkbox"/> EE <input type="checkbox"/> CH<br><br>NOTE: **This bulletin applies to North America markets.** | |

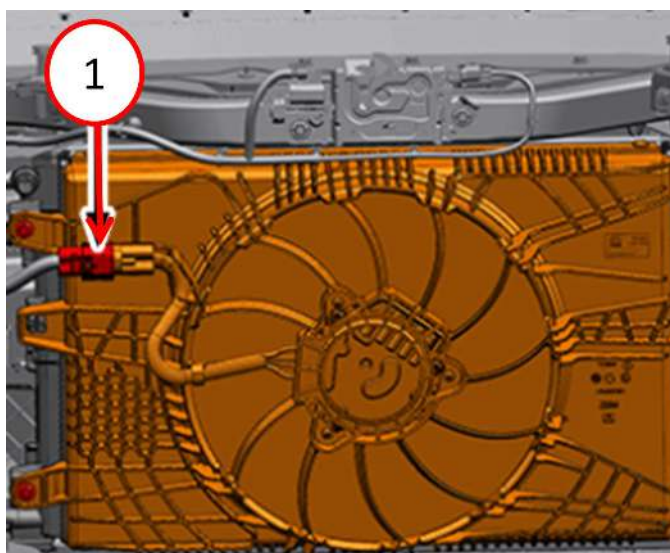
**Fig. 1**  
Cooling Fan Assembly

**NOTE: The cooling fan must be disconnected to prevent it from powering on, which may interrupt/ abort the flash process.**

4. Disconnect the cooling fan wire harness connector [Fig. 1](#).

35. Install the #38 AGSM fuse [Fig. 3](#) and the PDC cover [Fig. 2](#).
36. Position the rear carpet in place.
37. Connect the cooling fan wire harness connector [Fig. 1](#).
38. Install the front storage bin. Refer to the detailed service procedures available in DealerCONNECT/ServiceLibrary under: Service Info> 23 - Body / Exterior / Bin, Storage / Installation.
39. Clear any DTCs that may have been set in any modules due to reprogramming. The wiTECH application will automatically present all DTCs after the flash and allow them to be cleared.

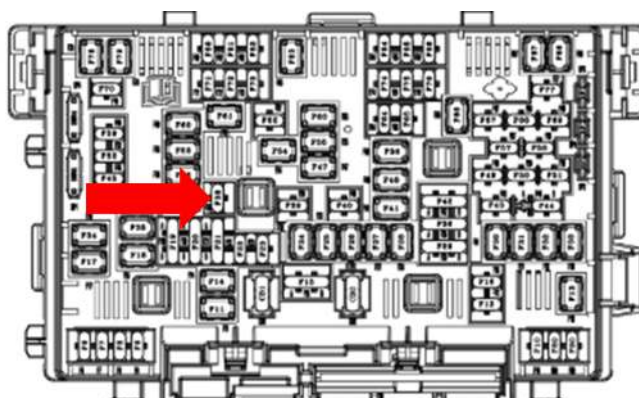
**Fig. 3**  
#38 AGSM Fuse Location

**Failure to remove the #38 AGSM fuse will result in damage to the shifter.**

6. Remove the PDC cover, locate and remove the #38 AGSM fuse [Fig. 3](#).

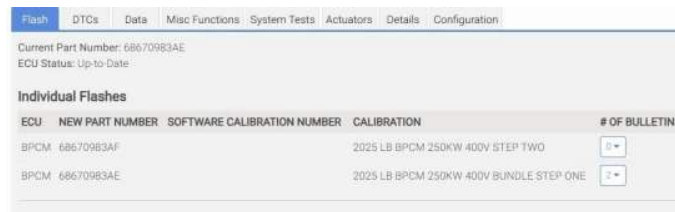
**Fig. 4**

Two Step Software Level AE And AF Screen

**If the BPCM is already at the AE level, the module must be reprogrammed to the AF level. Do not over flash at the AE level to get to the AF level.**

7. Inspect the software level on the BPCM by going into the "Flash" tab and compare to what software is available [Fig. 4](#).

8. Is the BPCM software at the **AE** level?
  - YES >>> Proceed to [Step 10](#).
  - NO >>> Proceed to [Step 9](#).
9. Reprogram the BPCM to the AE level. **Then proceed to [Step 10](#).**

10. Reprogram the BPCM to the AF level.\*\*
11. Reprogram the BPCM to the latest available software.
12. Clear DTCs.
13. Are any of the following DTCs now active or pending in the BPCM?
