| REFERENCE: | TSB: 08-026-25 REV. D<br>GROUP: 08 - Electrical | Date: | December 18, 2025 | REVISION: | 08-026-25 REV. C |
| VEHICLES AFFECTED: | 2024 (LB) Dodge Charger<br>This bulletin applies to vehicles equipped with 400V G2500 FR/RR Elec Drive Motors (Sales Code ELD). | | | MARKET APPLICABILITY:<br><div><input checked="" type="checkbox"/> NA<input type="checkbox"/> MEA<br/><input type="checkbox"/> SA<input type="checkbox"/> IAP<br/><input type="checkbox"/> EE<input type="checkbox"/> CH</div><br>NOTE: **This bulletin applies to North America markets.** | |

| <b>CAUSE:</b> | <b>EVCU software update</b> |

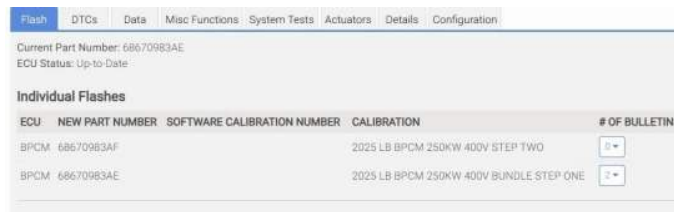
**Fig. 4**

Two Step Software Level AE And AF Screen

**If the BPCM is already at the AE level, the module must be reprogrammed to the AF level. Do not over flash at the AE level to get to the AF level.**

7. Inspect the software level on the BPCM by going into the "Flash" tab and compare to what software is available [Fig. 4](#).

8. Is the BPCM software at the **AE** level?
  - YES >>> Proceed to [Step 10](#).
  - NO >>> Proceed to [Step 9](#).
9. Reprogram the BPCM to the AE level. **Then proceed to [Step 10](#).**

10. Reprogram the BPCM to the AF level.\*\*
11. Reprogram the BPCM to the latest available software.
12. Clear DTCs.
13. Are any of the following DTCs now active or pending in the BPCM?
