**Technical Service Bulletin (TSB)**  
**Flash: Motor Control Processor A (MCP A) Updates 6B3**

| REFERENCE: | TSB: 08-027-25 REV. D<br>GROUP: 08 - Electrical | Date: | December 18, 2025 | REVISION: | 08-027-25 REV. C |
| VEHICLES AFFECTED: | 2025 (LB) Dodge Charger<br>This bulletin applies to vehicles equipped with 400V G2500 FR/RR Elec Drive Motors (Sales Code ELD). | | | MARKET APPLICABILITY:<br><div><input checked="" type="checkbox"/> NA<input type="checkbox"/> MEA<br/><input type="checkbox"/> SA<input type="checkbox"/> IAP<br/><input type="checkbox"/> EE<input type="checkbox"/> CH</div><br>NOTE: **This bulletin applies to North America markets.** | |
| CAUSE: | MCP A software update | | | | |

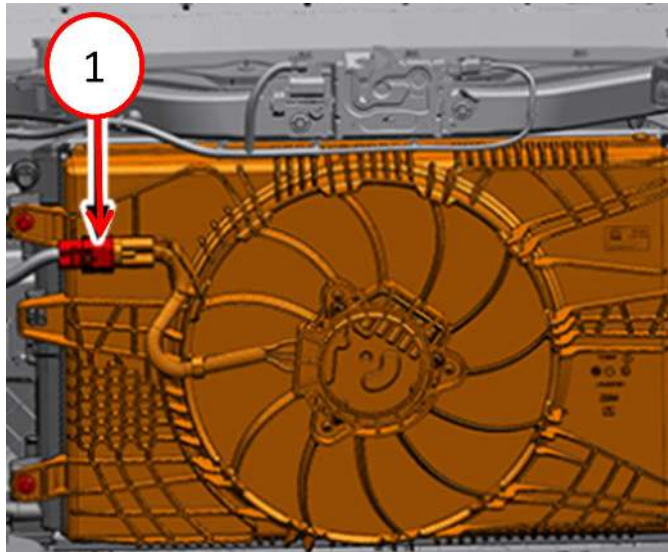
**Fig. 1**  
Cooling Fan Assembly

1 - Wire Harness To Disconnect/Connect

4. Disconnect the cooling fan wire harness connector [Fig. 1](#).

35. Install the #38 AGSM fuse [Fig. 3](#) and the PDC cover [Fig. 2](#).
36. Position the rear carpet in place.
37. Connect the cooling fan wire harness connector [Fig. 1](#).
38. Install the front storage bin. Refer to the detailed service procedures available in DealerCONNECT/ServiceLibrary under: Service Info> 23 - Body / Exterior / Bin, Storage / Installation.
39. Clear any DTCs that may have been set in any modules due to reprogramming. The wiTECH application will automatically present all DTCs after the flash and allow them to be cleared.

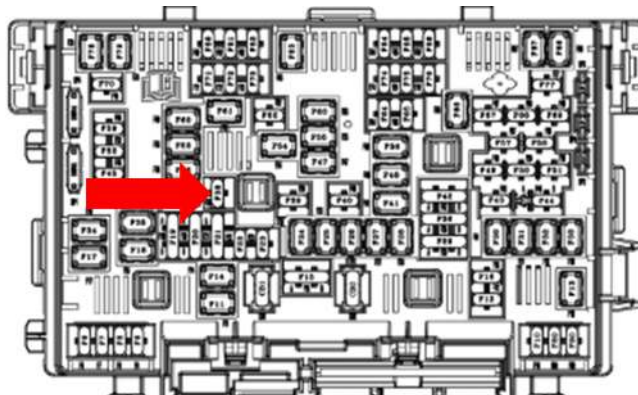
**Fig. 3**  
#38 AGSM Fuse Location

**Failure to remove the #38 AGSM fuse will result in damage to the shifter.**

6. Remove the PDC cover, locate and remove the #38 AGSM fuse [Fig. 3](#).
