| REFERENCE: | TSB: 08-028-25 REV. D<br>GROUP: 08 - Electrical | Date: | December 18, 2025 | REVISION: | 08-028-25 REV. C |
| VEHICLES AFFECTED: | 2025 (LB) Dodge Charger<br>This bulletin applies to vehicles equipped with 400V G2500 FR/RR Elec Drive Motors (Sales Code ELD). | | | MARKET APPLICABILITY:<br><input checked="" type="checkbox"/> NA <input type="checkbox"/> MEA<br><input type="checkbox"/> SA <input type="checkbox"/> IAP<br><input type="checkbox"/> EE <input type="checkbox"/> CH<br>NOTE: **This bulletin applies to North America markets.** | |

| <b>CAUSE:</b> | <b>EVCU software update</b> |

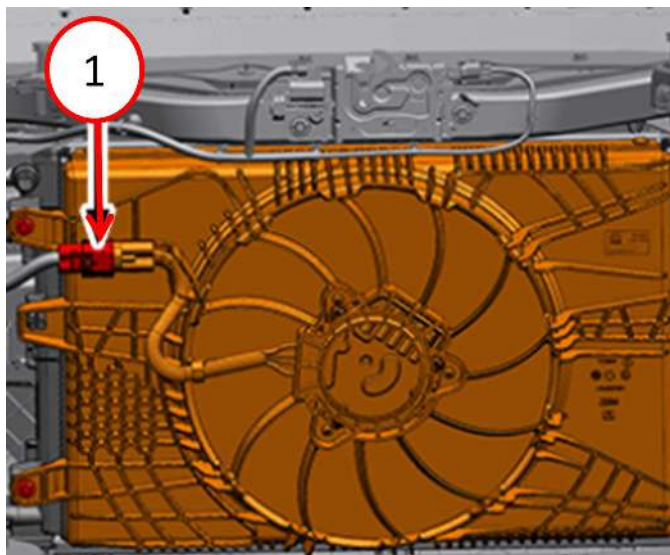
**Fig. 1**  
Cooling Fan Assembly

1 - Wire Harness To Disconnect/Connect

4. Disconnect the cooling fan wire harness connector [Fig. 1](#).

37. Connect the cooling fan wire harness connector [Fig. 1](#).

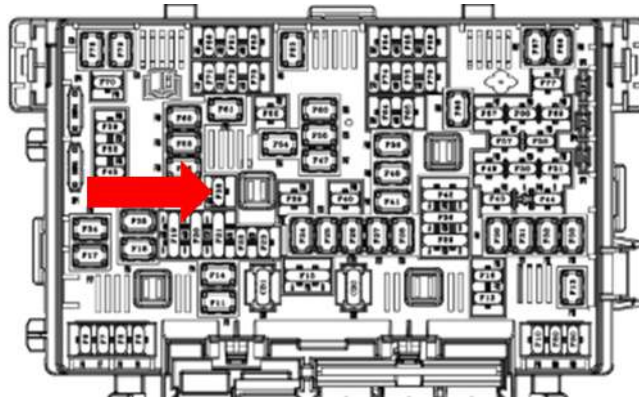
**Fig. 3**  
#38 AGSM Fuse Location

**Failure to remove the #38 AGSM fuse will result in damage to the shifter.**

6. Remove the PDC cover, locate and remove the #38 AGSM fuse [Fig. 3](#).

35. Install the #38 AGSM fuse [Fig. 3](#) and the PDC cover [Fig. 2](#).

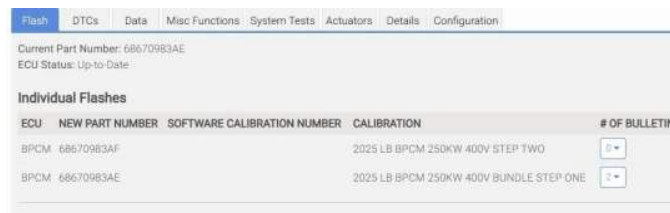
**Fig. 4**  
Two Step Software Level AE And AF Screen

**If the BPCM is already at the AE level, the module must be reprogrammed to the AF level. Do not over flash at the AE level to get to the AF level.**

7. Inspect the software level on the BPCM by going into the "Flash" tab and compare to what software is available [Fig. 4](#).
