| REFERENCE: | TSB: 08-071-25 REV. D<br>GROUP: 08 - Electrical | Date: | December 18, 2025 | REVISION: | 08-071-25 REV. C |
| VEHICLES AFFECTED: | 2024 (LB) Dodge Charger<br>This bulletin applies to vehicles equipped with 400V G2500 FR/RR Elec Drive Motors (Sales Code ELD). | | | MARKET APPLICABILITY:<br><input checked="" type="checkbox"/> NA <input type="checkbox"/> MEA<br><input type="checkbox"/> SA <input type="checkbox"/> IAP<br><input type="checkbox"/> EE <input type="checkbox"/> CH<br>NOTE: **This bulletin applies to North America markets.** | |

| <b>CAUSE:</b> | <b>BPCM software update</b> |

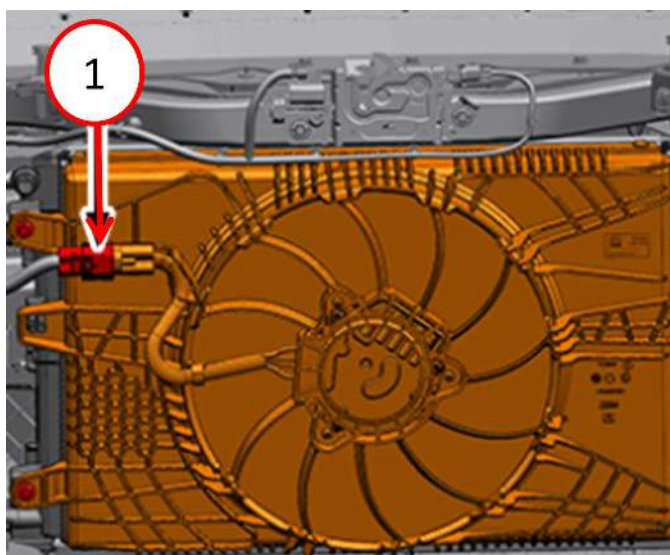
**Fig. 1**  
Cooling Fan Assembly

1 - Wire Harness To Disconnect/Connect

4. Disconnect the cooling fan wire harness connector [Fig. 1](#).

35. Install the #38 AGSM fuse [Fig. 3](#) and the PDC cover [Fig. 2](#).
36. Position the rear carpet in place.
37. Connect the cooling fan wire harness connector [Fig. 1](#).
38. Install the front storage bin. Refer to the detailed service procedures available in DealerCONNECT/ServiceLibrary under: Service Info> 23 - Body / Exterior / Bin, Storage / Installation.
39. Perform 10 vehicle sleep cycles by completing the following:
  - With all doors, frunk and trunk closed, Micropod unplugged and the ignition in the Off position, wait for **PRNDL light to go off. Wait three minutes.**
  - Place the ignition in the On position.
  - Repeat this process nine times.
40. Clear any DTCs that may have been set in any modules due to reprogramming. The wiTECH application will automatically present all DTCs after the flash and allow them to be cleared.

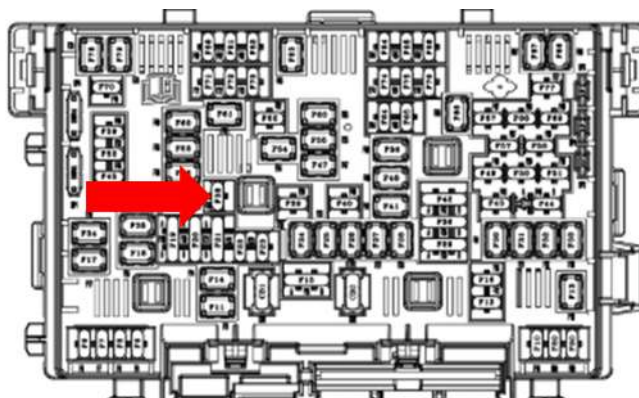
**Fig. 3**  
#38 AGSM Fuse Location

**Failure to remove the #38 AGSM fuse will result in damage to the shifter.**

6. Remove the PDC cover, locate and remove the #38 AGSM fuse [Fig. 3](#).

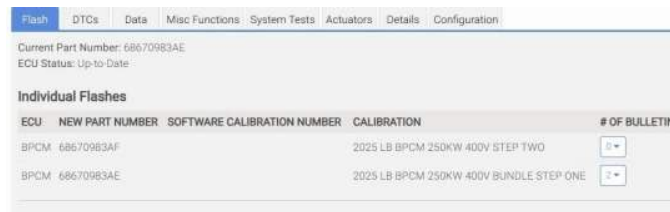
**Fig. 4**

Two Step Software Level AE And AF Screen

**If the BPCM is already at the AE level, the module must be reprogrammed to the AF level. Do not over flash at the AE level to get to the AF level.**

7. Inspect the software level on the BPCM by going into the "Flash" tab and compare to what software is available [Fig. 4](#).

8. Is the BPCM software at the **AE** level?
  - YES >>> Proceed to [Step 10](#).
  - NO >>> Proceed to [Step 9](#).
9. Reprogram the BPCM to the AE level. **Then proceed to [Step 10](#).**

10. Reprogram the BPCM to the AF level.\*\*
11. Reprogram the BPCM to the latest available software.
12. Clear DTCs.
13. Are any of the following DTCs now active or pending in the BPCM?
