| REFERENCE: | TSB: 08-074-25 REV. D<br>GROUP: 08 - Electrical | Date: | December 18, 2025 | REVISION: | 08-074-25 REV. C |
| VEHICLES AFFECTED: | 2024 (KM) Jeep Wagoneer S<br>This bulletin applies to vehicles equipped with 400V G2500 FR/RR Elec Drive Motors (Sales Code ELD). | | | MARKET APPLICABILITY:<br><div><input checked="" type="checkbox"/> NA<input type="checkbox"/> MEA<br/><input type="checkbox"/> SA<input type="checkbox"/> IAP<br/><input type="checkbox"/> EE<input type="checkbox"/> CH</div><br>NOTE: This bulletin applies to the North America market. | |

| <b>CAUSE:</b> | <b>EVCU software update</b> |

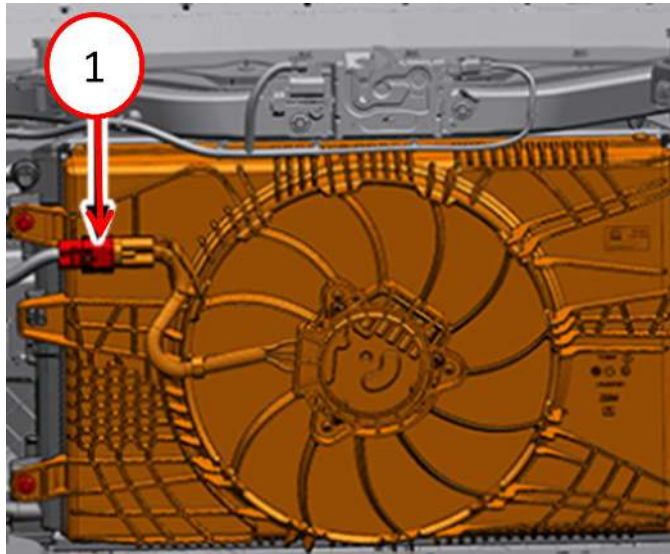
**Fig. 1**  
Cooling Fan Assembly

1 - Wire Harness To Disconnect/Connect

4. Disconnect the cooling fan wire harness connector [Fig. 1](#).

34. Connect the cooling fan wire harness connector [Fig. 1](#).

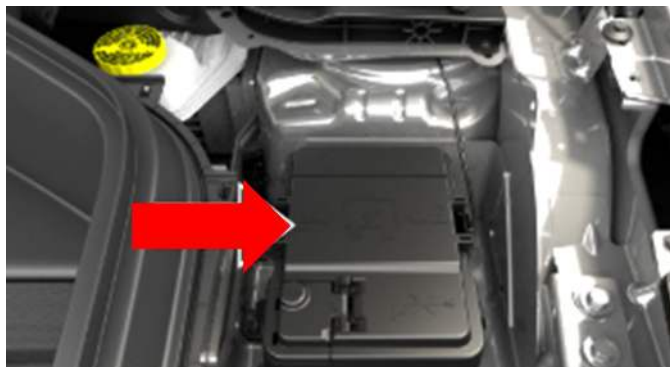
**Fig. 2**  
Front PDC Cover

**\*\*Failure to remove the #32 AGSM/GSM fuse will result in damage to the shifter.**

5. Remove the front PDC cover, locate and remove the #32 AGSM/GSM fuse [Fig. 2](#).

33. \*\*Install the #32 AGSM/GSM fuse and the front PDC cover [Fig. 2](#)\*\*.

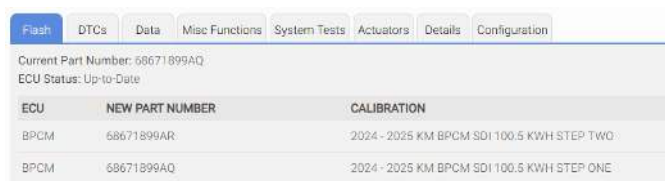
**Fig. 3**

Two Step Software Level AQ And AR Screen

**If the BPCM is already at the AQ level, the module must be reprogrammed to the AR level. Do not over flash at the AQ level to get to the AR level.**

6. Inspect the software level on the BPCM by going into the "Flash" tab and compare to what software is available [Fig. 4](#).
