**RSU With Additional Sleep Cycles for HV Battery Integrity Check  
- Flash: Battery Pack Control Module (BPCM) Updates 11B3**

| REFERENCE: | TSB: 08-076-25 REV. D<br>GROUP: 08 - Electrical | Date: | December 18, 2025 | REVISION: | 08-076-25 REV. C |
| VEHICLES AFFECTED: | 2024 (KM) Jeep Wagoneer S<br>This bulletin applies to vehicles equipped with 400V G2500 FR/RR Elec Drive Motors (Sales Code ELD). | | | MARKET APPLICABILITY:<br><div><input checked="" type="checkbox"/> NA<input type="checkbox"/> MEA<br/><input type="checkbox"/> SA<input type="checkbox"/> IAP<br/><input type="checkbox"/> EE<input type="checkbox"/> CH</div><br><b>NOTE:</b> This bulletin applies to the North America market. | |

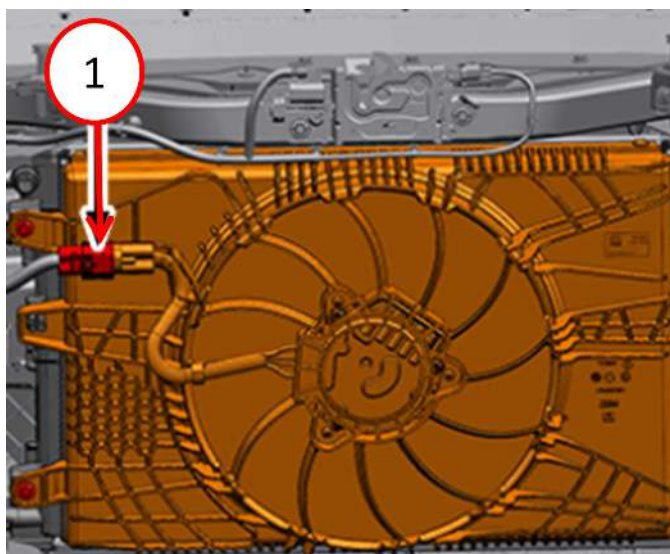
**Fig. 1**  
Cooling Fan Assembly

1 - Wire Harness To Disconnect/Connect

4. Disconnect the cooling fan wire harness connector [Fig. 1](#).

34. Connect the cooling fan wire harness connector [Fig. 1](#).

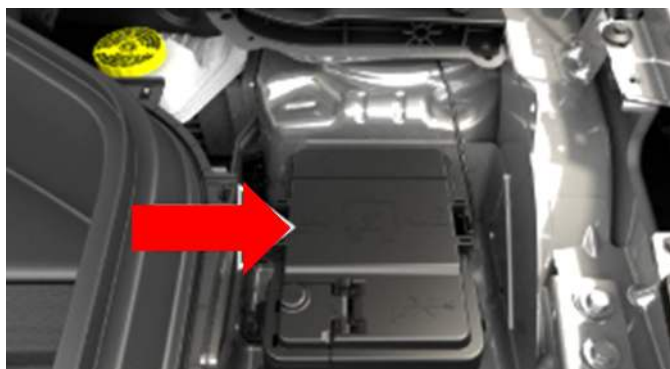
**Fig. 2**  
Front PDC Cover

**\*\*Failure to remove the #32 AGSM/GSM fuse will result in damage to the shifter.**

5. Remove the front PDC cover, locate and remove the #32 AGSM/GSM fuse [Fig. 2](#)**\*\***.

33. \*\*Install the #32 AGSM/GSM fuse and the front PDC cover [Fig. 2](#) \*\*.
