## Technical Service Bulletin (TSB)

### RSU With Additional Sleep Cycles for HV Battery Integrity Check - Flash: Motor Control Processor B (MCP B) Updates 11B3

| REFERENCE: | TSB: 08-077-25 REV. D<br>GROUP: 08 - Electrical | Date: | December 18, 2025 | REVISION: | 08-077-25 REV. C |
| VEHICLES AFFECTED: | 2024 (KM) Jeep Wagoneer S<br>This bulletin applies to vehicles equipped with 400V G2500 FR/RR Elec Drive Motors (Sales Code ELD). | | | MARKET APPLICABILITY:<br><div><input checked="" type="checkbox"/> NA<input type="checkbox"/> MEA<br/><input type="checkbox"/> SA<input type="checkbox"/> IAP<br/><input type="checkbox"/> EE<input type="checkbox"/> CH</div><br>NOTE: This bulletin applies to the North America market. | |

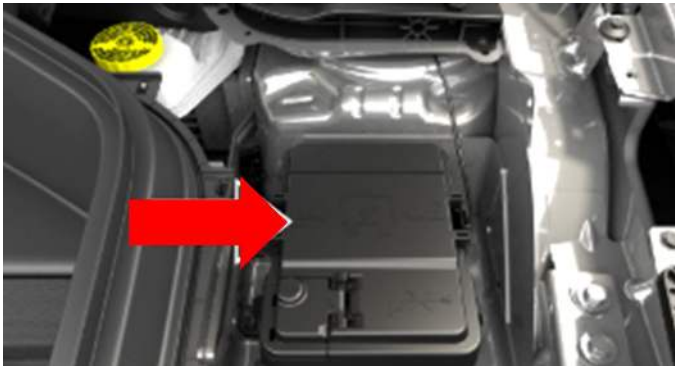
**Fig. 2**  
Front PDC Cover

**\*\*Failure to remove the #32 AGSM/GSM fuse will result in damage to the shifter.**

5. Remove the front PDC cover, locate and remove the #32 AGSM/GSM fuse [Fig. 2](#)\*\*.

33. \*\*Install the #32 AGSM/GSM fuse and the front PDC cover [Fig. 2](#)\*\*.
34. Connect the cooling fan wire harness connector [Fig. 1](#).
35. Install the front storage bin. Refer to the detailed service procedures available in DealerCONNECT/ServiceLibrary under: Service Info> 23 - Body / Exterior / Bin, Storage / Installation.
36. Perform 10 vehicle sleep cycles by completing the following:
  - With all doors, frunk and trunk closed, Micropod unplugged and the ignition in the Off position, wait for **PRNDL light to go off. Wait three minutes.**
  - Place the ignition in the On position.
  - Repeat this process nine times.
37. Clear any DTCs that may have been set in any modules due to reprogramming. The wiTECH application will automatically present all DTCs after the flash and allow them to be cleared.
