## Technical Service Bulletin (TSB)

### RSU With Additional Sleep Cycles for HV Battery Integrity Check - Flash: Motor Control Processor A (MCP A) Updates 11B3

| REFERENCE: | TSB: 08-078-25 REV. C<br>GROUP: 08 - Electrical | Date: | December 18, 2025 | REVISION: | 08-078-25 REV. B |
| VEHICLES AFFECTED: | 2024 (KM) Jeep Wagoneer S<br>This bulletin applies to vehicles equipped with 400V G2500 FR/RR Elec Drive Motors (Sales Code ELD). | | | MARKET APPLICABILITY:<br><div><input checked="" type="checkbox"/> NA<input type="checkbox"/> MEA<br/><input type="checkbox"/> SA<input type="checkbox"/> IAP<br/><input type="checkbox"/> EE<input type="checkbox"/> CH</div><br>NOTE: This bulletin applies to the North America market. | |

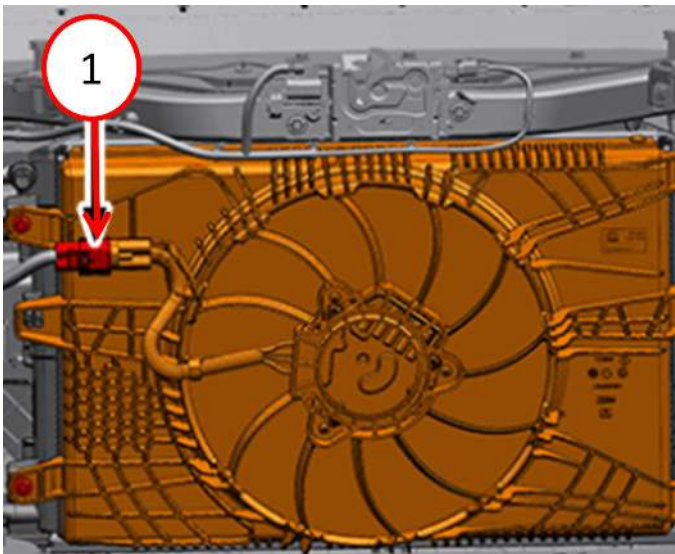
**Fig. 1**  
Cooling Fan Assembly

1 - Wire Harness To Disconnect/Connect

4. Disconnect the cooling fan wire harness connector [Fig. 1](#).

34. Connect the cooling fan wire harness connector [Fig. 1](#).

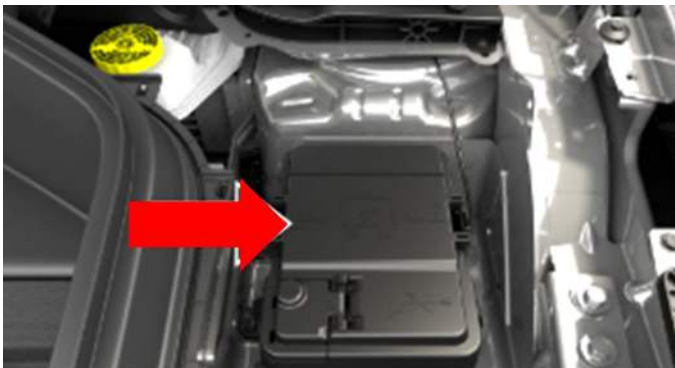
**Fig. 2**  
Front PDC Cover

**\*\*Failure to remove the #32 AGSM/GSM fuse will result in damage to the shifter.**

5. Remove the front PDC cover, locate and remove the #32 AGSM/GSM fuse [Fig. 2](#)\*\*.

33. \*\*Install the #32 AGSM/GSM fuse and the front PDC cover [Fig. 2](#)\*\*.
