| REFERENCE: | TSB: 08-127-25 REV. C<br>GROUP: 08 - Electrical | Date: | December 18, 2025 | REVISION: | 08-127-25 REV. B |
| VEHICLES AFFECTED: | 2025 (KM) Jeep Wagoneer S<br>This bulletin applies to vehicles equipped with 400V G2500 FR/RR Elec Drive Motors (Sales Code ELD). | | | MARKET APPLICABILITY:<br><div><input checked="" type="checkbox"/> NA<input type="checkbox"/> MEA<br/><input type="checkbox"/> SA<input type="checkbox"/> IAP<br/><input type="checkbox"/> EE<input type="checkbox"/> CH</div><br>NOTE: **This bulletin applies to North America markets.** | |

| <b>CAUSE:</b> | EVCU software |

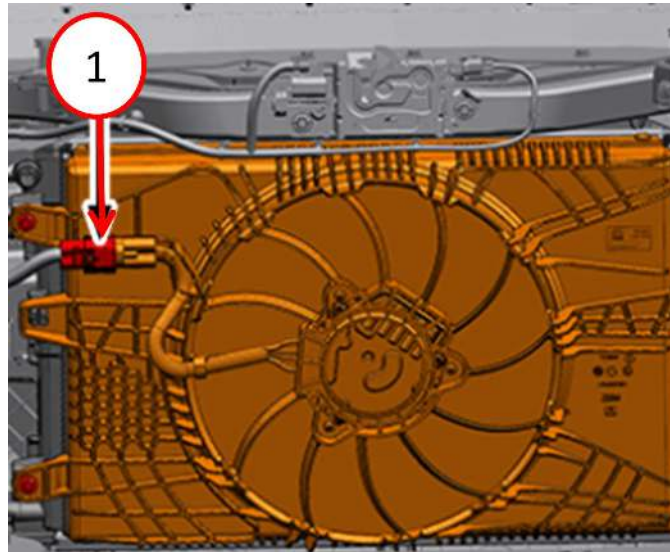
**Fig. 1**  
Cooling Fan Assembly

1 - Wire Harness To Disconnect/Connect

4. Disconnect the cooling fan wire harness connector [Fig. 1](#).

34. Connect the cooling fan wire harness connector [Fig. 1](#).

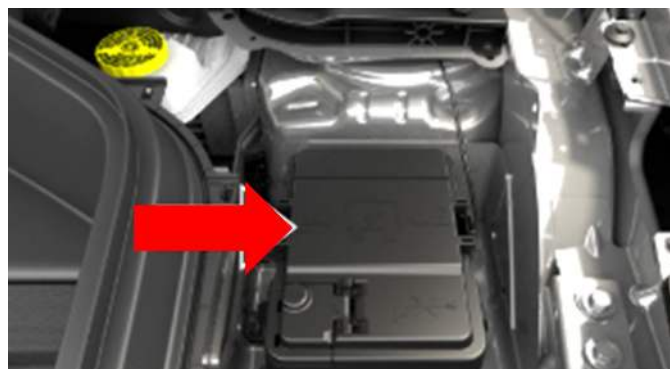
**Fig. 2**  
Front PDC Cover

**\*\*Failure to remove the #32 AGSM/GSM fuse will result in damage to the shifter.**

5. Remove the front PDC cover, locate and remove the #32 AGSM/GSM fuse [Fig. 2](#)**\*\***.

33. \*\*Install the #32 AGSM/GSM fuse and the front PDC cover [Fig. 2](#)\*\*.

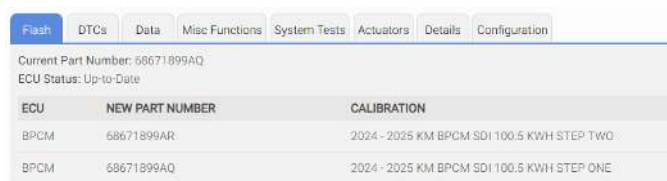
**Fig. 3**

Two Step Software Level AQ And AR Screen

6. Inspect the software level on the BPCM by going into the "Flash" tab and compare to what software is available [Fig. 3](#).

**If the BPCM is already at the AQ level, the module must be reprogrammed to the AR level. Do not over flash at the AQ level to get to the AR level.**
