| REFERENCE: | TSB: 08-128-25 REV. B<br>GROUP: 08 - Electrical | Date: | December 18, 2025 | REVISION: | 08-128-25 REV. A |
| VEHICLES AFFECTED: | 2025 (KM) Jeep Wagoneer S<br>This bulletin applies to vehicles equipped with 400V G2500 FR/RR Elec Drive Motors (Sales Code ELD). | | | MARKET APPLICABILITY:<br><div><input checked="" type="checkbox"/> NA<input type="checkbox"/> MEA<br/><input type="checkbox"/> SA<input type="checkbox"/> IAP<br/><input type="checkbox"/> EE<input type="checkbox"/> CH</div><br>NOTE: **This bulletin applies to the North America markets.** | |

| <b>CAUSE:</b> | <b>BPCM software</b> |

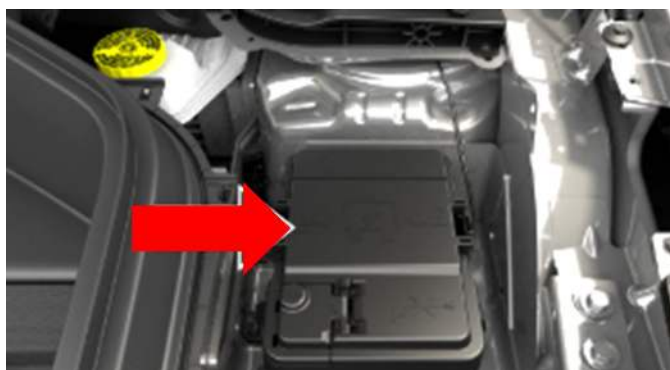
**Fig. 2**  
Front PDC Cover

**\*\*Failure to remove the #32 AGSM/GSM fuse will result in damage to the shifter.**

5. Remove the front PDC cover, locate and remove the #32 AGSM/GSM fuse [Fig. 2](#)\*\*.

33. \*\*Install the #32 AGSM/GSM fuse and the front PDC cover [Fig. 2](#)\*\*.
34. Connect the cooling fan wire harness connector [Fig. 1](#).
35. Install the front storage bin. Refer to the detailed service procedures available in DealerCONNECT/ServiceLibrary under: Service Info> 23 - Body / Exterior / Bin, Storage / Installation.
36. Clear any DTCs that may have been set in any modules due to reprogramming. The wiTECH application will automatically present all DTCs after the flash and allow them to be cleared.
