## Technical Service Bulletin (TSB)

### Flash: Motor Control Processor B (MCP B) Updates 6B3

| REFERENCE: | TSB: 08-409-25<br>GROUP: 08 - Electrical | Date: | December 18, 2025 | REVISION: | — |
| VEHICLES AFFECTED: | 2025 (KM) Wagoneer S<br>This bulletin applies to vehicles equipped with 400V G2500 FR/RR Elec Drive Motors (Sales Code ELD). | | | MARKET APPLICABILITY:<br><div><input checked="" type="checkbox"/> NA<input type="checkbox"/> MEA<br/><input type="checkbox"/> SA<input type="checkbox"/> IAP<br/><input type="checkbox"/> EE<input type="checkbox"/> CH</div><br>NOTE: This bulletin applies to North America markets. | |

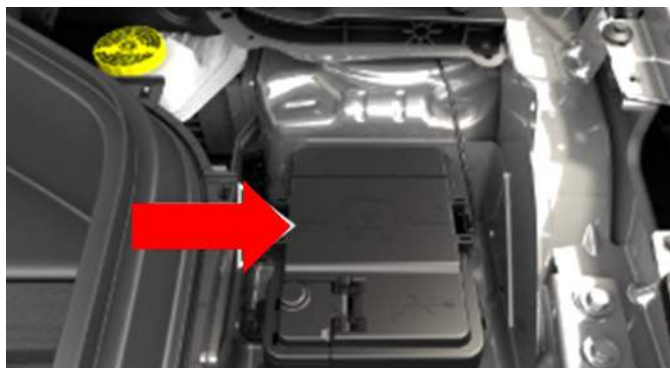
**Fig. 2**  
Front PDC Cover

**Failure to remove the #32 AGSM/GSM fuse will result in damage to the shifter.**

5. Remove the front PDC cover, locate and remove the #32 AGSM/GSM fuse [Fig. 2](#).

33. Install the #32 AGSM/GSM fuse and the front PDC cover [Fig. 2](#).
