| Subject:<br><br>CHECK ENGINE LIGHT ON WITH DTC P0451 P2451 P2422 P0441 | Service Alert No.: SA-059/25 |

2024 -2026 CX-90 PHEV

2025-2026 CX-70 PHEV

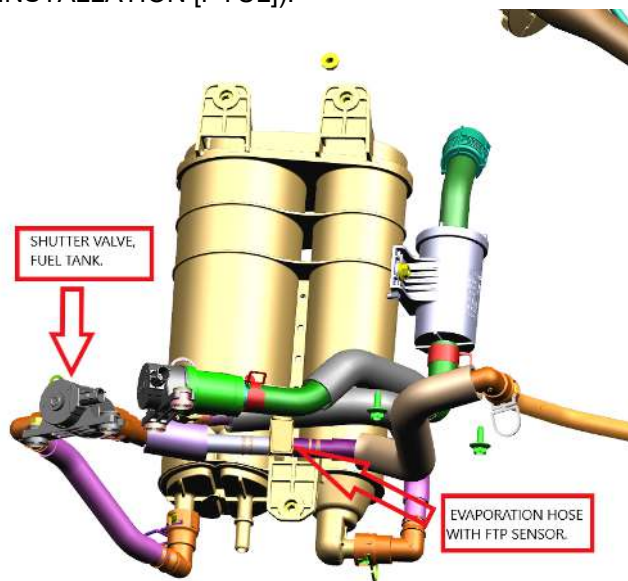
This may be caused by a concern with the fuel pressure sensor or shutter valve operation.

Replace the evaporative parts listed below following the instructions on MGSS (FUEL TANK SHUT VALVE REMOVAL/ INSTALLATION [PYUL]).
