## STAR ONLINE PUBLICATION

**Case Number:** S2123000034

**Symptom/Vehicle Issue:** C15A1-00 Unable To Obtain Desired Ride Height Service Air Suspension Message On Cluster

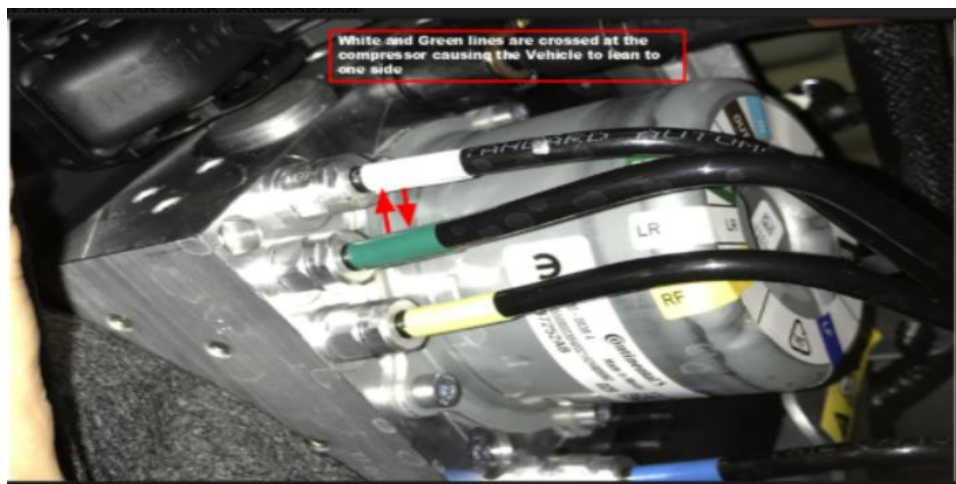
Not ok-

White and green are incorrect

**Discussion:** The airlines and compressor are color coded to identify which airline goes to what port of the compressor. Verify proper line routing as part of diagnosis.
