## STAR ONLINE PUBLICATION

**Case Number:** S2018000007 REV. D

**Symptom/Vehicle Issue:** Diagnostic Trouble Code (DTC) P0299 – Turbocharger Underboost Additional Diagnostics

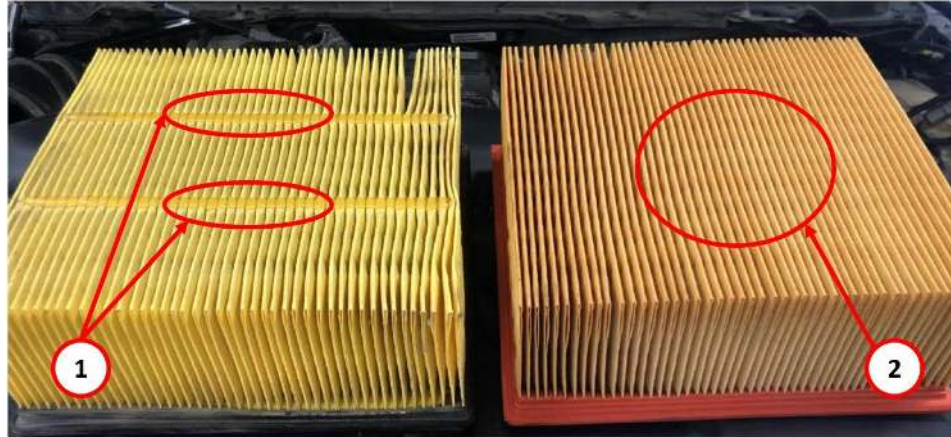
**Figure 1**

1. Remove, and inspect the engine air filter. Ensure that the air filter is clean, and not restricted.
2. Inspect the bottom of the air filter to see if it utilizes glue strips to separate the pleats. Newer design OEM replacement air filters, and some aftermarket filters utilize glue strips to separate the pleats. Please see ([Figure 1](#)). There have been reports that filters using this design can potentially cause this DTC. If the air filter installed on the vehicle utilizes these glue strips, swap it with one that is not equipped with them, and retest.

1. Glue Strips
2. No Glue Strips

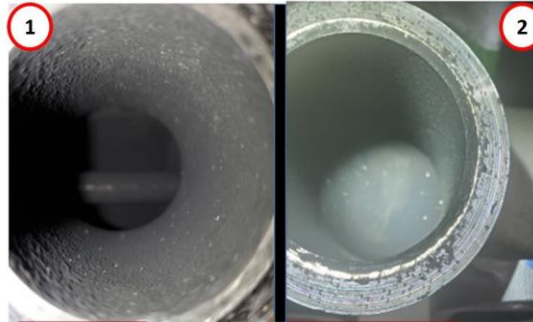
Figure 3

5. Remove the EGR Crossover tube from the EGR valve, and inspect the EGR inlet to see if there are signs that the valve internal seat has begun to rotate. Please see (Figure 3). The EGR internal shaft should be completely visible when looking into the crossover tube inlet.

1. Healthy part
2. EGR with rotated seat

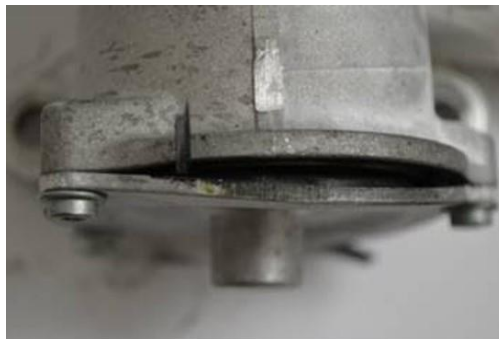
Figure 4

6. Thoroughly inspect the EGR valve end cap for signs of leaks (Figure 4). If found to be leaking, replace the EGR valve.
