## STAR ONLINE PUBLICATION

**Case Number: S2118000001 REV. B**

**Symptom/Vehicle Issue:** Malfunction Indicator Lamp (MIL) Illumination. Diagnostic Trouble Code (DTC) P0471 – Exhaust Pressure Sensor 1 Performance, Set.

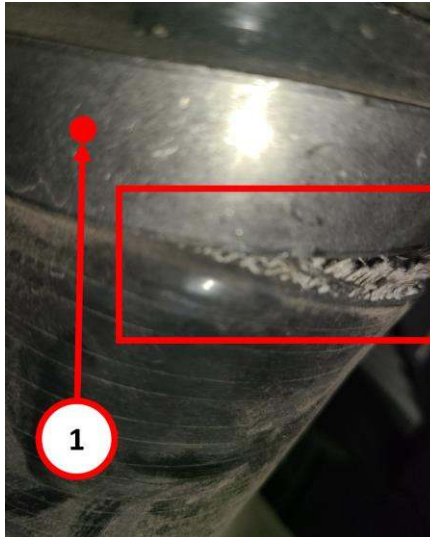
**Figure 3**

3. Inspect the exhaust system for restrictions (e.g. DOC/DPF face plugging).
4. If the exhaust is found restricted. Inspect the following areas for the cause of the restriction.
  - a. Restricted air intake
  - b. Restricted EGR systems,
  - c. Fuel system concerns causing over fueling, etc.
5. Inspect the Charge Air Cooler (CAC) hoses for loose connections/clamps, splits, and other damage which can also cause the exhaust system to plug up. Please see (**Figures 1, 2, and 3**).

1. CAC Hose Clamp

6. Repair the cause of the exhaust restriction prior to replacing any of the exhaust components.
