# TECHNICAL SERVICE BULLETIN

AN22-006A

NTB22-027A

## DTC B2E01-96 (INTERNAL BATTERY) STORED AS CURRENT IN IVC

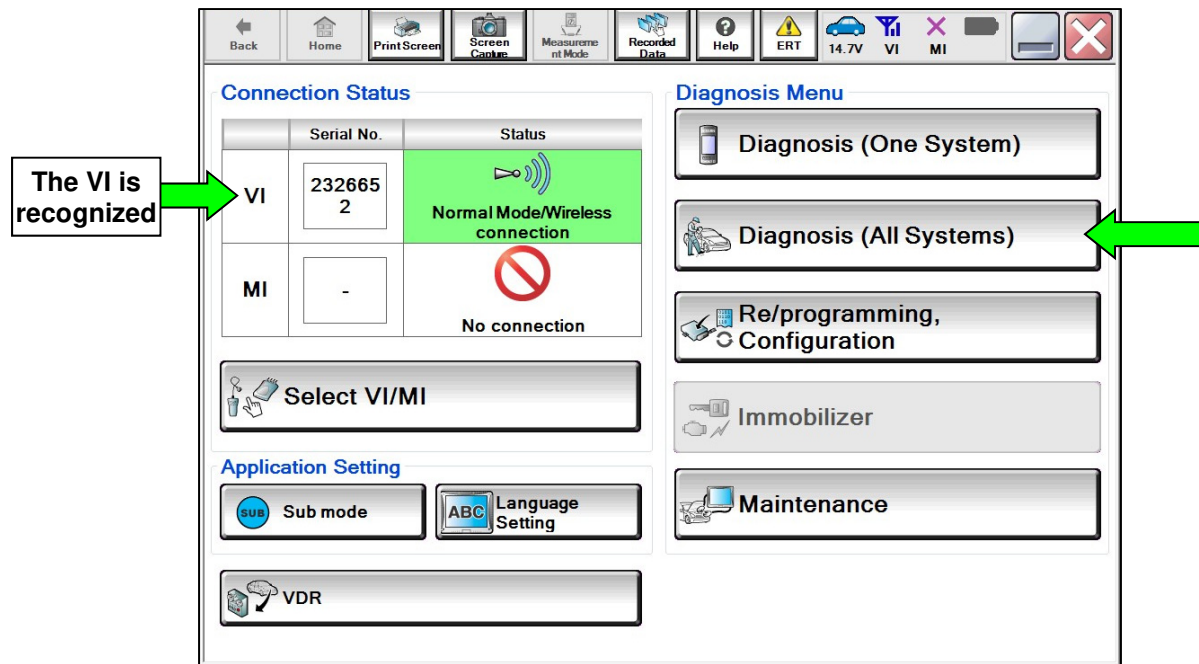
Figure 1

7. Wait for the VI to be recognized.
  - The serial number will display when the VI is recognized (Figure 1 on page 3).

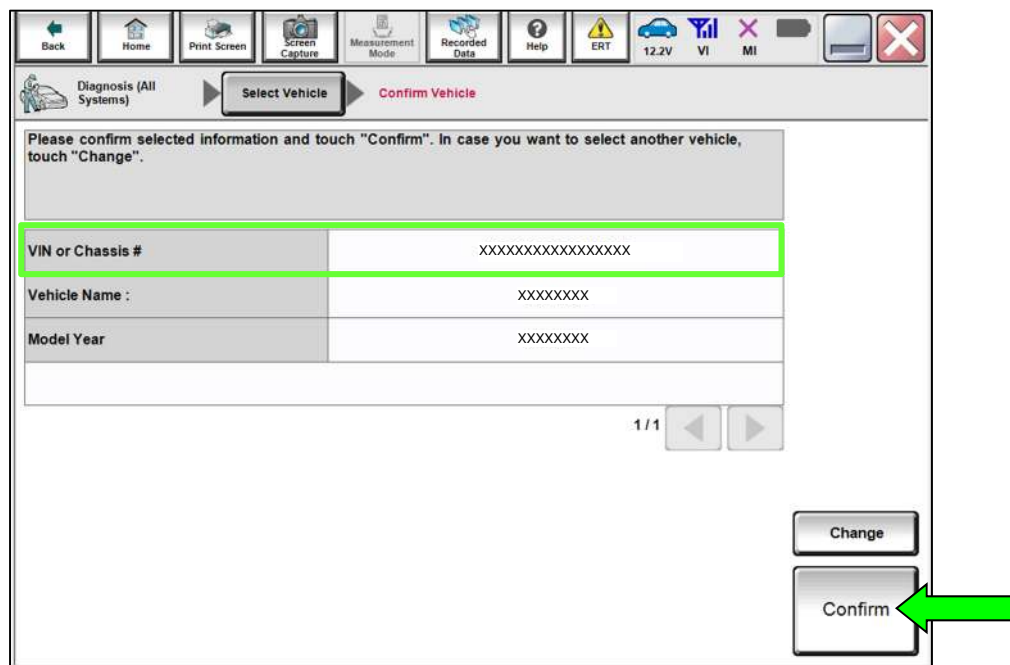
Figure 2

9. Verify the correct **VIN or Chassis #** is populated (Figure 2).
10. Select **Confirm**.

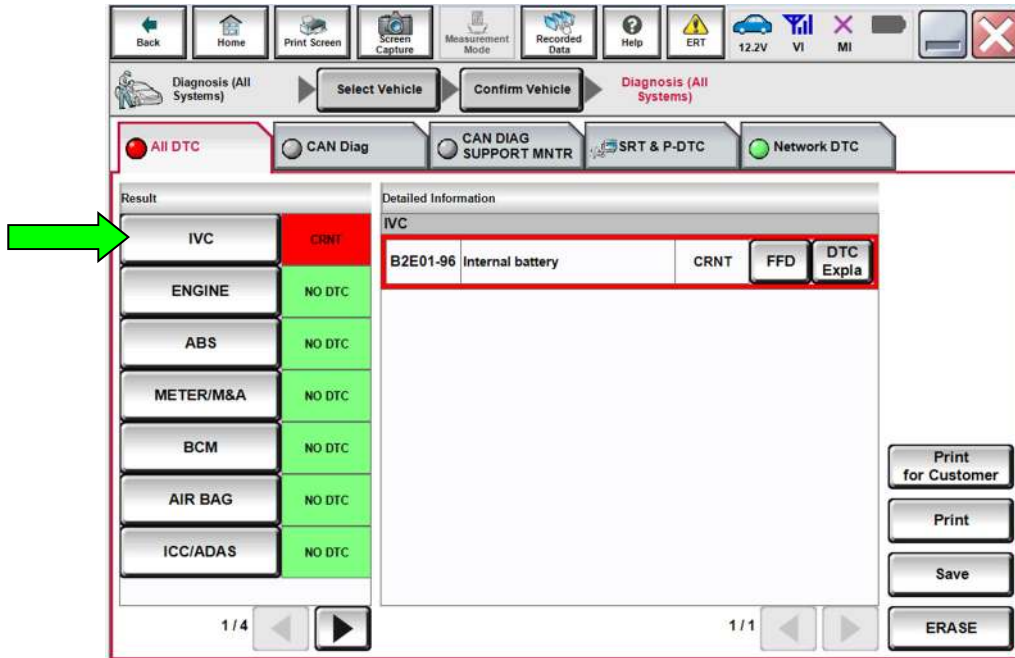
Figure 3

11. Confirm that DTC B2E01-96 for Internal battery is “CRNT” in the **IVC**.

- If only DTC B2E01-96 is present, select **IVC** (Figure 3) and then proceed to step 12.
- If additional DTCs, other than B2E01-96, are present in the **IVC**, refer to the ESM for further diagnostic information and repair first, and then proceed to step 12.

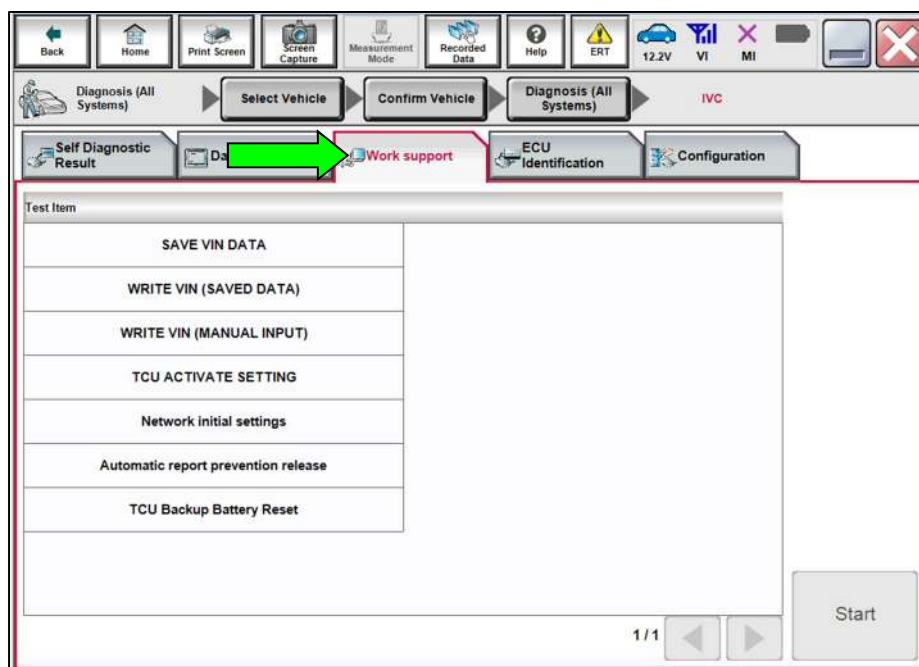
Figure 4

12. Select **Work support**.

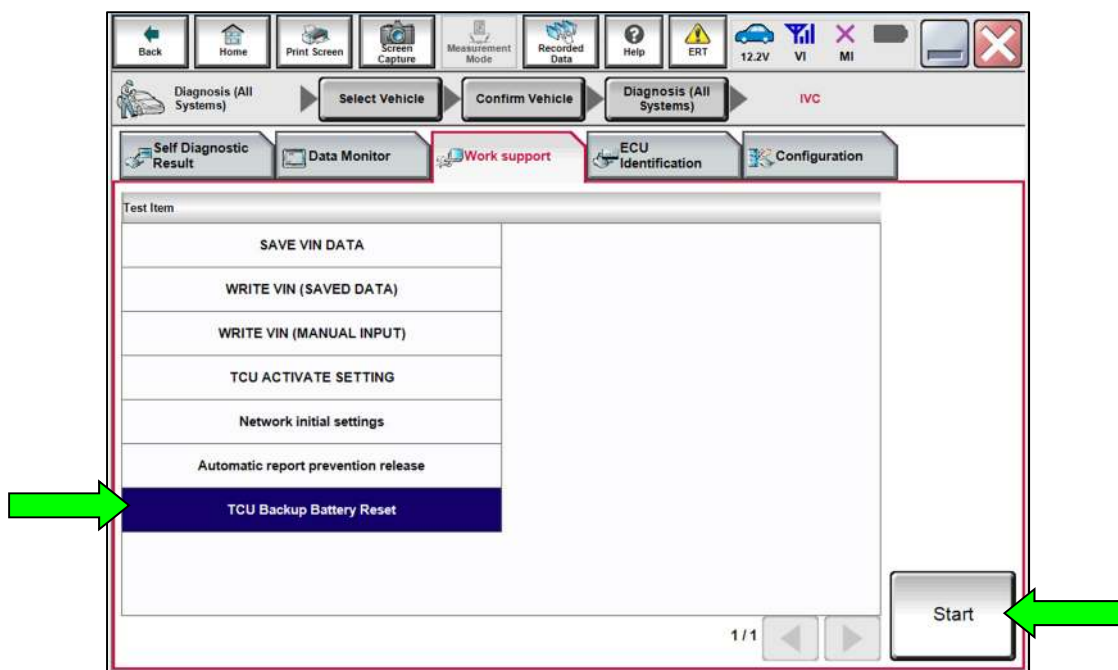
Figure 5

13. Select **TCU Backup Battery Reset**, and then select **Start**.

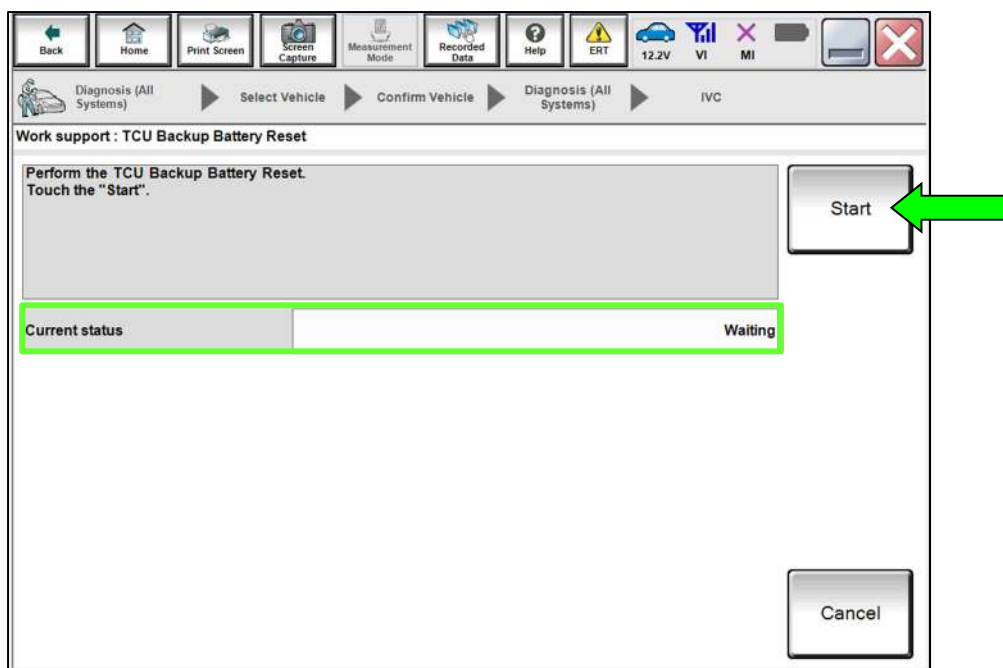
Figure 6

14. Verify that the **Current status** indicates “Waiting”, and then select **Start**.

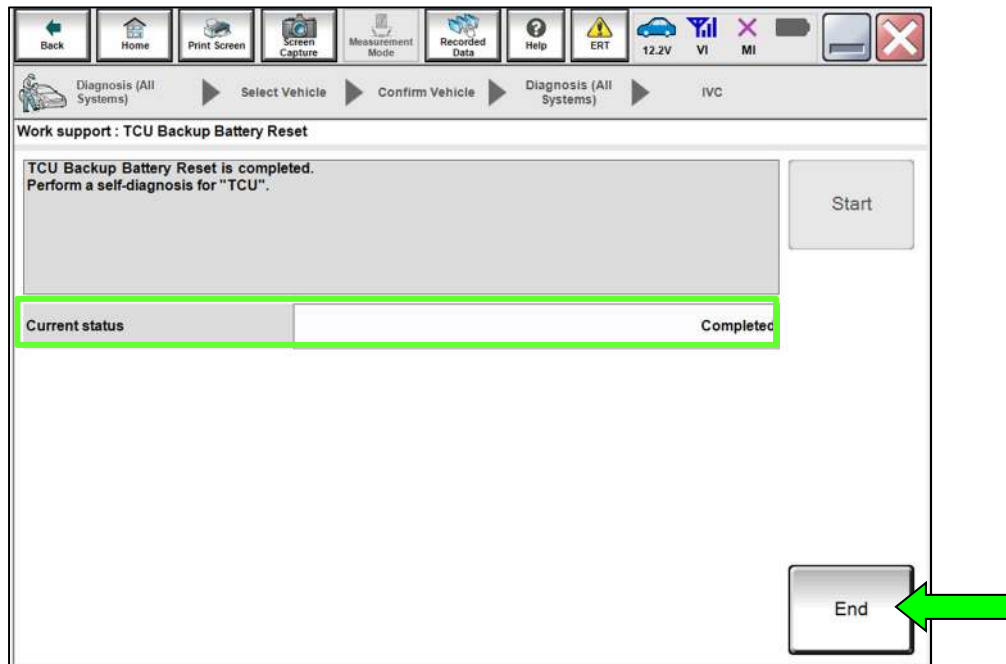
Figure 7

15. When the **Current status** has changed to “Completed”, select **End**.

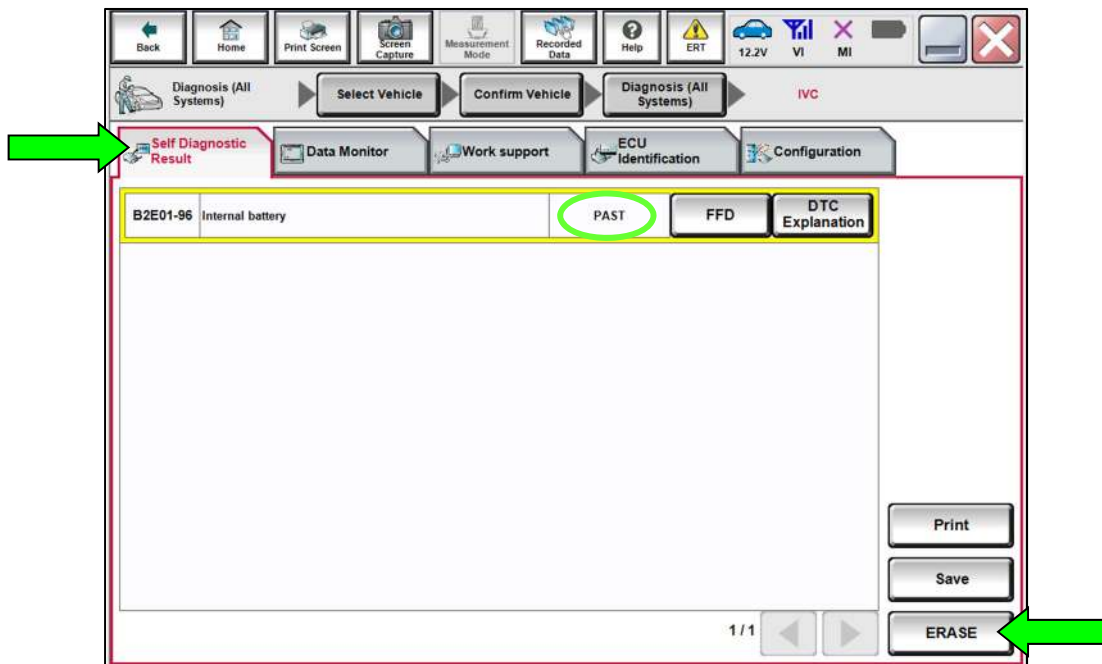
Figure 8

16. Select **Self Diagnostic Result** and confirm that DTC **B2E01-96 Internal battery** is “PAST”, and then select **ERASE**.
- If **B2E01-96 Internal battery** will not change to “PAST”, refer to the ESM for further diagnostic information.

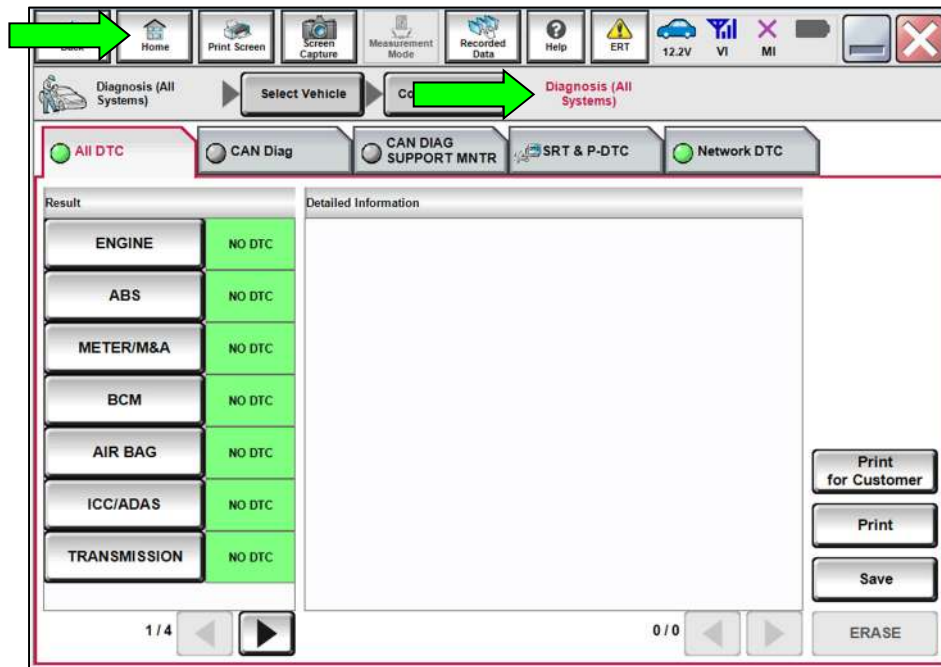
Figure 9

17. Select **Diagnosis (All Systems)**, where shown in Figure 9.
18. In **Diagnosis (All Systems)**, confirm that **B2E01-96 Internal battery IVC** has not returned, and then select **Home**.
  - If **B2E01-96 Internal battery** returns as “CRNT” or will not **ERASE**, refer to the ESM for further diagnostic information.
