Preliminary Information

PIT5912F Lane Keep Assist Unavailable / Adaptive Cruise Control Inop / Service Driver Assist Systems / Amber Front Collision Icon On / Dead Battery / No Crank / Front View Camera / Auto Start Stop Inop / DTC U3000 44 49 54 and/or 57

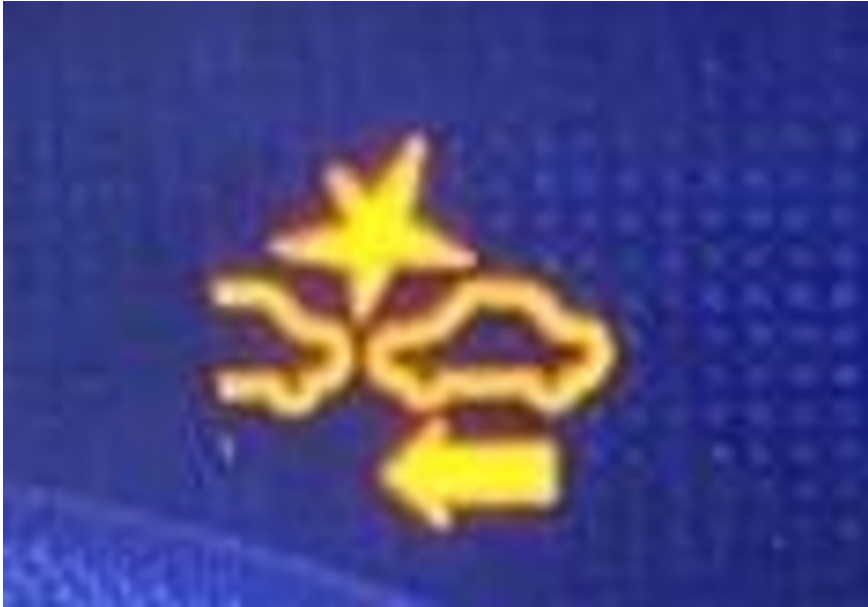
| Condition | <p>Some customers may comment on an amber Forward Collision icon displayed in the IPC, as shown below. Also, DTC U3000 symptom 44, 49, 54, and/or 57 may or may not be set current in the Front View Camera Module. In some cases, there could be a low or dead battery condition. Customers may also notice certain features related to the Front View Camera are unavailable, such as:</p> <ul style="list-style-type: none"><li>- Forward Collision Alert (RPO: UEU)</li><li>- Following Distance Indicator (RPO: UE4)</li><li>- Low Speed Collision Mitigation Braking (RPO: UHY)</li><li>- Pedestrian Collision Mitigation Braking (RPO: UKJ)</li><li>- Lane Keep Assist (RPO: UHX)</li><li>- Automatic High Beam Assist (RPO: TQ5)</li><li>- Adaptive Cruise Control (RPO: KSG)</li></ul> <p>Note: Because this condition could cause a low/dead battery, it can cause the Auto Stop/Start feature to be disabled due to the battery start of charge. The front view camera module issue should be corrected first before diagnosing an auto stop/start complaint.</p> |

1. Turn the ignition off.
2. Remove the F11DR fuse for the B174W Front View Camera, located in the X51R Right Instrument Panel Fuse block.
3. Leave the fuse removed for 1 minute, then reinstall the fuse.
4. Clear any DTC's and check camera operation.
5.
  - If the camera operation has returned, then no further action is required.
  - If the camera operation has NOT returned, then perform a camera relearn using GDS2.
6.
  - If the camera operation has returned after the camera relearn, then no further action is required.
  - If the camera operation has NOT returned after the camera relearn then perform normal SI diagnostics and repair as necessary.

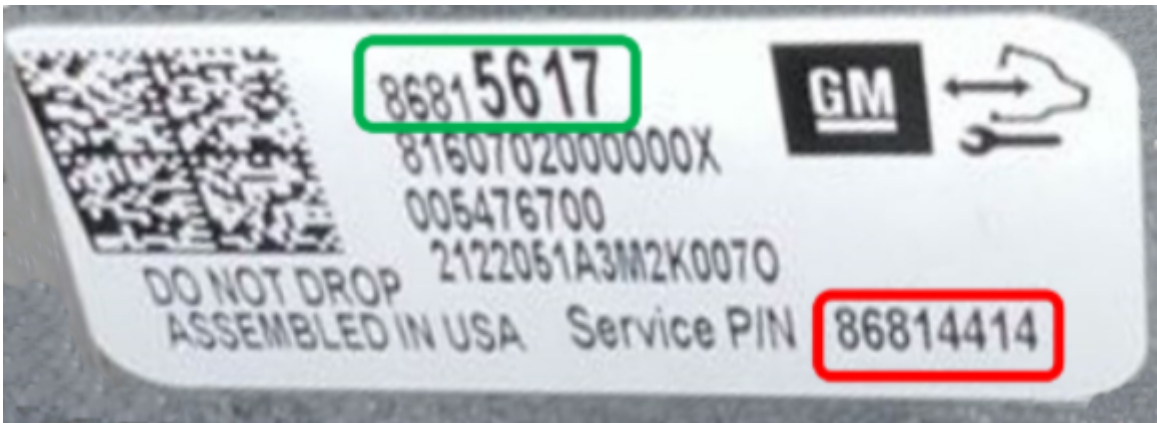
**Note:** If it is necessary to replace the Front View Camera, be sure to use the correct Part Number listed in the Electronics Parts Catalog. The Original Front View Camera may have "Service P/N 86814414" printed on the label (circled in red below) and that is the incorrect Part Number for this vehicle. Correct Part Number to use is in location circled in green below. If the part was ordered incorrectly it can be returned to the PDC using the correct MR return code.
