## SERVICE BULLETIN

**APPLICABILITY:** 2014MY XV Crosstrek Hybrid Models (HEV)

**NUMBER:** 07-98-15

**SUBJECT:** Relay Freezing Causing DTCs P1C30 and U0110

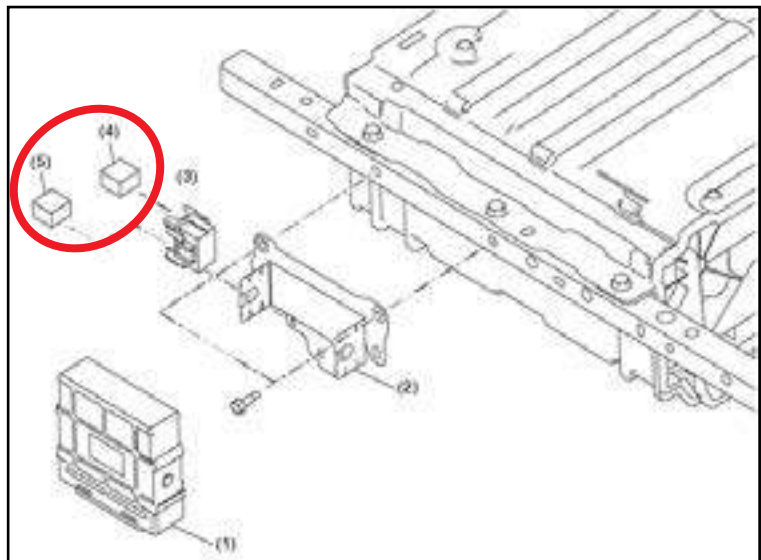
This bulletin announces a change to the power supply relay used for the Drive Motor Control Module (DMCM) and the cooling fan / drive motor inverter. In specific cold climate (below freezing) conditions, if there is a small amount of condensation inside the relay, it can in rare cases freeze and cause the relay to remain open which in some cases, sets DTCs P1C30 and / or U0110.

1. Drive Motor Control Module (DMCM)
2. DMCM Mounting Bracket
3. Relay Holder
4. DMCM Power Relay
5. Cooling Fan / Drive Motor Inverter Power Supply Relay

- If DTC P1C30 and / or U0110 are found stored in memory and the outside temperatures are (or were recently) below freezing, replace both of the power supply relays (4 and 5) as shown in the illustration above.
- Record the customer's radio station presets (and navigation favorites where applicable).
- When either of the power supply relays is replaced, both the auxiliary and the engine start batteries must be disconnected, **auxiliary battery first**. Remove the 12mm nut from the restart battery sensor stud and remove the cable along with the ground terminal from the Auxilliary battery.

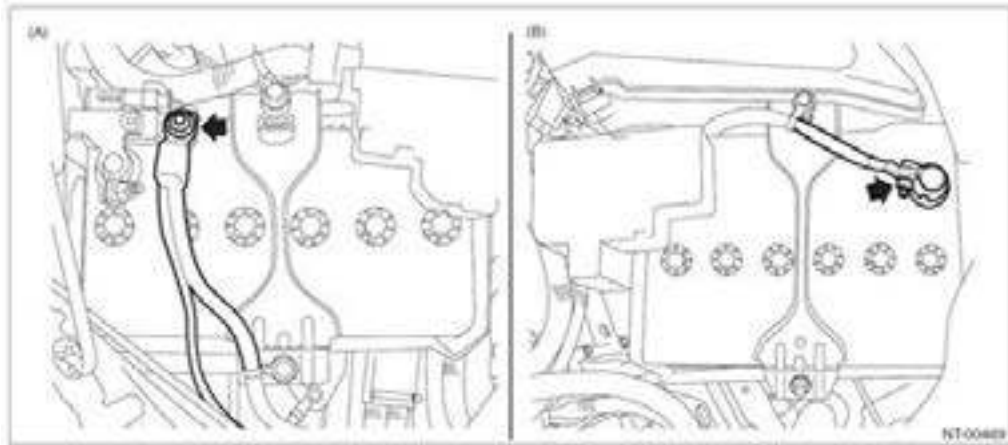
**12v Engine Restart Battery (A)**

**12v Auxiliary Battery (B)**

**IMPORTANT: DO NOT** remove the sensor assembly from the restart battery terminal.

- After reassembly, reconnect the engine restart battery first then the auxiliary battery. Torque the 12mm nut securing the negative cable to the restart battery sensor to 2.6 ft. lbs (31 inch-pounds).
- Reset the customer's radio station presets (and navigation favorites where applicable).
