## SERVICE BULLETIN

**APPLICABILITY:** 2008MY and Later Impreza, WRX and STI  
 2009MY and Later Forester M/T Equipped Vehicles  
 with Hill Start Assist

**NUMBER:** 03-72-14

**SUBJECT:** Hill Start Assist (HSA) Warning Light, DTC C0076

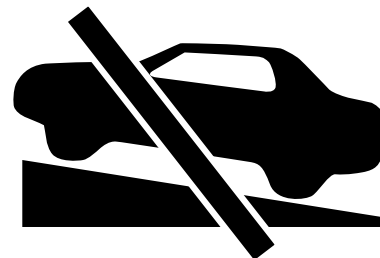
This bulletin provides information to address a customer concern of intermittent operation of the Hill Start Assist warning lamp. When the HSA warning lamp is illuminated, the hill start assist system is inoperative. DTC C0076 may be stored in memory along with detail codes 2610H and / or 2620H. All of these codes refer to the operation of the clutch switches.

- For detail code 2610H, check the clutch pedal switch signal using the SSMTIII following the procedure in the applicable Service Manual.
- For detail code 2620H, check the clutch pedal switch clearance following the procedure in the applicable Service Manual.

Once it has been determined the clearance adjustments are both within specification and switch signal functions are operating normally, the most likely cause for the intermittent HSA warning lamp illumination is the vehicle operator resting their left foot on the clutch pedal with enough pressure to activate the switches. Interview the customer about their driving habits then, if necessary, a road test while observing where they rest their left foot (especially in traffic) would be a good way to confirm the root cause of the condition. If you confirm the customer is resting their foot on the clutch pedal when they are not: starting out, shifting, or coming to a stop, an explanation of why their driving habits may be causing the HSA lamp to illuminate would be recommended. Because of the minimal amount of clearance which exists when the clutch switches are properly adjusted, even the slightest amount of unintentional pressure on the clutch pedal can result in false input signals to the respective control units resulting in the illumination of the HSA indicator lamp.
