# Technical Service Bulletin

## 69 Airbag control module test plans not completing, B130455, B130555, B159B00

69 23 89 2070322/1 May 19, 2023.

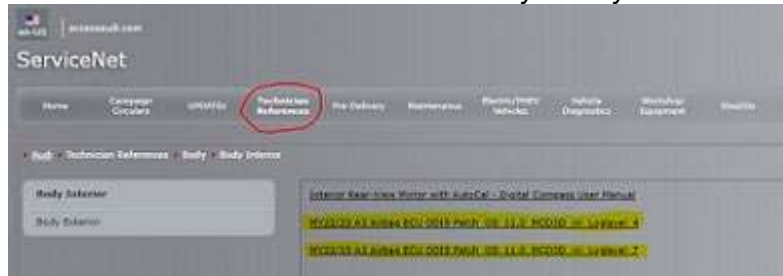
**Figure 1.** Both of the ODIS patch files are located in ServiceNet.

1. If a configuration of the airbag control module fails (e.g. after replacing a front seat belt), perform an ignition cycle. Interrogate the airbag control module fault memory again, and attempt to run the test plans again.
2. If they still fail, use the oldest possible hardware version of the diagnostic tester (e.g. VAS6150D) and start diagnosis again.
3. If the configuration is still unsuccessful, an ODIS patch needs to be installed to ensure proper communication with the airbag control module. This ODIS patch consists of two files which are available in ServiceNet (Figure 1):

ServiceNet>>Technician References>>Body>>Body Interior.
