# Technical Service Bulletin

## 91 No diagnostics communication to the telematics control module; DTC U142100

91 23 08 2056076/18 June 29, 2023. Supersedes Technical Service Bulletin Group 91 number 23-04 dated June 12, 2023, for reasons listed below.

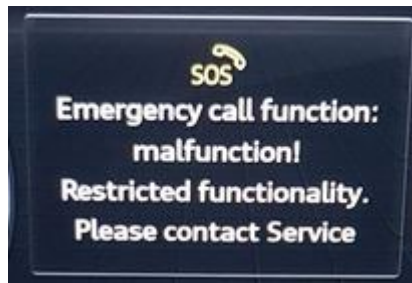
- An SOS Warning might be displayed in the instrument cluster (Figure 1).

**Figure 1.** Emergency call malfunction warning.

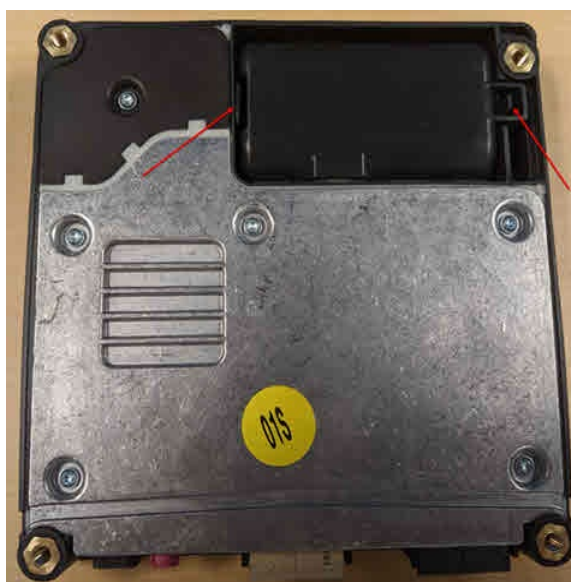
**Figure 2.** Backup battery compartment location.

1. Remove and unplug the telematics control module, J949 (address word 0075) according to the Elsa Repair Manual.
2. Open the battery compartment of the telematics control module, J949 (address word 0075), and disconnect the backup battery (Figures 2 - 3).

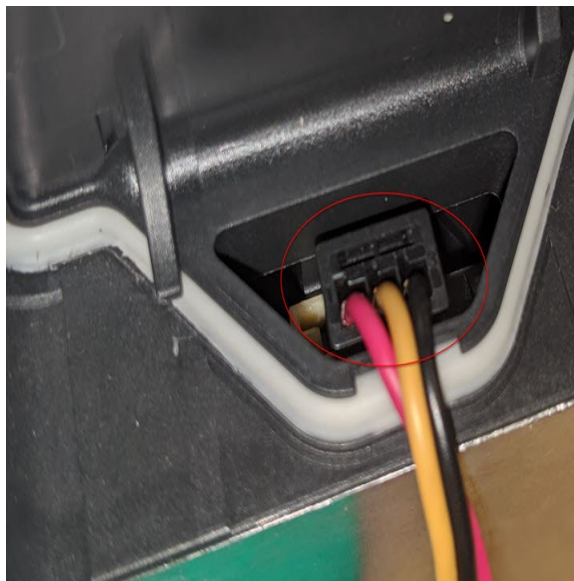
**Figure 3.** Backup battery connector (no release mechanism).
