## Technical product information

| <b>Topic</b> | Bentayga V8 Kovomo - DTC P304300 with symptom code (10061) - Fuel Pump Mechanical Malfunction - MIL lamp | | |

### Bentayga Series - V8 Kovomo

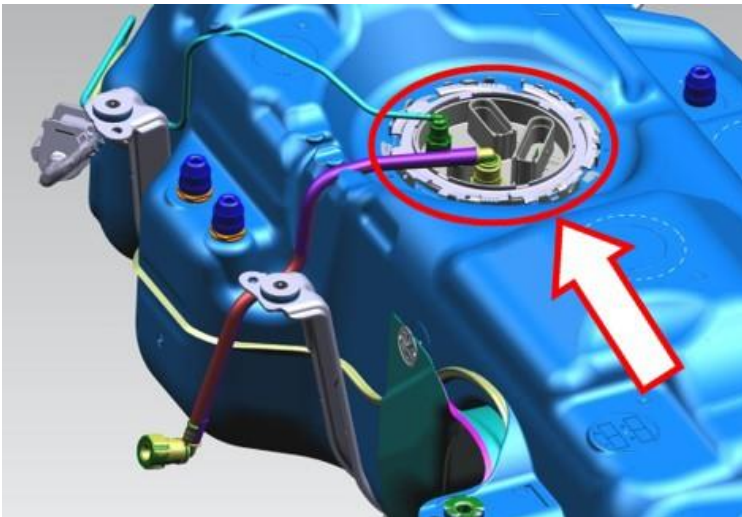
Figure 1

4) Conduct a visual inspection of the fuel pump delivery module (Top) for any obvious signs of damage (Figure 1)
