## Technical product information

| <b>Topic</b> | DTC P263500 with symptom code -10061 - Noise from within the fuel tank |
| <b>Brand</b> | Bentley |

### Bentayga W12 and Bentayga W12 Speed

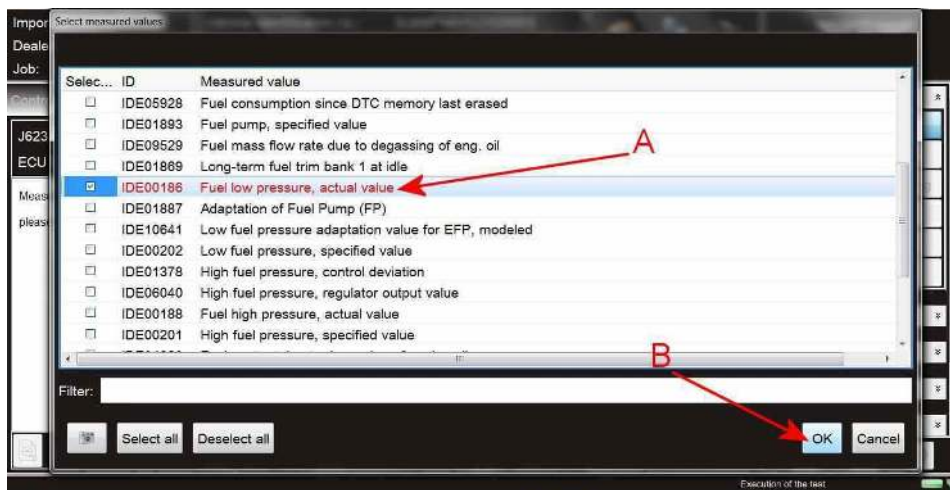
- The engine must be running and at operating temperature, Do Not switch off the engine until advised **CAUTION: Ensure that suitable exhaust extraction is used whilst the engine is running within the workshop**
- Using ODIS Carry out a full GFF of all control modules
- Clear all applicable DTC's
- Select Engine control module 1
- Select Guided functions - Read measured values
- Referring to Figure 2 (Point A) - Navigate to Measured value IDE00186 Fuel low pressure, actual value

- Select OK (Point B)

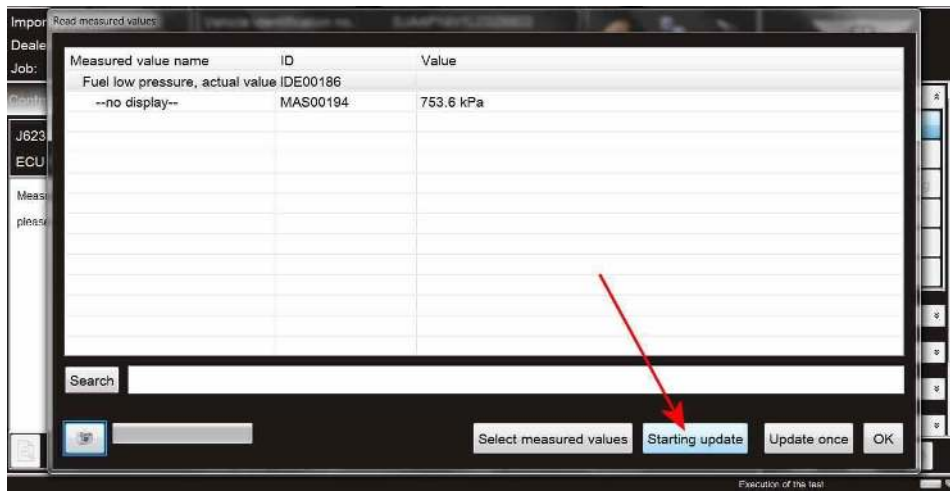
2) Referring to Figure 3 - Select Starting update

- Switch off the engine and leave the ignition on
- Monitor the pressure decay of the low pressure fuel system for 10 minutes

- Should the pressure drop below 300 kPa after 10 minutes and the fuel tank fuel pump is noisy (as per the video on the Bentley hub) the operative should replace the fuel pump as instructed within Rep.Gr 20 - Fuel pump, fuel level sensors, and jet pump (RH) - To remove and fit
