# Technical Bulletin

**21 14 03** April 24, 2014 **2026771** Supersedes T. B. V211108 dated November 16, 2011 to include additional model year applicability.

### Engine Lacks Performance, Engine Warning Light ON, DTCs P2563, P2564, P0299 or P20D8 Stored in ECM Fault Memory

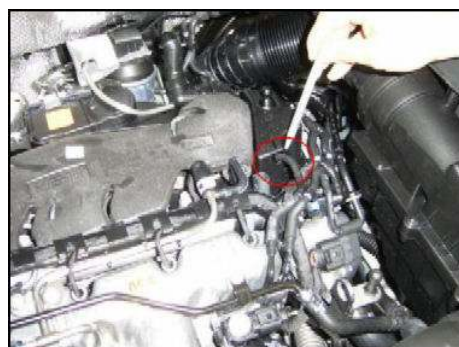
**Figure 1**

Hose not inserted into the vacuum container.

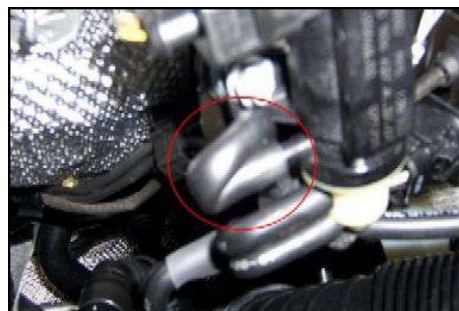
**Figure 2**

Vacuum hose at the solenoid valve, or in the pipe system, is kinked.

- Re-position hoses to avoid pinching. It is not necessary to replace the hoses.

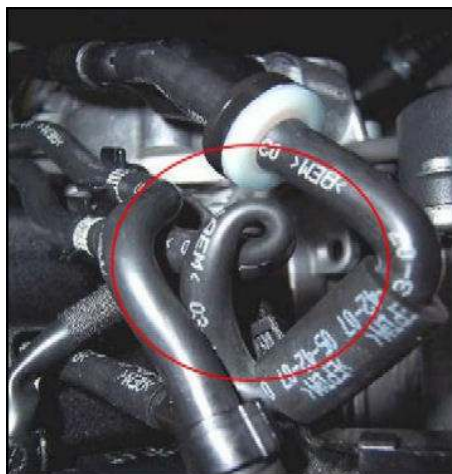
Figure 3

Vacuum hose at the solenoid valve, or in the pipe system, is twisted.

- Re-position hoses to avoid pinching. It is not necessary to replace the hoses.

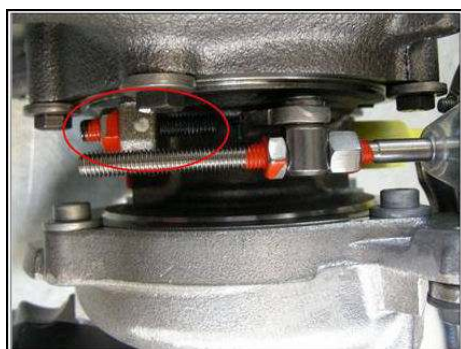
Figure 4

- Inspect the turbocharger stud with clamp nut (min. flow adjustment screw) ( Figure 4).

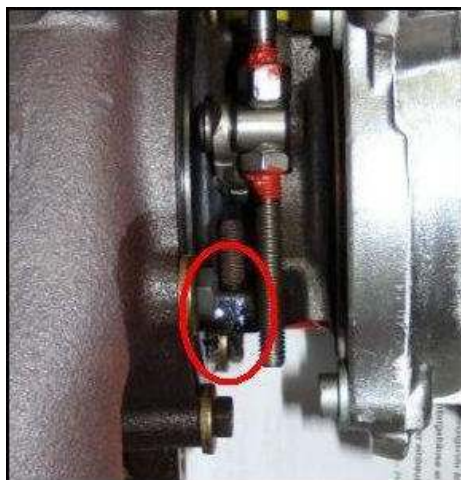
Figure 5

- Inspect the turbo charger to see whether the stud with clamp nut is broken (Figure 5).

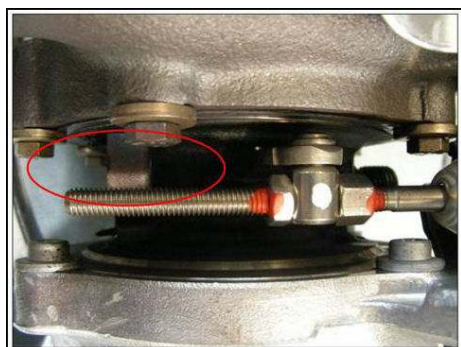
Figure 6

- Inspect the turbo charger to see whether the stud with clamp nut is missing (Figure 6).
- If the stud or clamp nut are missing, replace turbocharger.

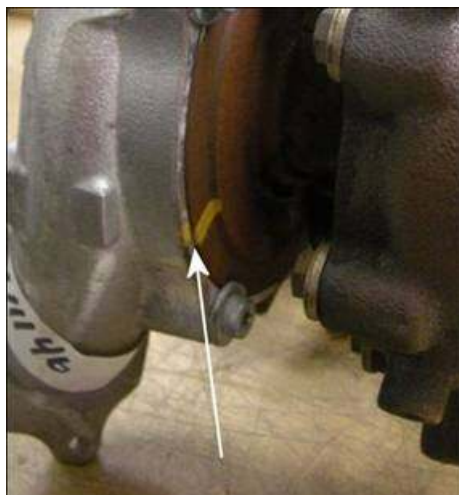
**Figure 7**

- Carefully inspect the turbocharger housing around the entire housing assembly for an alignment mark (Figure 7). If the alignment mark is misaligned, this indicates that the housing has rotated.
- If misaligned, replace turbocharger.

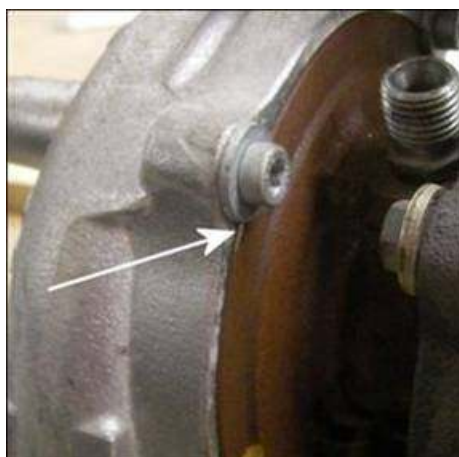
**Figure 8**

- Carefully inspect the turbocharger housing around the retaining bolts for witness marks (Figure 8), indicating that the housing has rotated.
- If witness marks are present from washers, replace turbocharger.

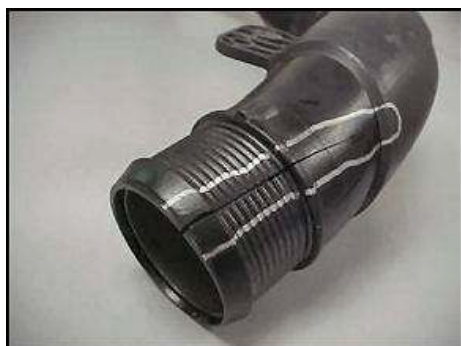
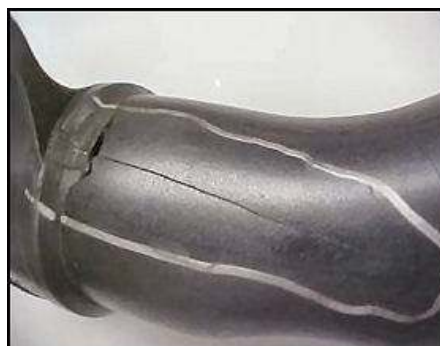
- Inspect the plastic boost pipe that runs from the intake side of the turbocharger to the intercooler for cracks or leaks (Figures 9 and 10).

These cracks can be difficult to see. It may be necessary to pressure test the charge air system according to the repair manual under Engine > Engine Mechanical, Fuel Injection and Glow Plug > 21 turbo charger, G charger =>Diagnosis and Testing => Charge Air System, Checking for Leaks.

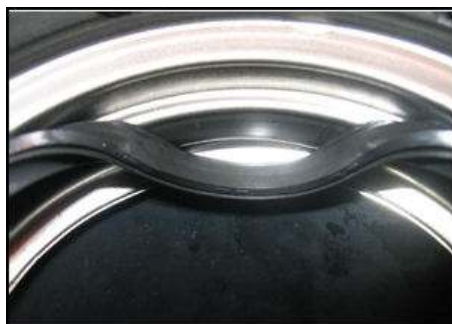
Figure 11

- Inspect the boost pressure hose connections to the intercooler for leaks.
- Ensure that the seals are in the proper position and not damaged (Figure 11). Damaged or missing seals should be replaced. The seals are available separately, it is not necessary to replace the entire hose.
