| REFERENCE: | TSB: 08-121-23<br>GROUP 08 -<br>Electrical | Date: | May 6,<br>2023 | REVISION: | — |
| VEHICLES<br>AFFECTED: | 2022 (DT) RAM 1500 Pickup<br>This bulletin applies to vehicles equipped with the<br>following: Global Telematics Box Module (Sales<br>Code RDG). | | | MARKET APPLICABILITY:<br><div><input checked="" type="checkbox"/> NA<input type="checkbox"/> MEA</div> <div><input type="checkbox"/> SA<input type="checkbox"/> IAP</div> <div><input type="checkbox"/> EE<input type="checkbox"/> CH</div> | |

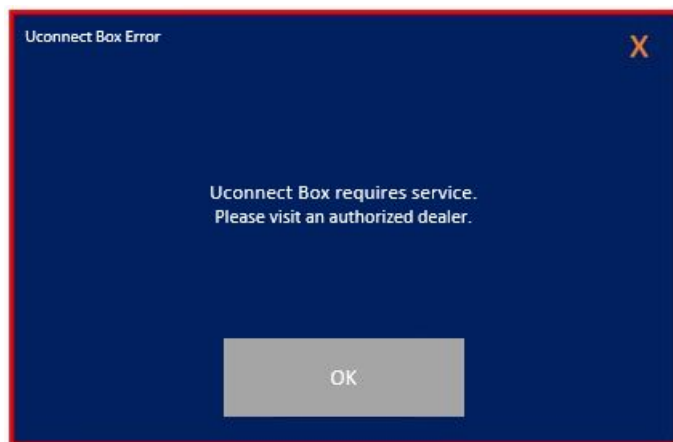
**Fig. 1**  
**Uconnect Box Error Message**

| CAUSE: | TBM Software | | | | |

Message display on the radio screen, “Uconnect Box requires service. Please visit an authorized dealer.” (Fig. 1) , with no active or stored DTCs set by the TBM.

This bulletin provides information regarding the latest Firmware Over The Air (FOTA) update and provides the service technician an overview of the steps a customer will need to take to complete the update. The TBM software will be updated from 4.13 and 5.25 to 5.39.1.
